Learning from Earthquakes

The M_w 5.8 Virginia Earthquake of August 23, 2011

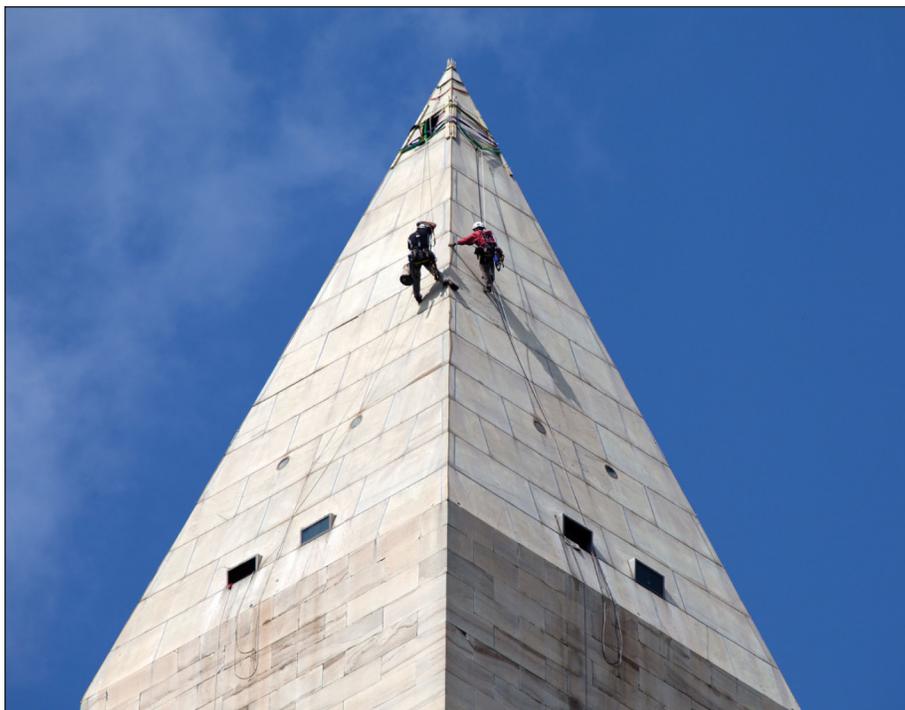
Figure 16. Inspectors from WJE conducting an exterior inspection (photo: National Park Service, 2011b).

An official interior and exterior damage assessment was conducted by the National Park Service, including a climbing team to “rappel all four faces of the Washington Monument to perform a close range survey of the exterior surfaces” (Smith, 2011) (Figure 16). The National Park Service engaged two outside engineering firms (WJE Associates and Tipping Mar Associates) to assist with the investigation. Although the external inspection was officially completed in early October 2011, the Washington Monument currently remains closed to the public (Ruane, 2011a).
