EERI Earthquake Reconnaissance Team Report:
M5.0 Cushing, Oklahoma, USA
Earthquake on November 7, 2016

February 2017

A product of the EERI Learning From Earthquakes Program

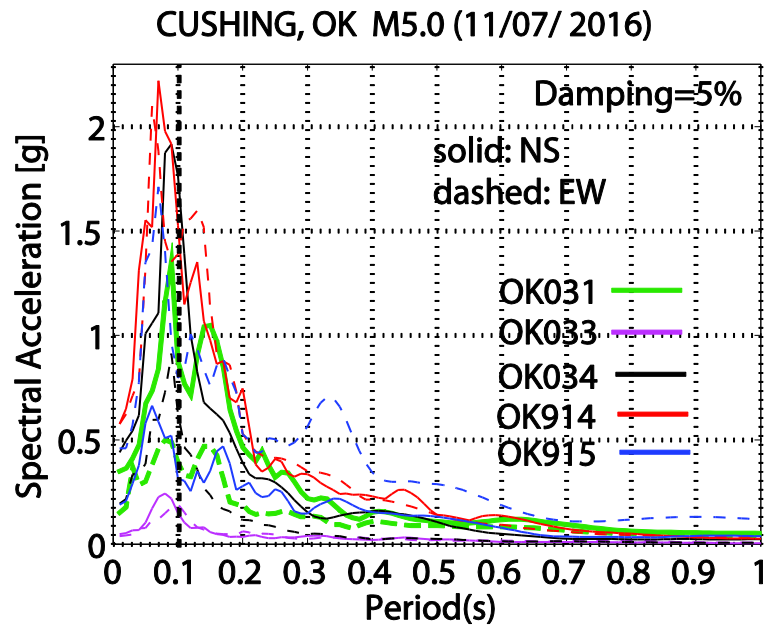
Three different spectra are discussed in this subsection. Figure 7 presents the 5% damped response spectra of accelerations recorded at sites listed in Table 1. The most striking feature of the spectra is the consistency of spectral amplification near a 0.1 s period (.07-0.13s). Many one- to two-story buildings, the most common building type in Cushing, have periods in this range.

Figure 7. Response spectra of recorded accelerations of 5 closest stations to the epicenter (and/or town of Cushing). The striking peaks around 0.1 s is consistent for all stations. Spectral peaks around 0.1 s indicate an amplification of about 3 when compared to zero-period accelerations (source: M. Çelebi, USGS, 2016e).

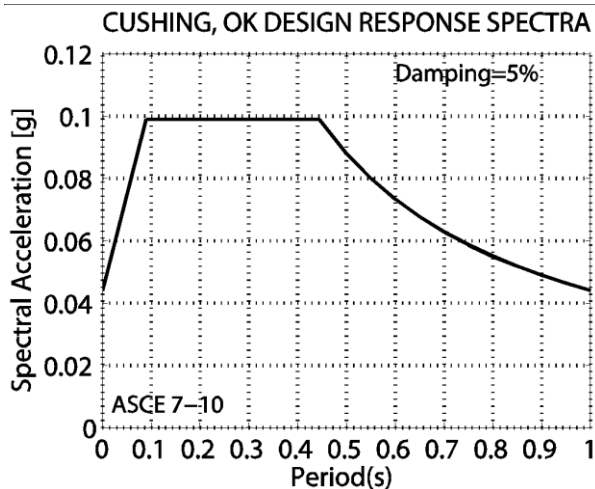
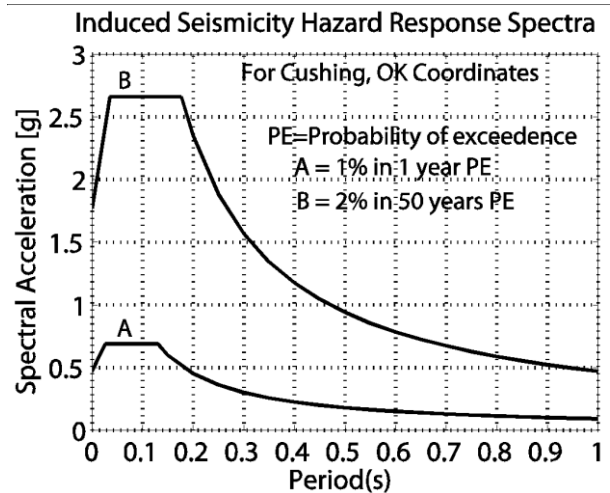
For comparison, Figure 8a (left) shows the ASCE 7-10-based design response spectrum (5 % damped) for the coordinates of Cushing, OK. There is an order of magnitude difference between the recorded response spectra and the design response spectrum.

Furthermore, in Figure 8b (right), we introduce induced-seismicity-based hazard response spectra for 1% in 1-year (line A) and 2% in 50-years (line B) probabilities of exceedances (USGS 2016d). These are constructed for zero period acceleration (ZPA or peak acceleration) and for 0.2 and 1 second spectral acceleration data for the designated seismic hazard forecast. The methodologies behind the induced seismicity seismic hazard maps are documented (Petersen et al., 2015, 2016). Figure 8 clearly shows that the response spectra of recorded motions significantly exceed spectrum A (1% in 1-year probability of exceedance) but generally falls short of spectrum B (2% in 50-years).

Figure 8. (a) Design response spectra (5 % damped) for coordinates of Cushing, OK, according to ASCE 7-10, and (b) induced-seismic-hazard-based response spectra (A and B) for 1% in 1-year and 2% in 50-years probability of exceedances, respectively (source: M. Çelebi, USGS 2016d).

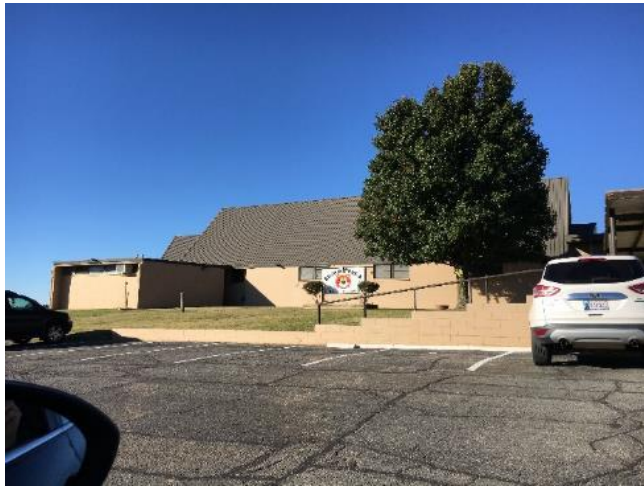
Minor structural damage to schools was only reported at Sunnyside Elementary (Figure 22a), one of eight schools in the Cushing Public School District. Sunnyside is less than 2 miles South/Southeast from the epicenter of the November 6, 2016 magnitude 5.0 earthquake. Damage to this school building included: cracks in mortar joints and brick units (near window openings in the brick veneer, Figure 22b), fallen ceiling tiles, and suspended grid. A steel-framed canopy structure is located outside the main entrance to the school building, and moderate damage was observed to this structure. The canopy structure apparently separated laterally from the brick veneer, and displaced vertically downward after the earthquake event; the steel support posts for the canopy roof also displaced laterally relative to the canopy beams. No attachment (i.e. weld or bolts) was observed between the cap plate on the post and the canopy beam, which allowed the relative displacement to occur, and resulted in an unstable condition. Nuts on anchors between the steel baseplate at the bottom of the posts and the concrete sidewalk were not fully tightened, allowing the baseplate to rotate relative to the sidewalk (Figure 22c). It is unlikely that the nuts were fully tightened prior to the earthquake. Installation of a single 2x4 nominal wood member as temporary shoring between the underside of the canopy beam and concrete sidewalk below was completed prior to the time of structural damage assessment (Figure 22d).

Figure 22. (a) Overall view of Sunnyside Elementary; (b) cracking in brick veneer near main entrance; (c) loose anchor nuts in canopy post base plate connection to concrete sidewalk; and (d) 2x4 stud post member installed as temporary shoring by school maintenance staff (photos: E. Wilson).

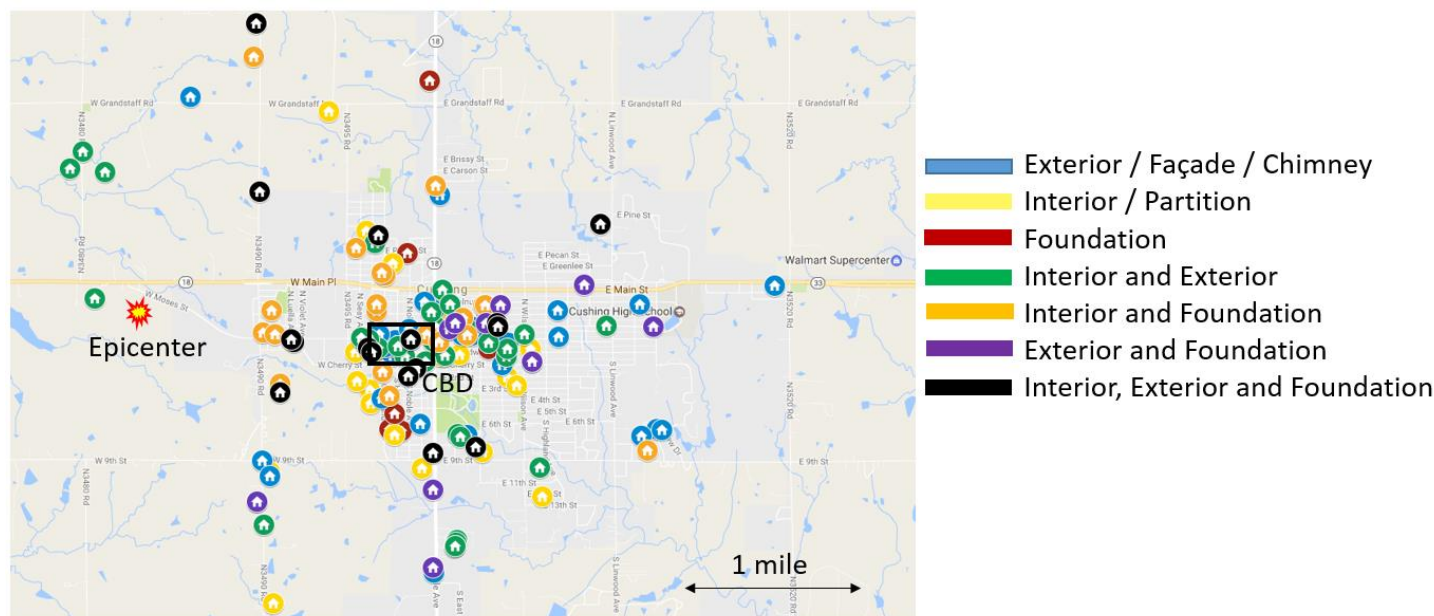
Following the preliminary damage assessments, the City of Cushing set up a local hotline for residents and businesses to report damage to the City Manager's Office. The hotline received over 150 reports of damage. Figure 23 shows approximate damage descriptions called-in to the hotline within the first week after the earthquake.

Figure 23. Coarse damage descriptions called in to Cushing City Manager's office as of one week after the earthquake (data source: City of Cushing damage hotline; map: E. Jampole).

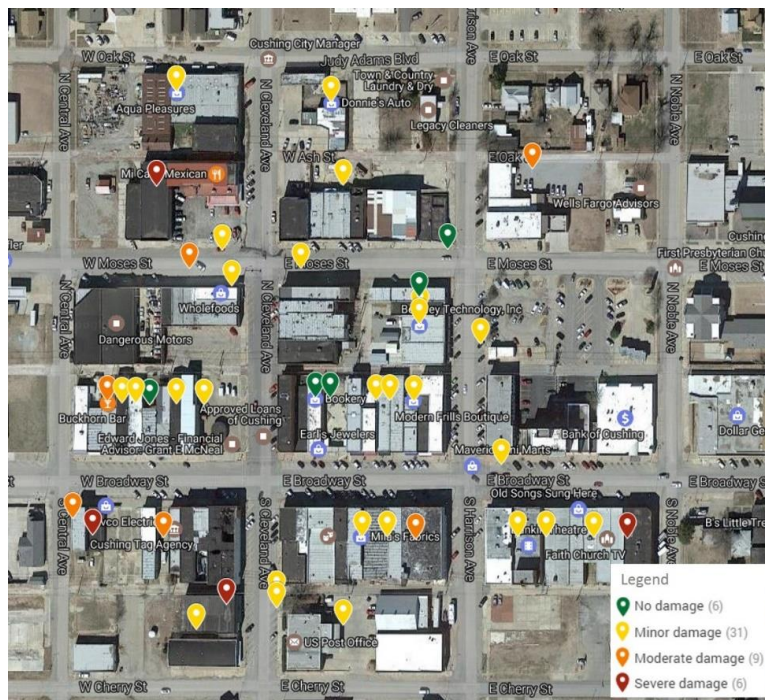
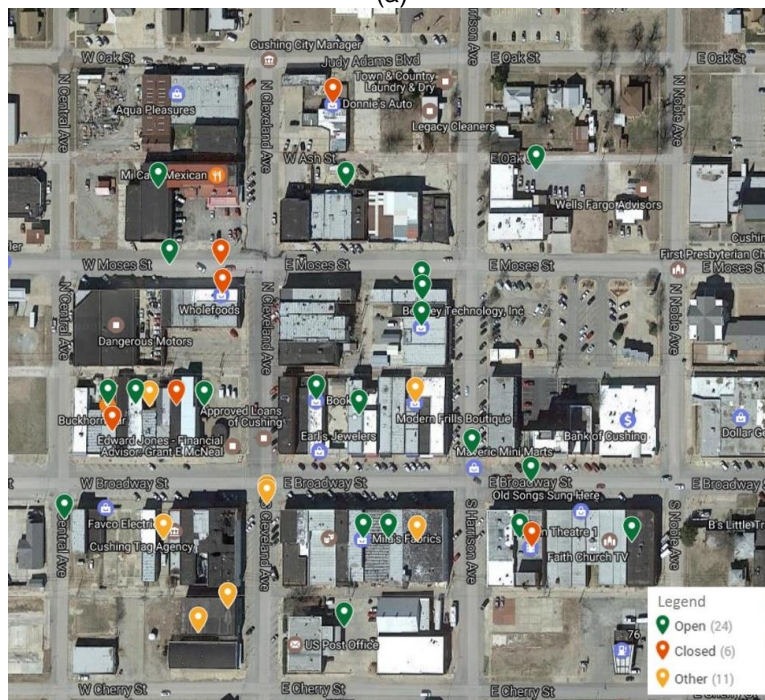
The downtown area has a much older building stock. Following EERI's resilience-based framework for observing and documenting earthquake impacts on businesses (EERI, 2016d), the reconnaissance team visited most businesses located in the CBD. For each business, members of the EERI team performed a short building damage assessment and recorded the business operational status in a short survey form. The results of these assessments are shown in Figure 25 and Table 3. The damage assessment of 52 buildings in the downtown area shows that over 70 percent of the buildings had no damage or minor damage (Table 3). About 17 percent had moderate damage, and 12 percent had severe damage.

Figure 25. Maps showing the results of the EERI reconnaissance team's business survey in downtown Cushing, Oklahoma, including (a) Building Damage Assessment results categorized by severity of damage; and (b) Business Operational Status categorized as "Open," "Closed," or "Other" (source: EERI Reconnaissance Team survey).

Building Damage	Numbers of Building	Percent
No damage	6	11.5
Minor damage	31	59.6
Moderate damage	9	17.3
Severe damage	6	11.5
Total	52	100.0
