## Learning from Earthquakes

# Preliminary Observations on the Tecomán, Colima, Mexico, Earthquake of January 21, 2003

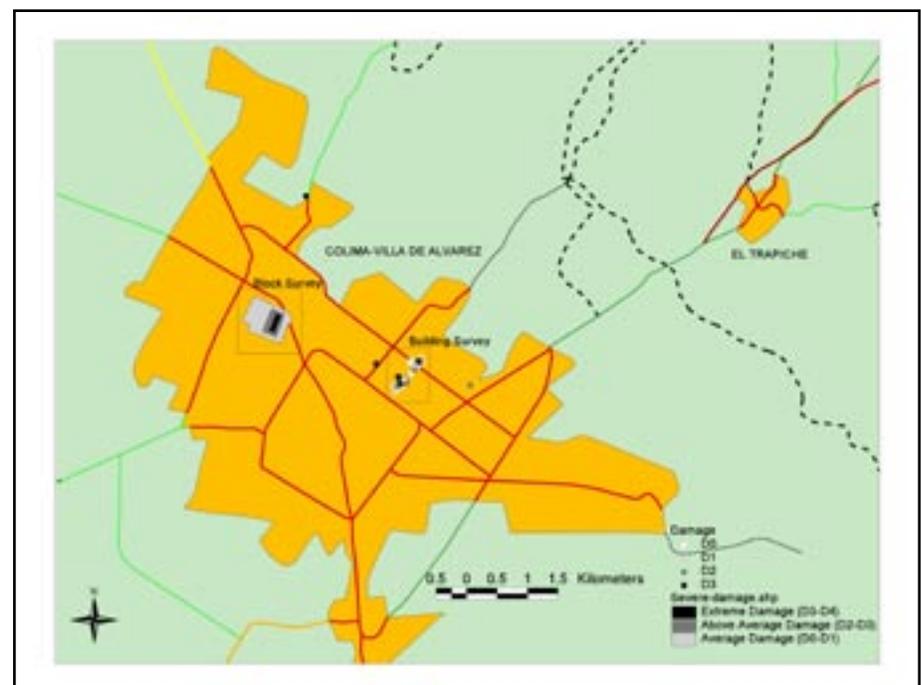
Damage surveys in the conjoined cities of Colima and Villa de Álvarez indicated locations of damage concentration around the neighborhoods of San Isidro (Villa de Álvarez) and Lomas de Circunvalación (Colima) (see Figure 4). In addition, damage to adobe housing in downtown Colima was extensive. Damage surveys were carried out using PQuake software (Georgia Institute of Technology), which directly integrates digital photography and handheld GPS technology to facilitate documenting, mapping, analyzing, and visualizing damage data. The use of PQuake permitted a digital data set of the earthquake effects to be created in a timely manner. Damage surveys were performed either by assigning an average damage index (D0 = no damage, D5 = collapse) to a whole block (Block Survey), or by assigning damage indices to individual buildings.

foundation material. Intense damage in the Lomas de Circunvalación neighborhood is limited to a few city blocks. Construction patterns do not vary in this neighborhood, suggesting that damage is due to localized ground-motion amplification, suspected to be associated with fills.

**Figure 4 - Damage survey map of the city of Colima indicating areas of high damage concentration.**
