NCREE REPORT

The February 6, 2016 M_L -6.6 Meinong, Taiwan Earthquake and Lessons Learned

**National Center for Research on Earthquake Engineering (NCREE)
Taiwan**

March 31, 2016

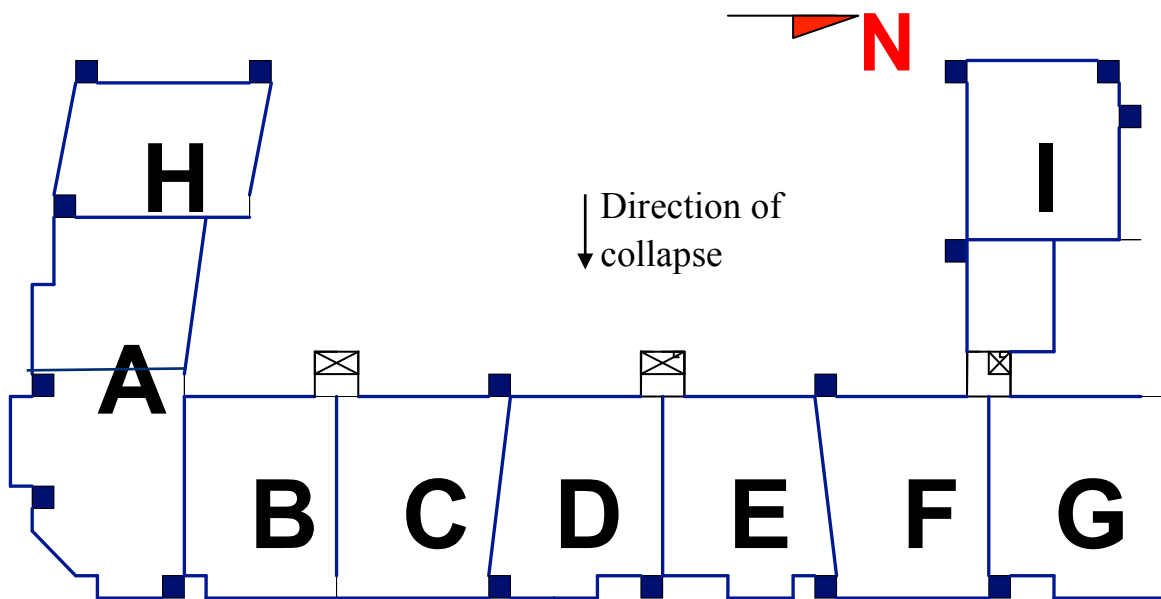
Figure 2.3 Floor plan layout of Weiguan Jinlong Building in Yongkang District (provided by Dr. Jui-Liang Lin)

results showed that the main column reinforcement couplers were spliced in the same elevation. The reinforcements were detached from the coupler splices while the hook of column transverse reinforcements exhibited a non-seismic bending angle of only 90 degrees. The floor plan drawing currently available (Figure 2.3) showed that only a single bay was provided in the shorter structural axis, with very low structural redundancy. The building exterior facing Yongda Road had fewer walls. The rear side of the building, on the other hand, had more walls at the staircases and elevator lobbies. More damages were thus observed at the side of Yongda Road. The lower floors were allocated for commercial use and had less walls and probably less structural strength compared to the other floors. Most damages were tended to occur at these lower floors. During the earthquake, columns on one side of the building were mainly subjected to axial compressive forces, while columns on the other side were mainly subjected to axial tensile forces. The columns may be damaged if their strengths were unable to withstand the seismic forces. At the same time, rebar seismic detailing may be inadequate (transverse reinforcement may be too loose, the bends may have failed to be inserted into the concrete core, the main beam reinforcement may be improperly anchored to the column core, the coupler splices failed, or the main column reinforcements may be spliced in the same elevation) which resulted in lack of ductility and led to subsequent collapse during the earthquake. There were many factors that compromised the structure's ability to withstand earthquakes, leading to the collapse in the structurally weak layers of the building and horrendous casualties.

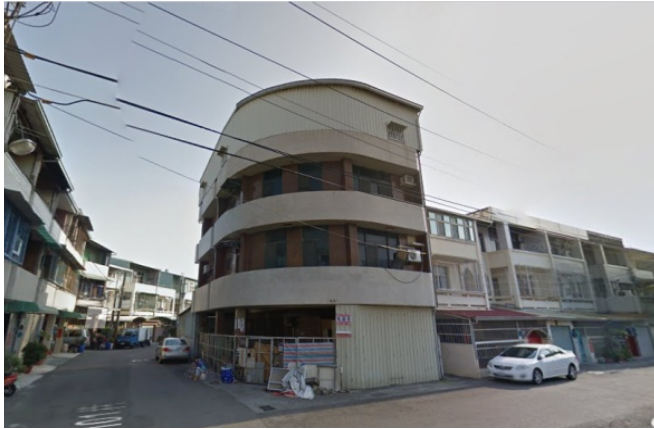
(a) Original appearance of the building

This apartment is located at Lane 101, Taizi Road, Rende District, Tainan City. The building has 3 above ground floors with an extra floor constructed using corrugated metal sheets atop the roof. The building was constructed in 1980. Since the building was constructed many years ago, the vertical elements failed to provide adequate anti-earthquake capabilities. Poor structural configuration also led to torsions in the structural system which led to the collapse of the structurally weak layer (Figure 2.7).

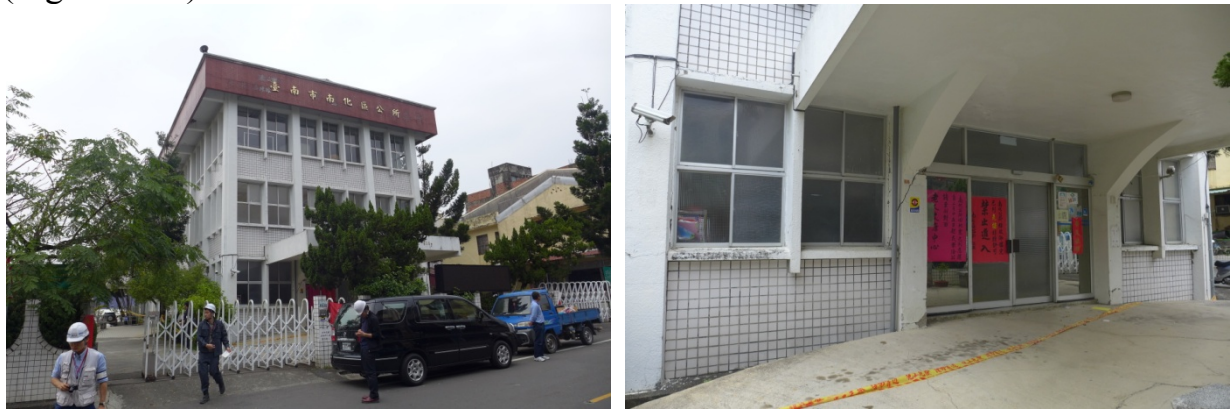
District, Tainan City, with coordinate of 120.4777° East and 23.0430° North. This building is a 3-story reinforced concrete building (Figure 2.29). The 1st floor is used for carrying out administrative tasks of the district office and lacked any partitioning walls. Only an infill brick wall was provided at the rear side of the building. Although the building did not collapse during this earthquake, there were significant shear failures observed on a large number of columns. The protective concrete cover spalled off from some of the columns, exposing the steel reinforcements as well as inlaid pipes contained within (Figure 2.30).

Figure 2.29 Nanhua District Office, a 3-story reinforced concrete building.

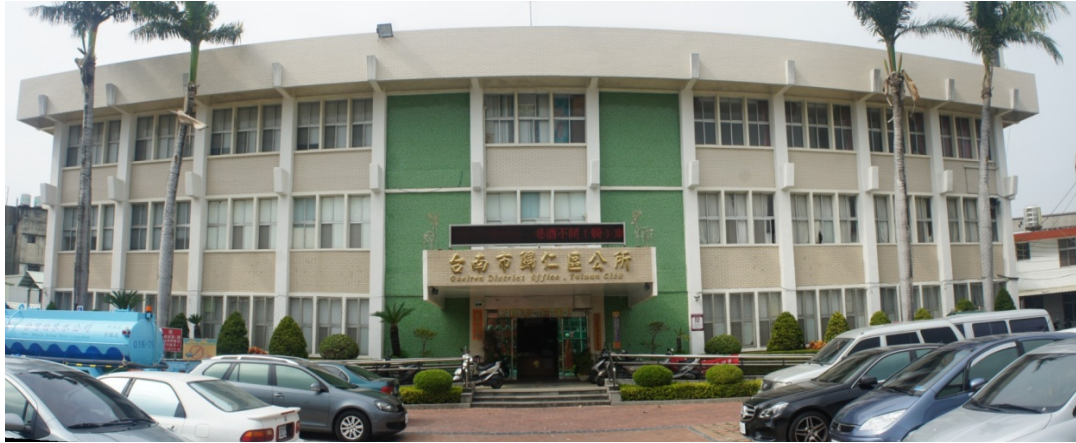
Gueiren District Office is located at No. 2, Section 2, Zhongshan Road, Gueiren District, Tainan City with the coordinate of 120.2939° East and 22.9672° North. This is a 3-story reinforced concrete building (Figure 2.31). The first floor is an open space used for conducting day to day administrative affairs of the district office. This building was damaged during the Chi-Chi earthquake in 1999 and thus underwent seismic retrofit in 2011. A total of 4 shear walls were provided in the front and back sides of the building (Figure 2.32). No structural damage was observed after this earthquake, showing that the structural retrofit was capable of improving the overall earthquake resisting capability of the entire building.

Figure 2.31 Gueiren District Office, a 3-story reinforced concrete building

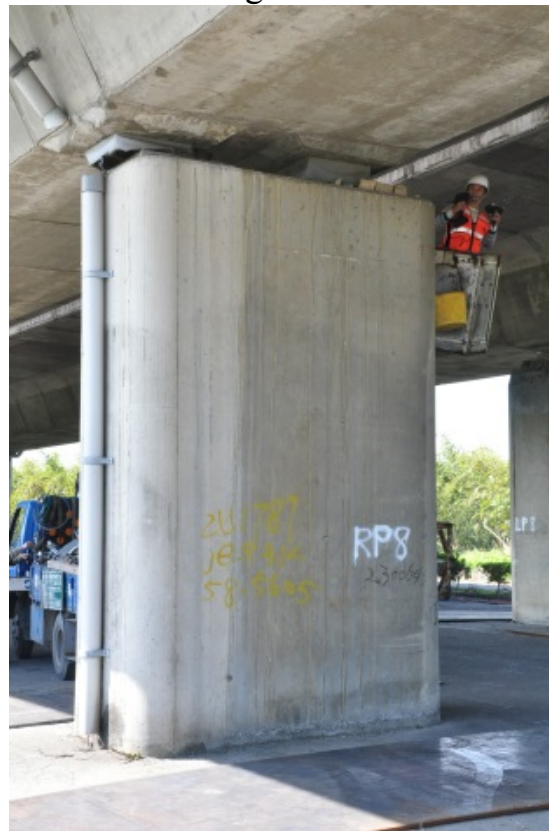
Figure 3.1 Bridge damage investigations for Bridge No. 24 of Provincial Highway 86

(d) Bridge damage inspection process

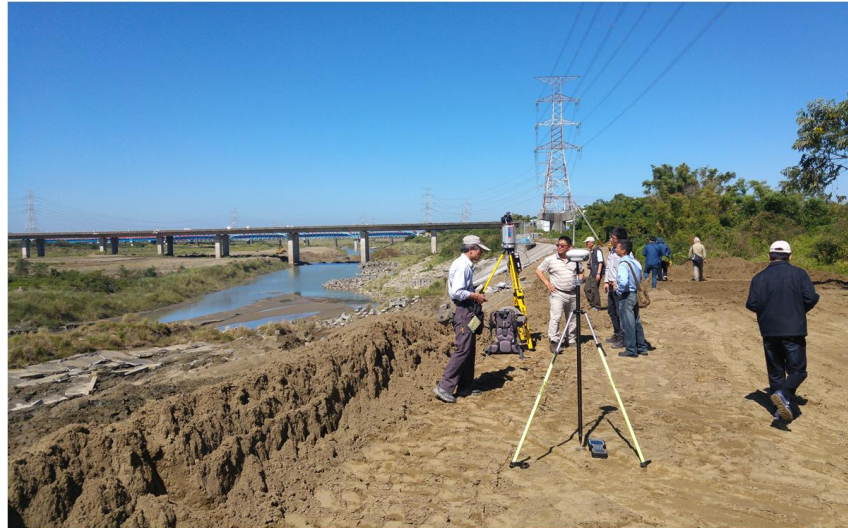
This earthquake caused large scale lateral spreading damages of Rixin embankments at Danei Bridge of Zengwun River in Tainan District (Figure 4.3) and right side levees at the Freeway No. 3 connection of Zengwun River Bridge (Figure 4.4). Cracking of concrete bank protection as well as warping and sinking of the levee road were also observed for the levees on the right bank of Erxi Bridge. Large amounts of sand due to soil liquefaction were also observed at locations where bank protection used to be at the lateral spreading spots of the Zengwun River levees. NCREE personnel also collected samples from these places (Figure 4.5) for subsequent laboratory testing.

Figure 4.3 Supporting companies conducting digital topographic scanning and mapping at the lateral spreading site of Rixin embankments (provided by Shang-Yi Hsu)

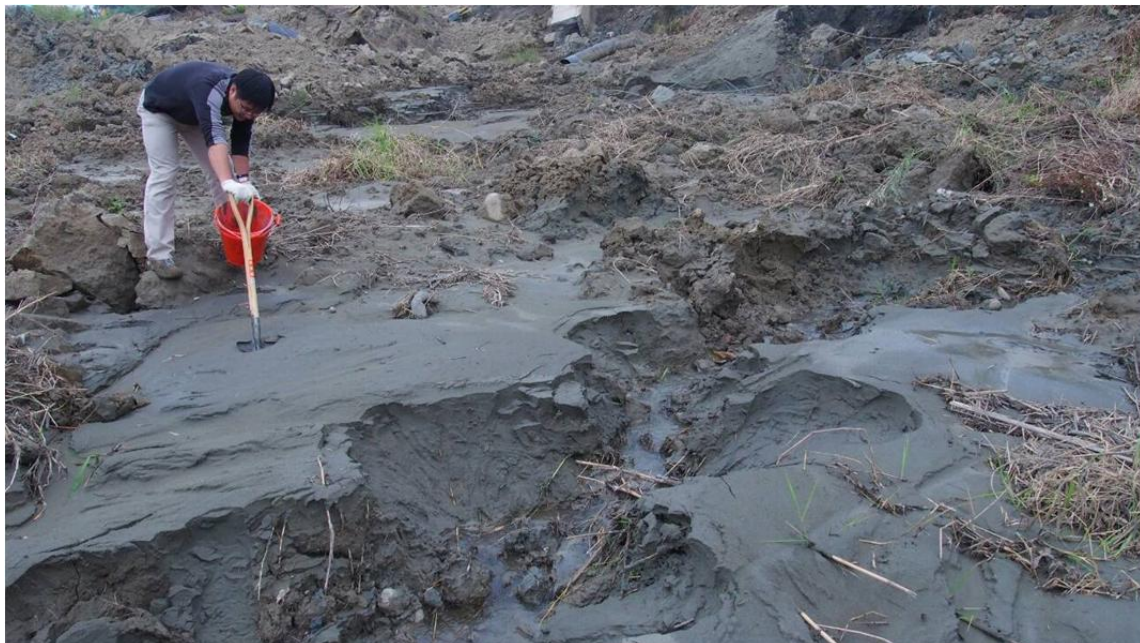
Figure 4.5 Collecting samples of liquefied soil at the lateral spreading site of Zengwun River embankments (provided by Hsuan-Chih Yang)

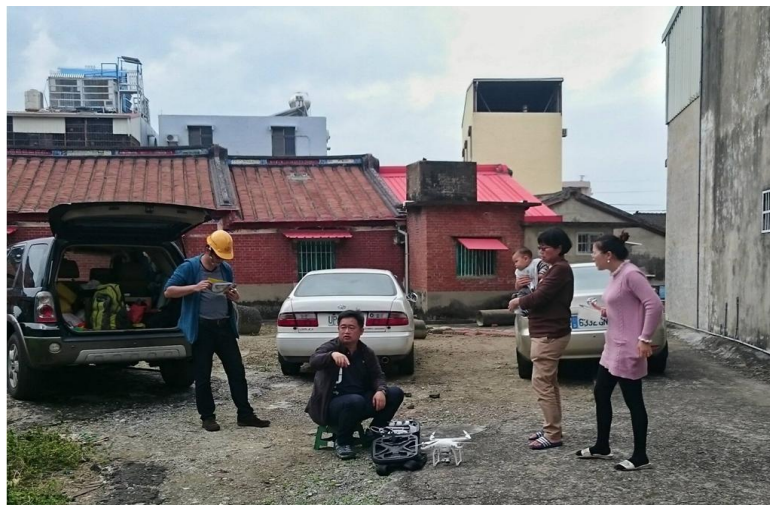
Geotechnical disasters caused by major earthquakes such as regional liquefaction or subsidence as well as lateral spreading of embankments or sliding of slopes tend to cover large areas and result in extensive damages. Some of these damages were located in relatively inaccessible areas. Remote-controlled aerial photography is the key in fulfilling comprehensive and real-time assessment requirements needed for this type of geotechnical disaster inspection (Figure 4.6). It can provide the real-time evidence and establish a basis for on-site disaster inspection for determining the extent of damage.

Figure 4.6 Setting up aerial photography tools for Sanmin Street, Sinshih District during this field survey (provided by Wei-Kuang Chang)
