LUGU, TAIWAN SEPTEMBER 18, 2022, M_w 6.9 EARTHQUAKE PRELIMINARY VIRTUAL RECONNAISSANCE REPORT (PVRR)

Virtual Assessment Team (VAT) Lead: Erica Fischer, Oregon State University	
Virtual Reconnaissance Assessment Team (VRAT) Authors: (in alphabetical order)	
<p>Sofia Aldea, Universidad Tecnica Federico Santa Maria Jorge Archbold, Universidad del Norte James Bantis, Stanford University Miguel Bravo, University of Cambridge Julian Carrillo, Universidad Militar Nueva Granada Luis Ceferino, New York University Katherine Cheng, UC Davis Diego Cordero, CMG Ahmed Elkady, University of Southampton Hector Guerrero, UNAM Selim Günay, UC Berkeley Manny Hakhamaneshi, California High-Speed Rail Authority Pablo Heresi, U Técnica Federico Santa María</p>	<p>Vedant Mathur, UC Berkeley Amory Martin, Exponent Amy Metz, Oregon State University Zorana Mijic, Portland State University Eduardo Miranda, Stanford University Cesar Pajaro, Universidad del Norte Alan Poulos, Stanford University Maria Camila Lopez Ruiz, UC Berkeley Claudio Sepulveda, UC San Diego Elmon Toraman, New York University Anne Wein, USGS Kai Wu, Texas A&M University Juan S. Zambrano, Oregon State University</p>

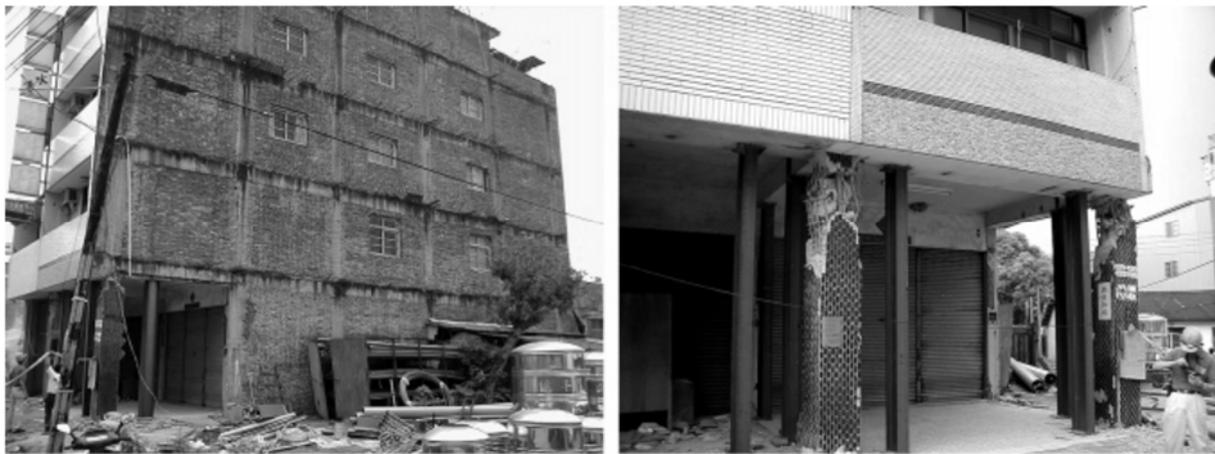
Soft stories are a common issue in many mid- to high-rise buildings in Taiwan constructed before the 1999 M_w 7.7 Chi-Chi earthquake (Yin, 2018; Naeim et al., 2000). Figure 3.1 shows a typical building with a soft story shored for stability following a previous earthquake.

Figure 3.1. Typical soft story building with masonry infill walls and temporary shoring (Naeim et al., 2000).

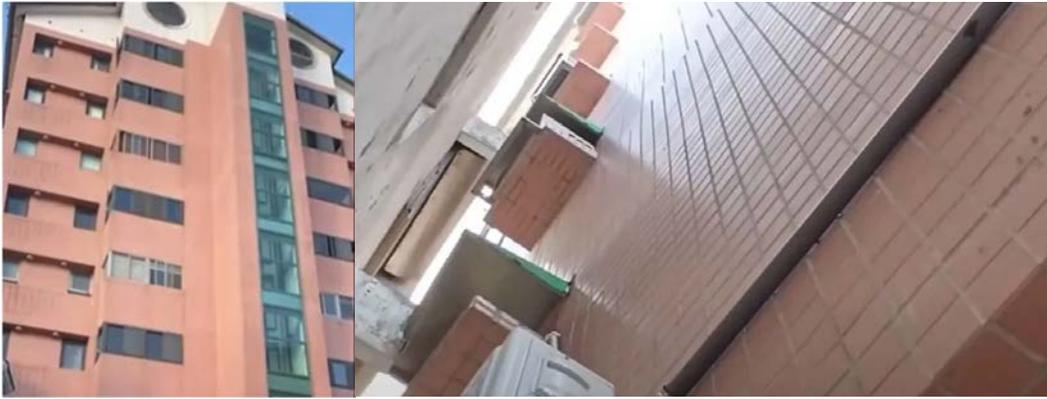
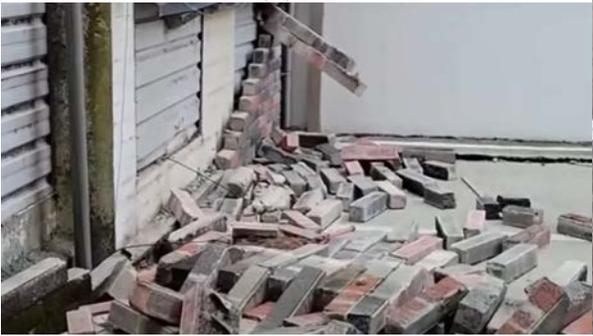
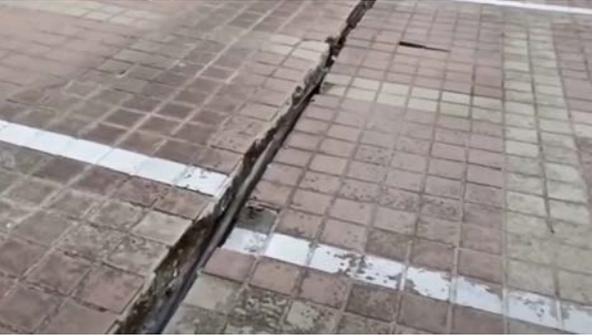
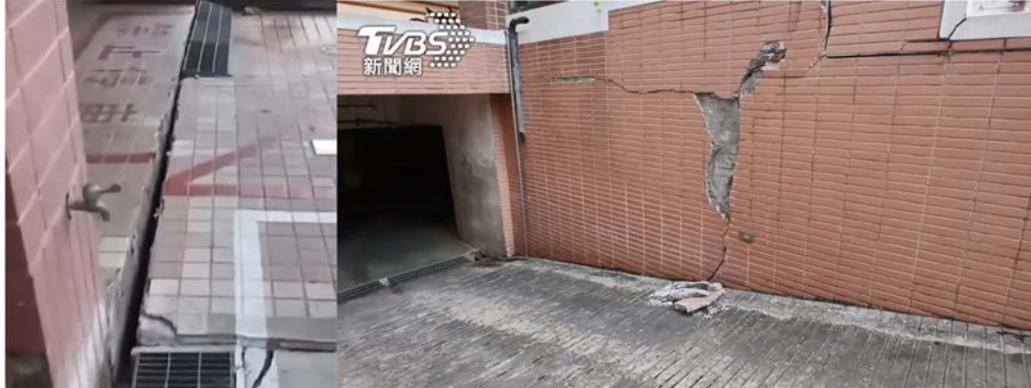
The tallest building in Yuli Township is a 9-story residential building. A soft-story mechanism occurred in this building such that the first story collapsed. Damage throughout the rest of the building included brick facade damage such that bricks have fallen off the building due to differential settlement (Figure 4.8). The building is now leaning. Elevation differences and ground cracks are observed in the surrounding of this building (Figure 4.8).

Figure 4.8. Damage to the tallest building in Yuli Township (a) Elevation view of building showing building leaning; (b) View looking up the side of the building showing the building leaning; (c) brick facade damaged due to earthquake; (d) and (e) cracks in the ground surrounding the building (Source:ETTV News); (f) cracks in the wall leading into the parking garage under the building (張寓科 張家寶, 2022).

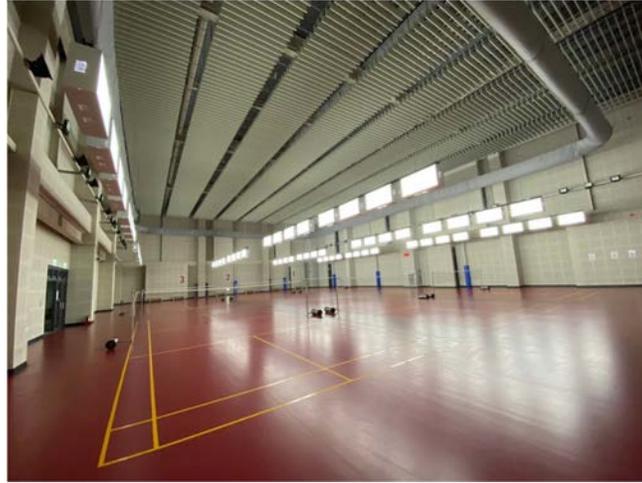
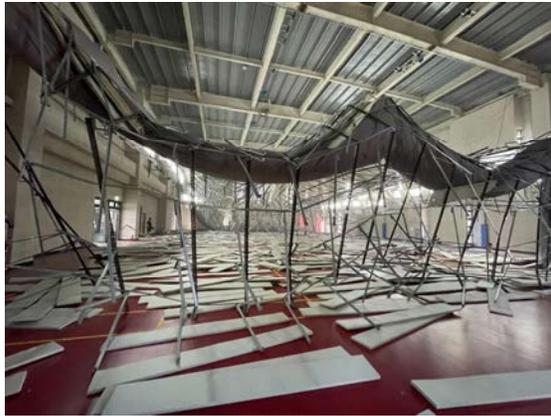
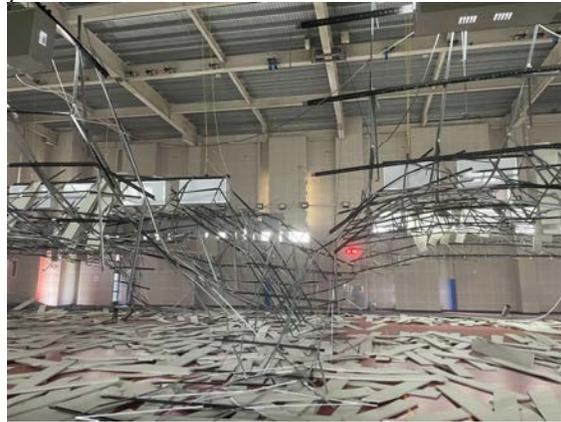
The ceiling of an indoor badminton court, on the fifth floor of Bade Civil Sports Center in Taoyuan City's Bade District, collapsed (Figure 4.15) (Everington, 2022). The facility had finished installing the lights within the structure one week prior to the earthquake. No one was injured during the collapse although a badminton game was occurring at the time of the earthquake. This demonstrates an example of the need for nonstructural components not only to be functional, but also to remain undamaged to avoid falling hazards and other threats to human life and health. Ceiling tile damage was also observed in a mall in Kaohsiung City, called Kaohsiung Dream Era (Figure 4.16).

Figure 4.15. Ceiling of the badminton facility (a) before the earthquake; (b) and (c) after the earthquake (Everington et al., 2022; Yilong, 2022).

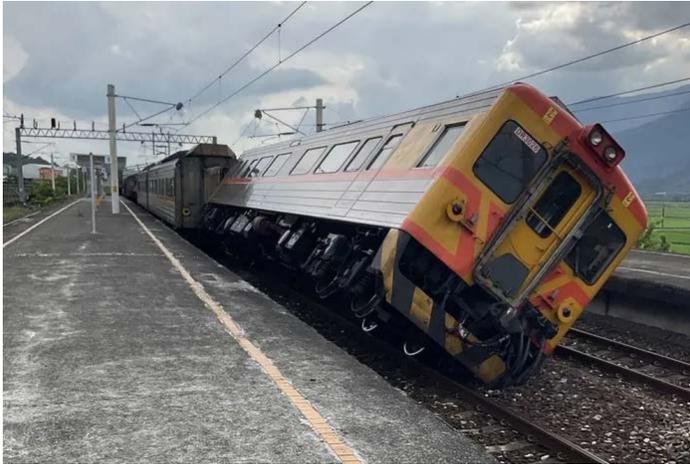
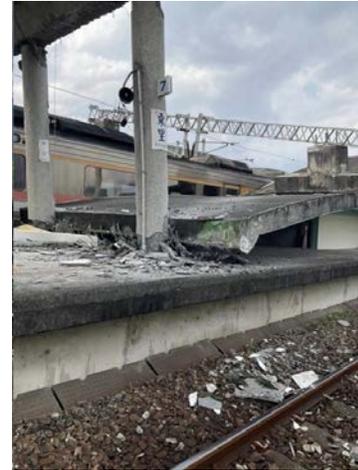
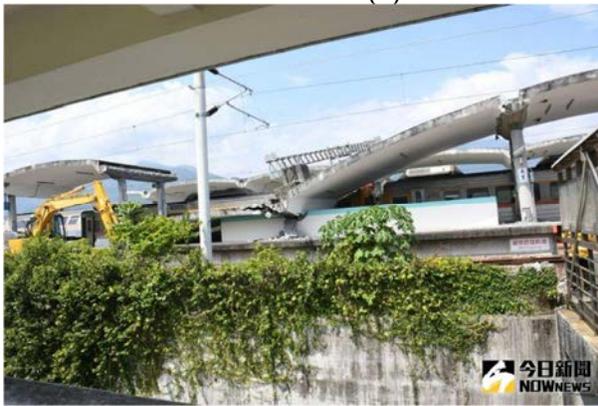
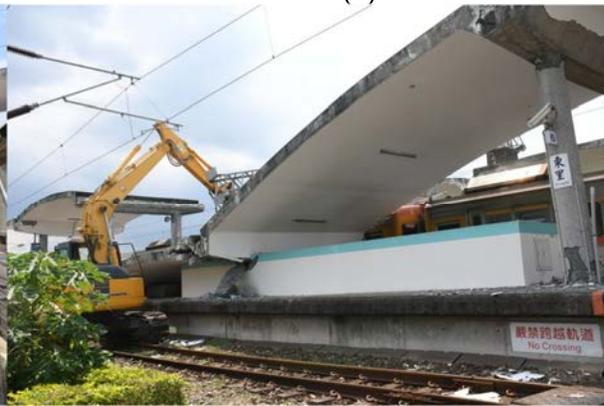
A canopy at the Dongli station collapsed. The debris from this canopy caused a train derailment of six cars. There were about 20 passengers within the cars, but none were injured (Figure 5.1) (Associated Press, 2022). More than 10 routes of the Taiwan Railway and 3 railway bridges were damaged (Newtalk, 2022). Officials suspended rail services between Hualien and Taitung counties along a 106 km (66 miles) section following damages to overhead power lines, tracks, and multiple railway bridges (Taiwan: Rail, 2022). Services were restored by 9/22, including trains running between Hualien Station and Fenglin as well as between Fuli, Hualien County and Taitung Station (Taiwan: Rail, 2022). However, rail transport disruptions remained along a section of the Eastern Trunk Line in eastern Taiwan as of 9/22 due to collapsed bridges (Gaoliao and Luntian Bridge) (Taiwan: Rail, 2022). In addition, several rail stations remain closed, such as Yuli Station (Taiwan: Rail, 2022).

Figure 5.1. (a) Train derailment at Dongli station in Hualien. Photo taken by Taiwan Railways Administration; (b) - (d) Collapsed train platform canopy at Dongli Station in Hualien County (NowNews, 2022).

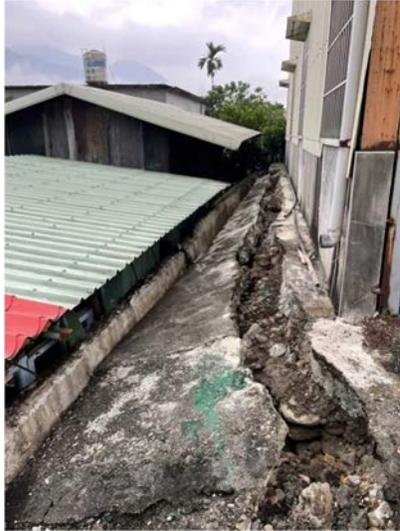
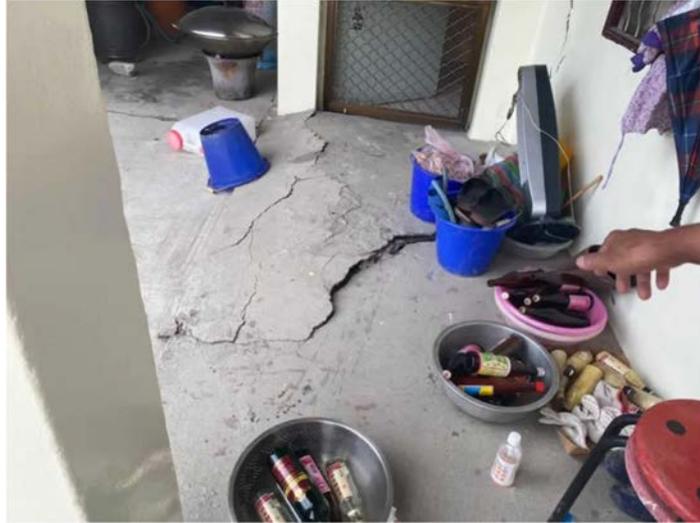
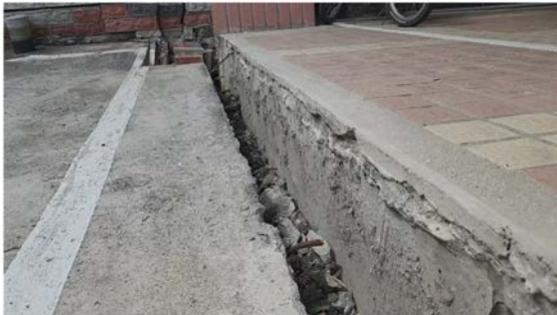
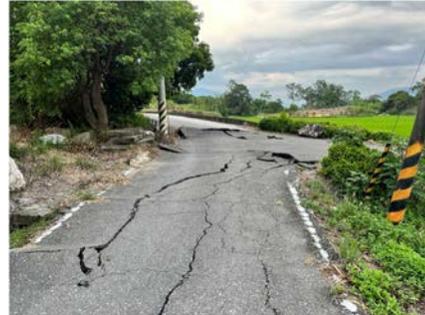
could be indicative of segmentation of the faults. Further surface rupture was seen on sports fields, including deformation of a track in Yuli Township (Figure 6.3a) and surface rupture on a baseball field (Figure 6.3b). Both of these occurred in Yuli Township. Additional cracks in foundations due to ground failure are shown in Figure 6.4. There were no reports on the locations of these damages.

Fig. 6.4. Additional foundation damage due to ground failure (a) Crack in foundation (Lee, 2022 a); (b) Crack in courtyard flooring (Lee, 2022 b); (c) Observed separation of foundations with visible rebar (Yongbo & Yuhan, 2022); (d) Pavement failure due to ground failure (Yen, 2022)

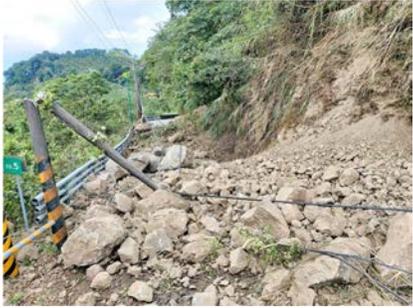
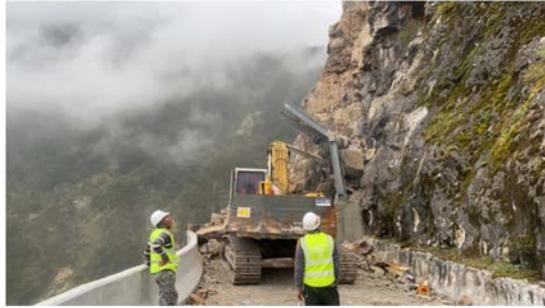
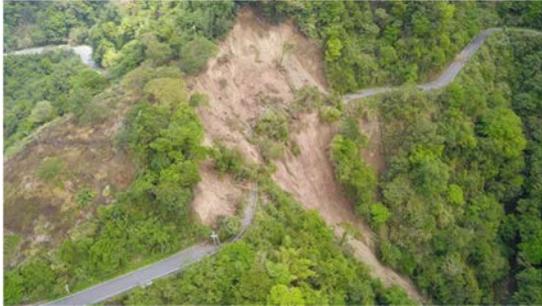
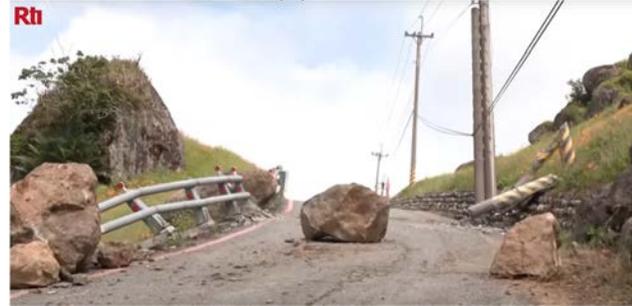
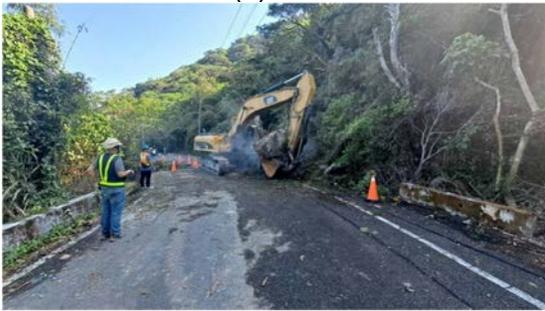
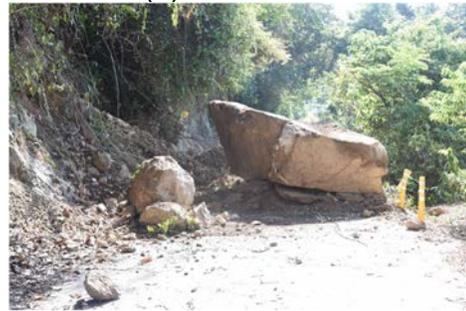
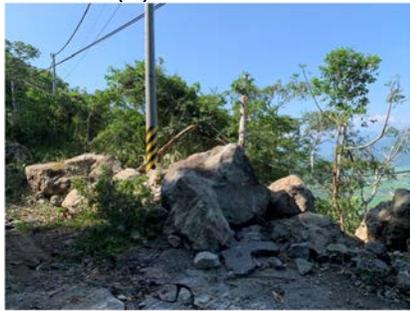
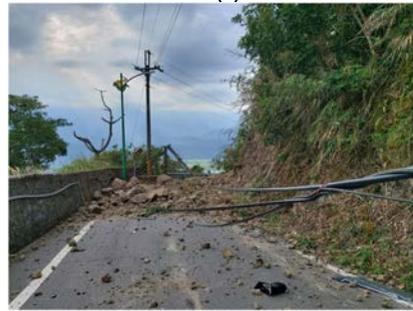
Landslides occurred throughout Taiwan due to the earthquake. Below is a list of the landslides collected through media sources and in-field reporting. Figure 6.7. shows the Landslide map developed by USGS. Multiple mountain roads were blocked by landslides, trapping tourists in the mountains. There was a quick response to clear out the roads, but the response was hampered by aftershocks (Public Television News Network, 2022a). About 3,400 tourists were trapped on Chike Mountain due to roads blocked from landslide debris and rockfalls. Meishankou and Xiangyang road was blocked due to landslides. The debris was cleared; however, additional landslides occurred during aftershocks. The road was scheduled to be reopened on September 19; however another landslide occurred, causing the reopening to be delayed. Several more aftershocks caused more delays (Public Television News Network, 2022b). Rockfalls occurred on a Sixty Stones Mountain road that also experienced surface road ruptures and collapsed power lines. As of September 18, the road was still damaged but open enough to evacuate tourists (Public Television News Network, 2022b). Photos of these rockfalls and landslides are shown in Figure 6.9.

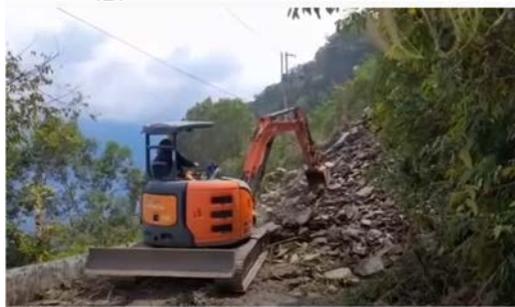
Figure 6.9. Landslide debris (a) Hualien County's Yuli Township (Shan, 2022); (b) Nanheng Highway, between Meishankou and Xiangyang (Public Television News Network, 2022 b); (c) Chikeshan Industrial Road (Xuesheng, 2022); (d) Rockfall on Sixty Stones Mountain Road (Radio Taiwan International, 2022); (e) Repair of Sixty Stones Mountain Road (Radio Taiwan International, 2022); (f) (Radio Taiwan International, 2022), and (g) Rockfall and landslide observed in Mount Liushishi in Hualien (Liu, 2022 a); (h) Chikeshan Industrial Road (CNA, 2022); (i) Pingtung's Jiufawan Road (CNA-南部地方組, 2022); and (j) Luye Luming section of the Taiwan-Ninth Line (*Taiwan Posts English* 2022)

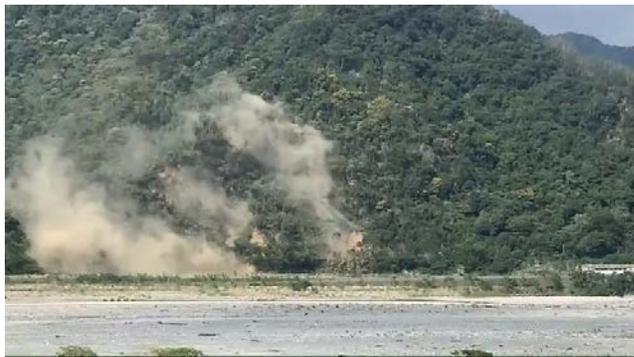
Figure 6.10. Rockfall and landslide at Sixty Stone Mountain (a) (Ren, 2022) (b) (Photo captured by Henry Hsu)

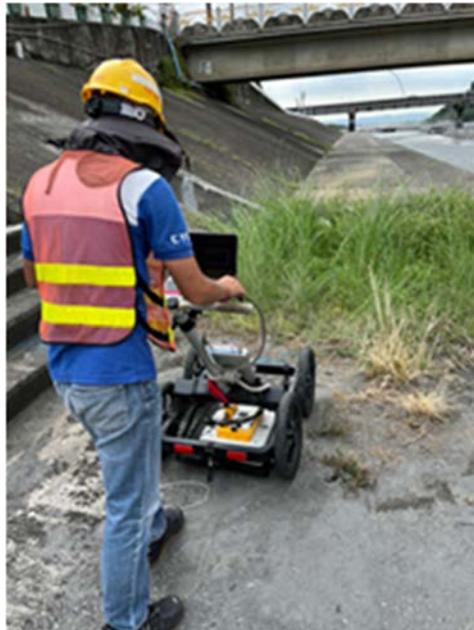
After the earthquake, the Seventh River Management office immediately inspected any dykes in regions that experienced ground shaking equivalent to a magnitude 4 or higher earthquake through unmanned aircraft and on-site visual inspections. Water distribution structures in Qishan, Liugui, Taoyuan, and Pingtung City were also inspected. For high-risk sections such as the Linyuan embankment levee structure, non-destructive testing equipment was deployed (Figure 7.2). Inspections also occurred at a project under construction at the Sanye Creek in Tainan city (黃副主任, n.d.).

Figure 7.2. Non-destructive testing of Linyuan Embankment (黃副主任, n.d.)

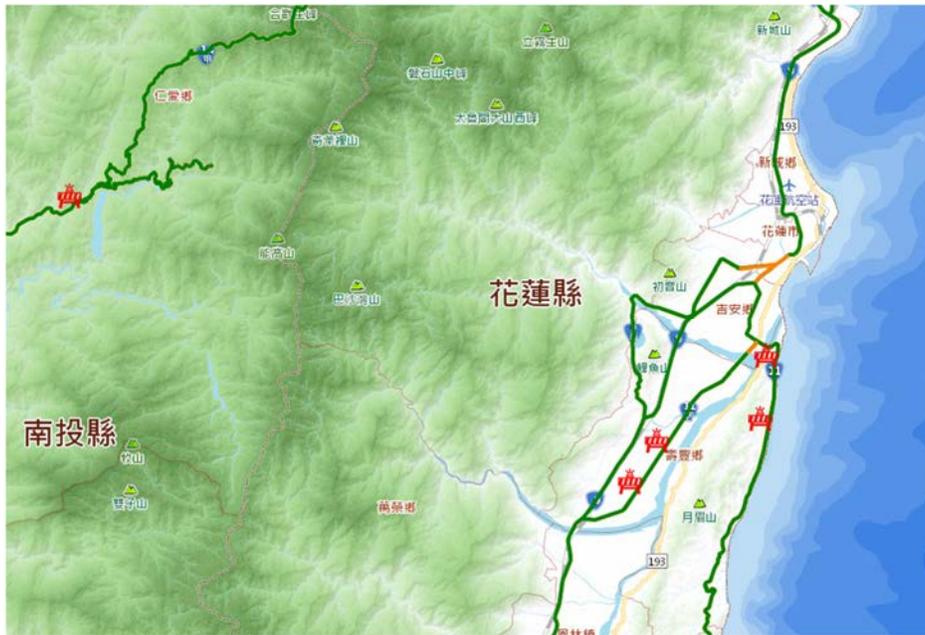
The Guluanxi Bridge repair is estimated to take more than 2 years. Roadways in the Hualien area are being repaired. Figures 7.3 and 7.4 show the road repair sections on September 20 and September 22, respectively.

Figure 7.3. Taken at 9/20/2022 7:52PM PST from <https://168.thb.gov.tw/thb168> showcasing road conditions in the Hualien area. Red barricade icon is showing “under construction”, while orange is showing slightly more congested traffic flow.

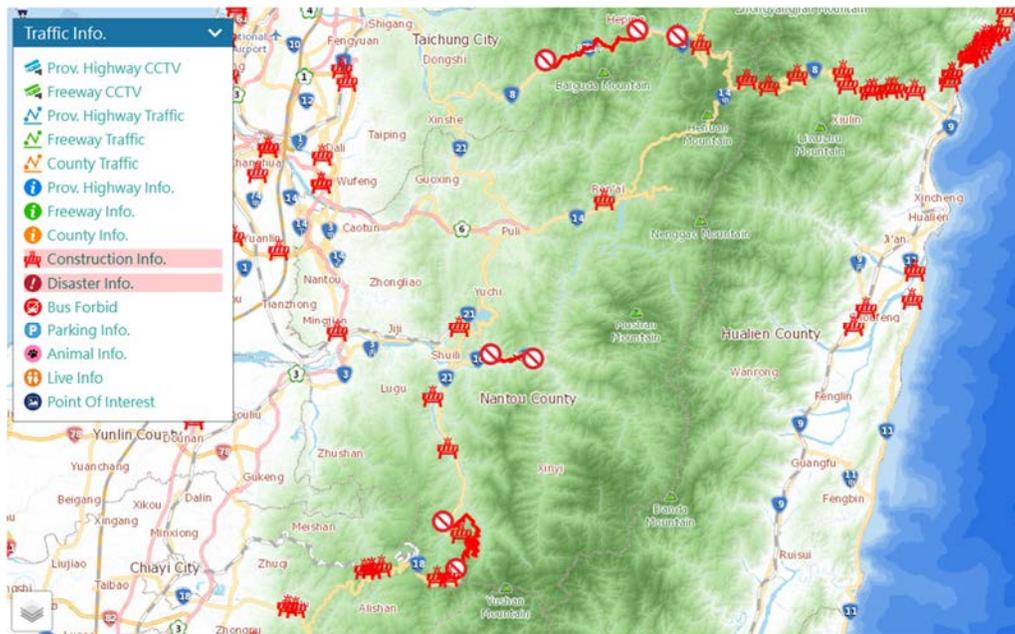
Figure 7.4. Taken at 9/22/2022 3PM PST from <https://168.thb.gov.tw/thb168> showcasing road conditions in the Hualien area. Red barricade icon is showing “under construction”, while red roads are currently down due to the earthquake.
