## Learning from Earthquakes

# Preliminary Observations on the Al Hoceima, Morocco, Earthquake of February 24, 2004

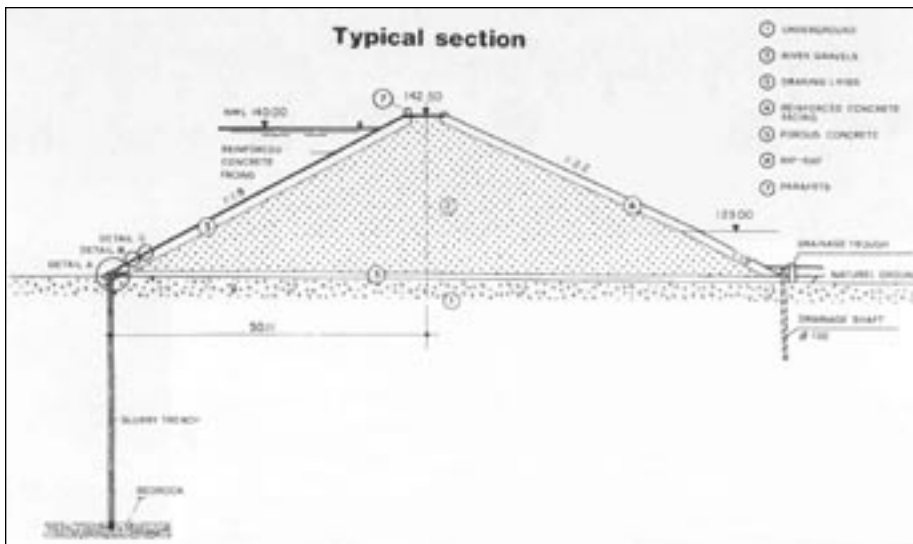
and composed of two primary segments, a 160-m long reinforced concrete gravity section containing the outlet works and spillway, and a 460-m-long reinforced concrete-faced gravel-fill embankment (Figures 2-5). Following the earthquake, the safety of the dam was of great concern to the population living downstream and to the Moroccan Ministry of Water, the owner and operator of the dam. Because of this, the Moroccan government asked the investigators to make a reconnaissance visit to the area to evaluate the condition and stability of the dam.

The only earthquake-related effects noted were two small transverse cracks in the asphalt-paved roadway surface on the crest of the dam. The southerly crack was approximately above the contact between the eastern edge of a buried concrete slab in the spillway structure and above the southern contact between bedrock on which the spillway structure is founded and the valley alluvium on which most of the embankment section is founded. The northern transverse crack was similarly located approximately above the contact between valley alluvium and bedrock contact beneath the northern

part of the embankment. Neither crack was wider than a few millimeters. The cracks were caused either by differential response of the embankment to ground shaking, or by slight settlement within the valley alluvium or possibly within the embankment. A re-survey of benchmarks on the crest of the dam indicates that as much as 10 mm of settlement occurred between the two cracks during the earthquake. The cracks were assessed as superficial and insignificant with respect to the performance and safety of the dam.

**Figure 5** Typical cross section of embankment segment of the El Khattabi dam (Moroccan Ministry of Equipment drawing).

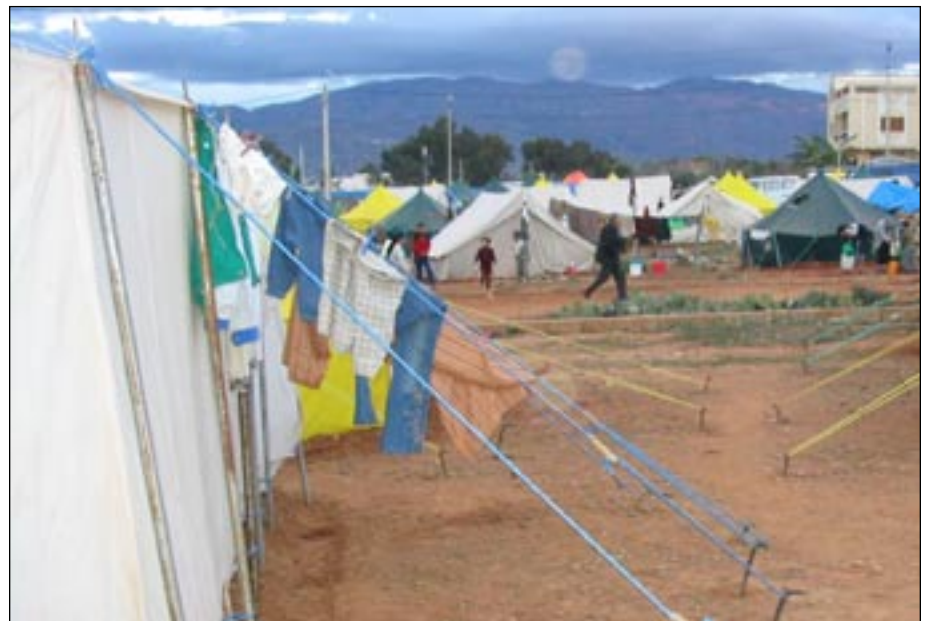
**Figure 9.** Tent city erected in Imzouren to provide temporary housing for people displaced from their permanent housing units (photo: Youd).
