M6.4 Paratebueno Earthquake

June 8, 2025

NHERI DesignSafe Project ID: PRJ-6007

JOINT RECONNAISSANCE REPORT (JRR)

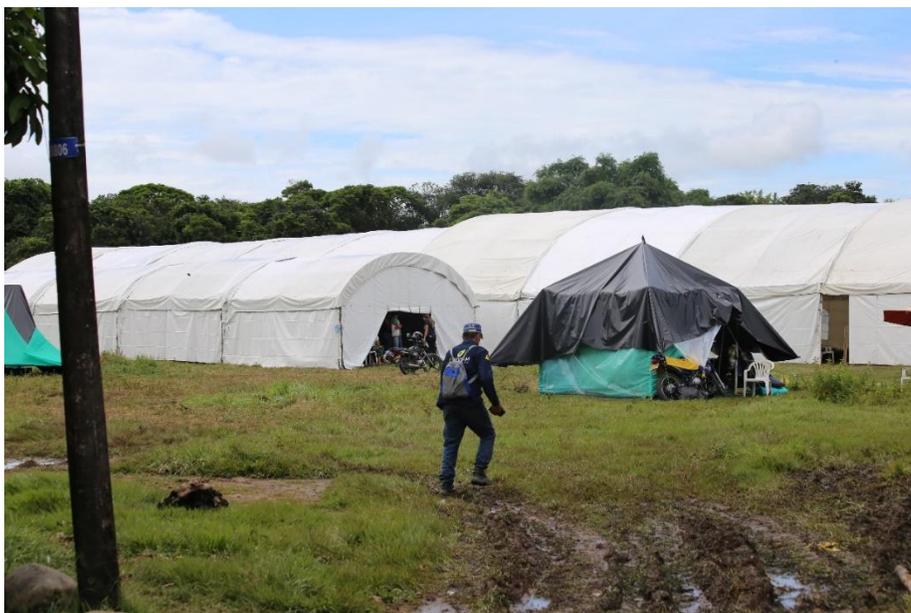
Figure 1.6. Response in Santa Cecilia, Paratebueno (Credit: Archbold).

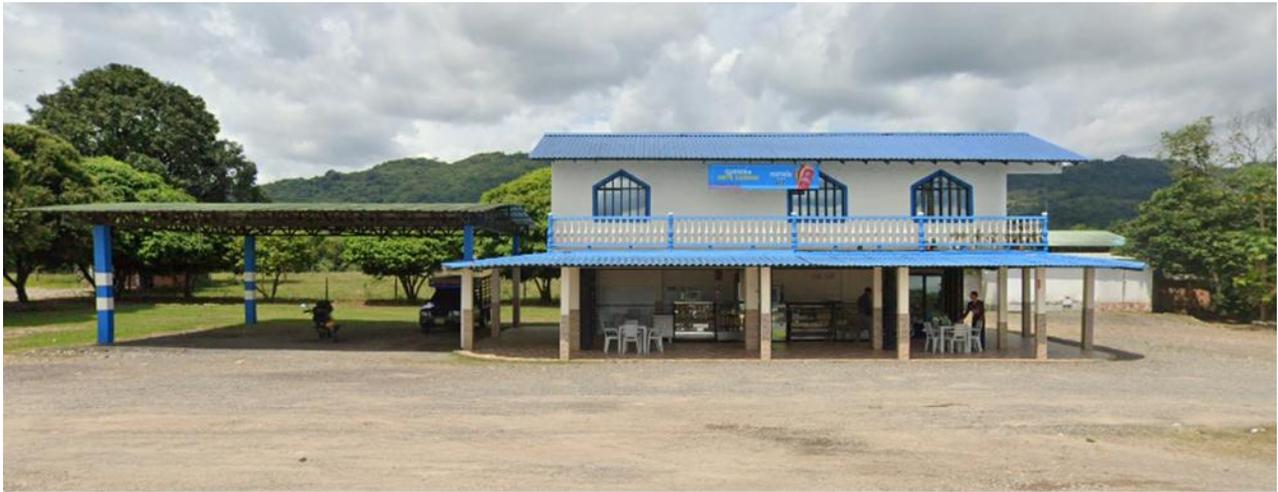
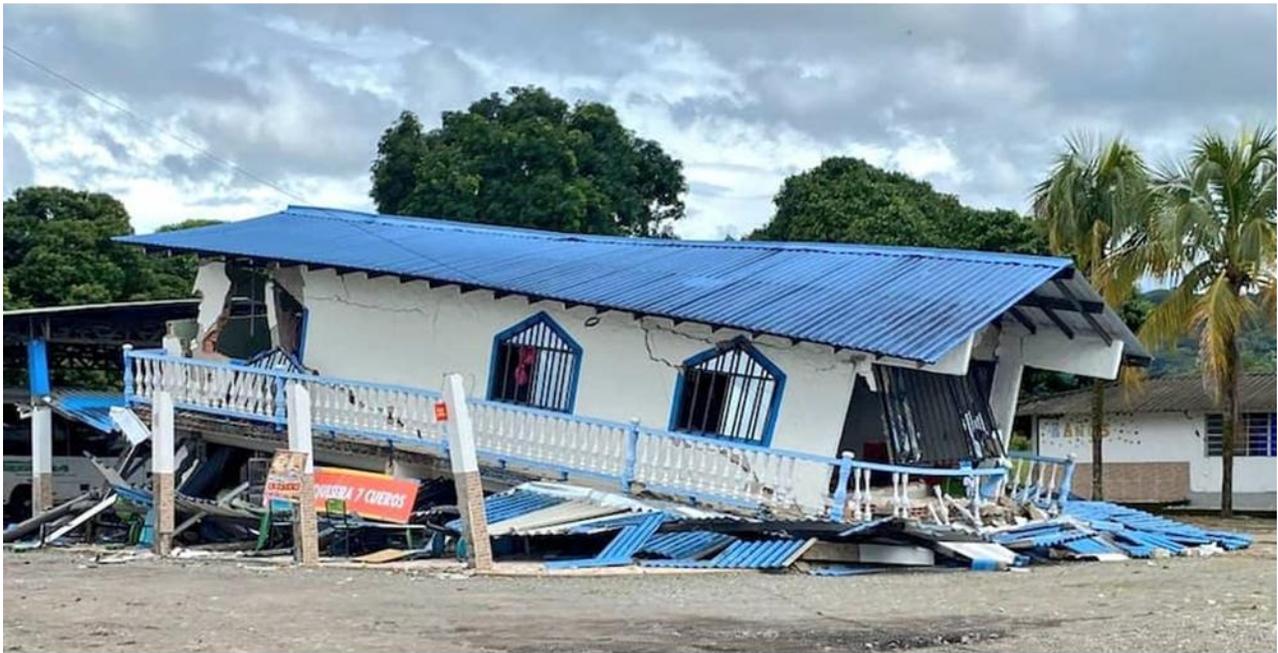
Soft- or weak-story failure was observed in the ground-floor collapse of a two-story mixed concrete and steel frame commercial building with infill walls (see Figure 4.7 for before-and-after images of the structure). This type of failure can occur due to inadequate connections between concrete and/or steel elements, as illustrated in Figure 4.8.

Figure 4.7. Family-owned business Siete Cueros in Santa Cecilia, Paratebueno: (a) before the seismic event (Source: Google Maps) and (b) after the event (Source: El Espectador, 2025).

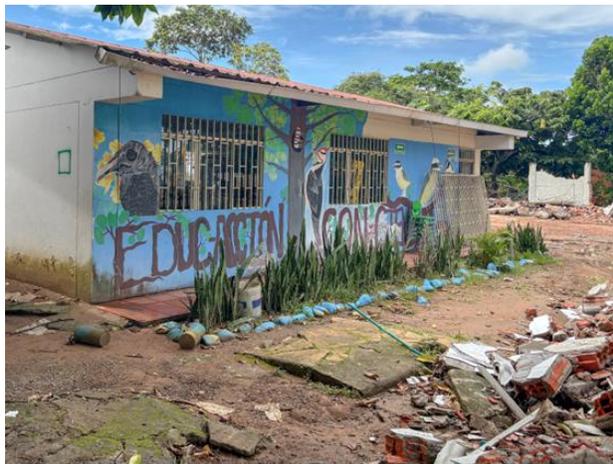
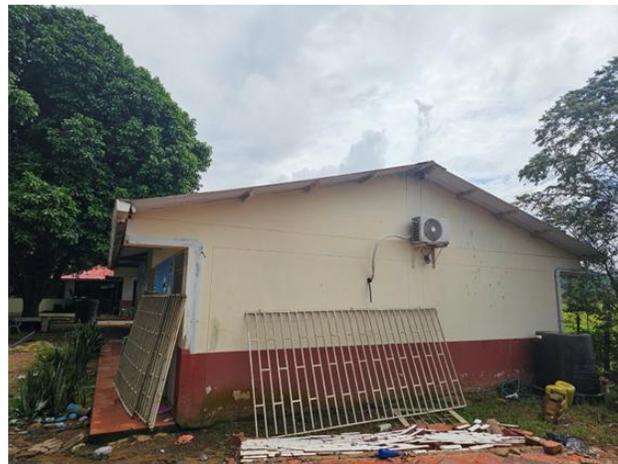
Figure 4.11 shows examples of damage and disruption observed by the CEER FAST. In Figure 4.11a and b, a one-story reinforced concrete moment-frame classroom building is shown with no visible structural damage. An adjacent classroom, shown in Figure 4.11c, sustained non-structural damage, including partial ceiling collapse. On the blackboard, the date of the last class held before the earthquake—June 6, 2025—is still visible. In Figure 4.12d, broken laptops from government programs aimed at providing computers to rural schools can be seen scattered on the floor.

Figure 4.11. (a–b) One-story reinforced concrete moment-frame classroom building with no visible structural damage; (c) Non-structural damage observed inside a classroom; (d) Broken laptops found on the floor; one bears the inscription “Computers to Educate” (Credit: Archbold and Carrillo).

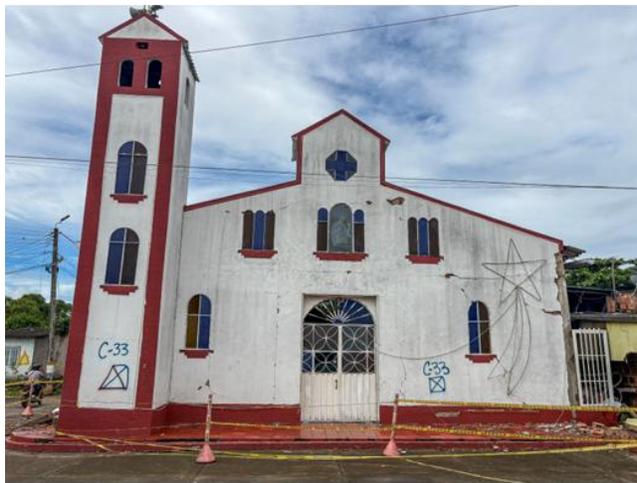
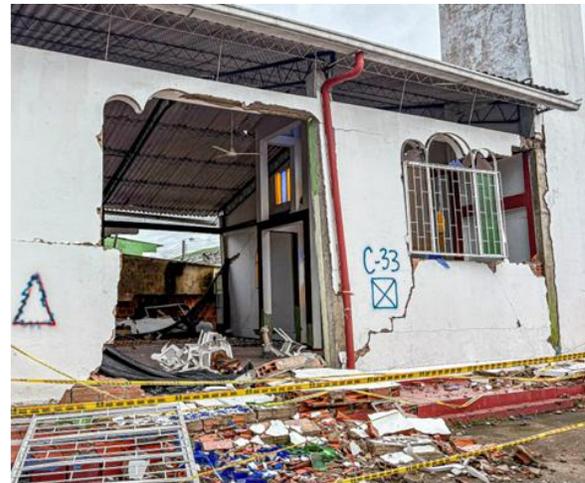
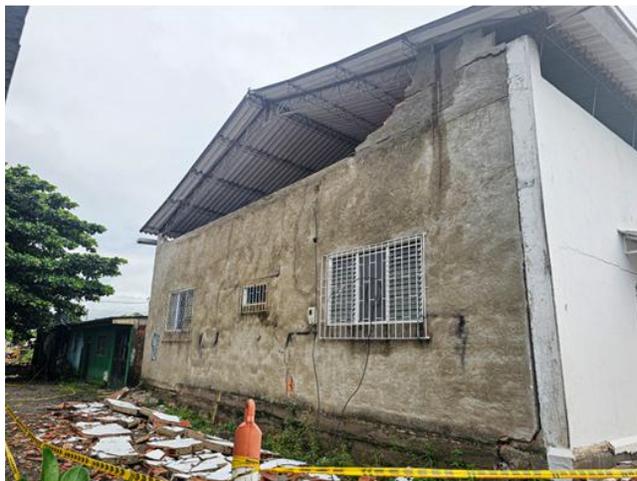
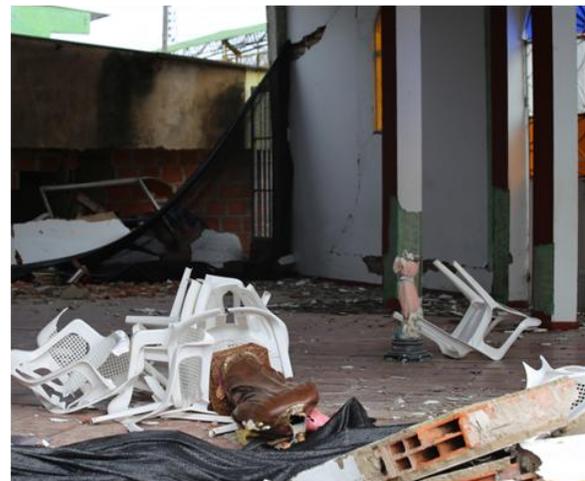
The Catholic church in the town center of Santa Cecilia, Paratebueno, was one of the most visibly affected religious structures observed by the FAST. The team documented severe structural and non-structural damage, including major cracking in load-bearing masonry walls and columns, localized collapse of plaster finishes, and visible signs of roof misalignment. The extent of the damage rendered the building unsafe for use, and parts of the interior were inaccessible at the time of inspection (see Figure 4.13). As a central gathering space for the community, the church's closure has had a notable social and emotional impact on residents.

Figure 4.13. Damage to the church at Santa Cecilia: (a) front façade, (b) side view, (c) rear view, and (d) interior of church (Credit Archbold and Carrillo).

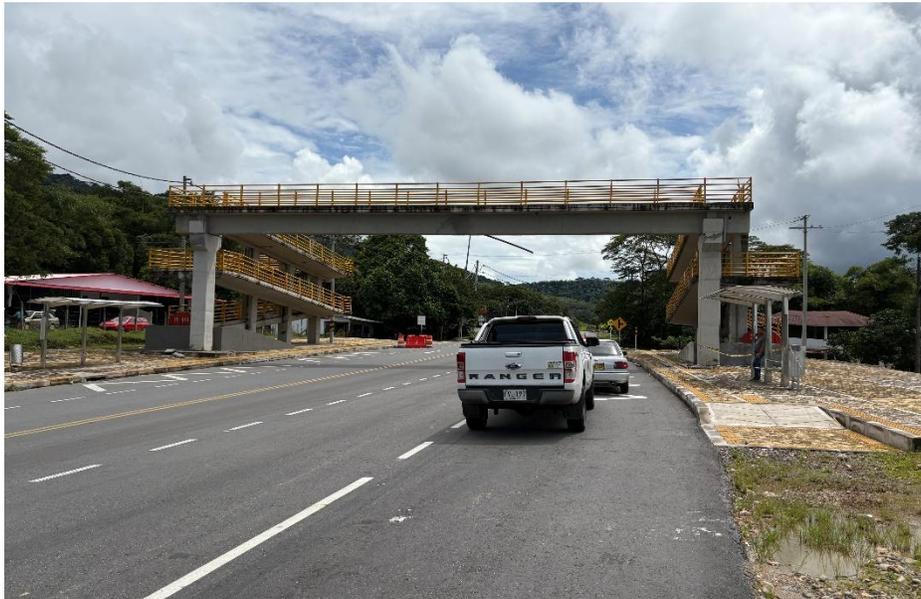
A reinforced concrete pedestrian bridge on the main highway connecting Cumaral with Paratebueno, near the entrance to the town of Japón, Cundinamarca, approximately 22 km from the epicenter, was closed to the public following the earthquake (Figure 5.10). Damage to the bridge included failure of the shear keys: two exhibited a diagonal shear fracture, while the other two displayed a horizontal shear failure (Figure 5.11). Some non-structural damage was observed on the drainage pipe adjacent to the bridge. Evidence of pounding between the deck and the ramp of the pedestrian bridge was also noted, along with a possible fracture of the cantilevered approach structure (Figure 5.12). In addition, debris was found below the pier cap due to the spalling of the shear keys (Figure 5.13).

Figure 5.10. Pedestrian Bridge along main highway connecting Cumaral with Paratebueno, near the entrance to town of Japón, Cundinamarca (Credit: Archbold and Carrillo).
