Water Infrastructure Performance

WW Infrastructure Performance – Earthquake Facilities

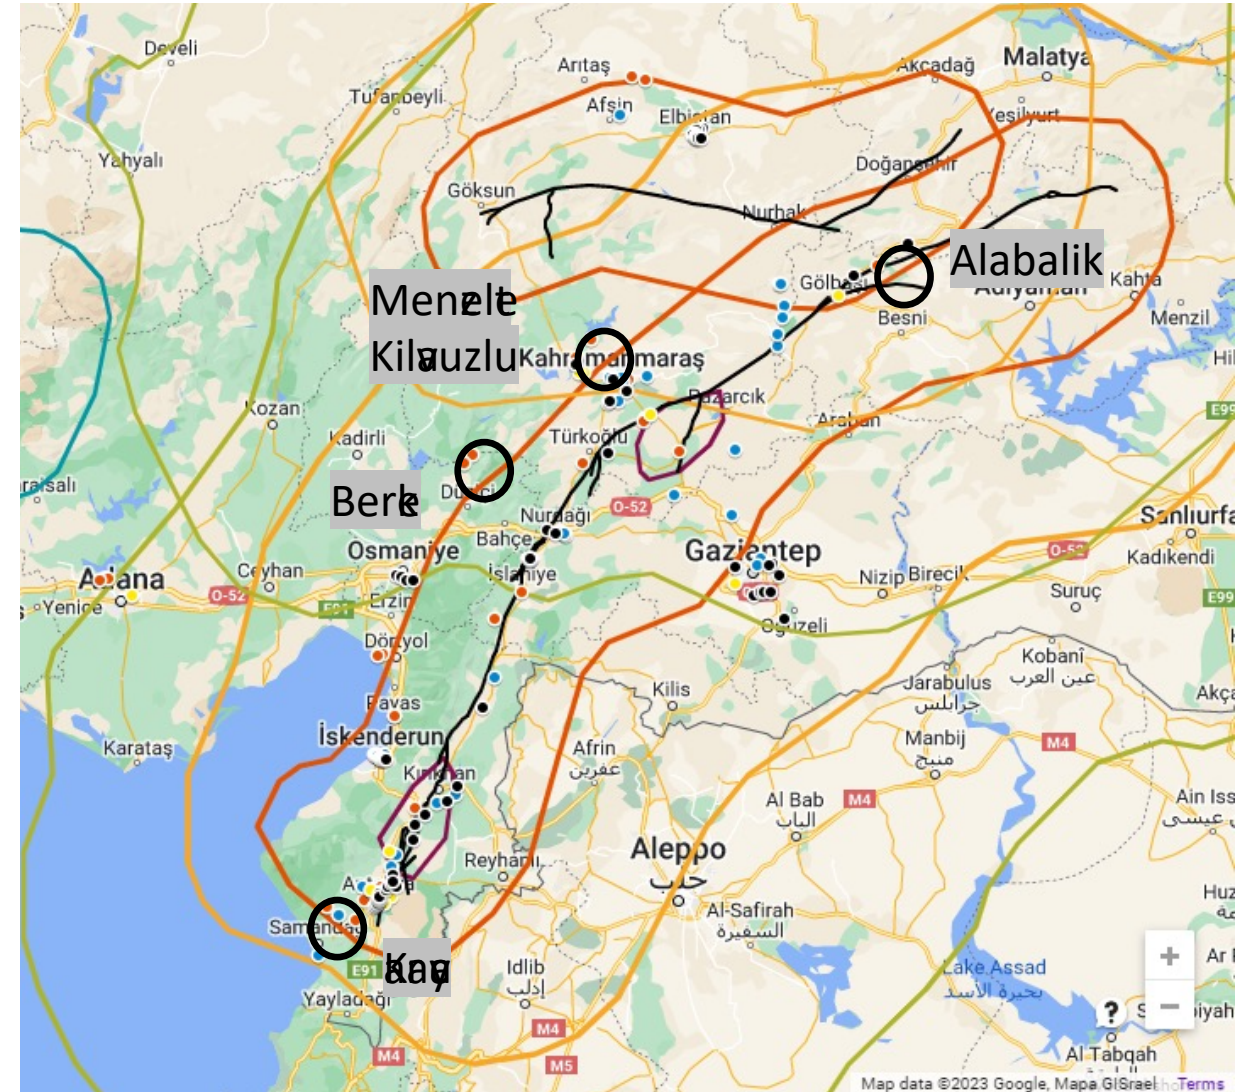
Infrastructure Performance – Dams

- Embankment Dams
 - Sulansuyu
 - Sugu
 - Krala
 - Arikli
- Hydroelectric Dams
 - Alabalik (5 MW)
 - Menzele (124 MW 1992)
 - Kiluzlu (54 MW 2012)
 - Berke (504 MW 1999)
 - Karay (3.3 MW 1999)

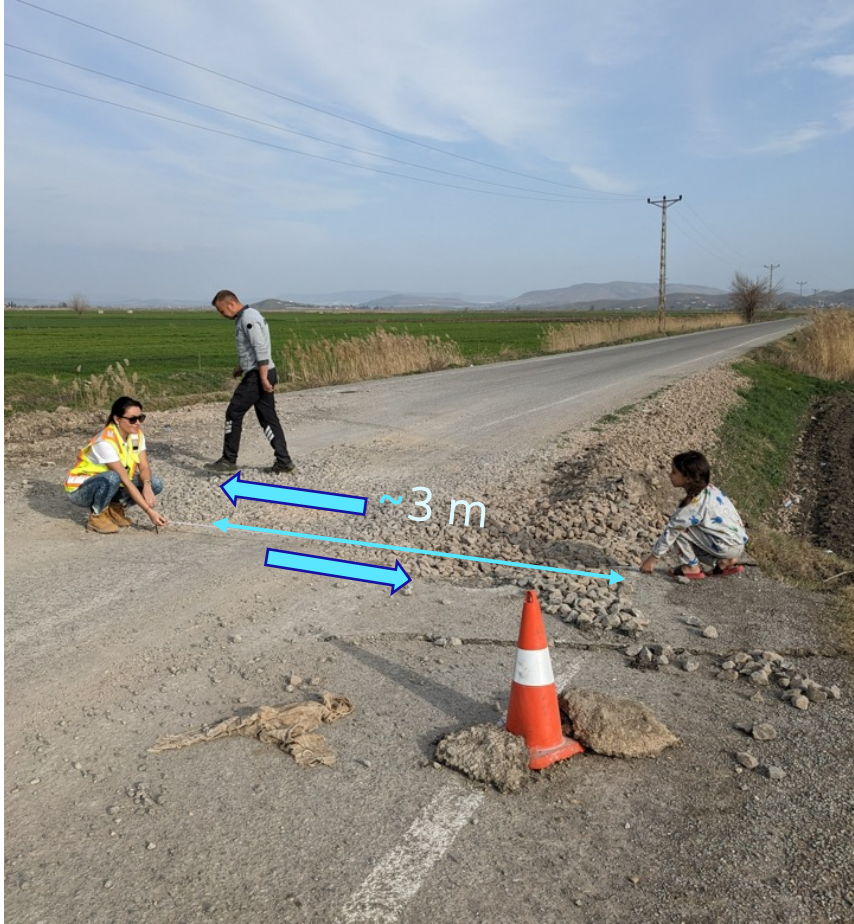
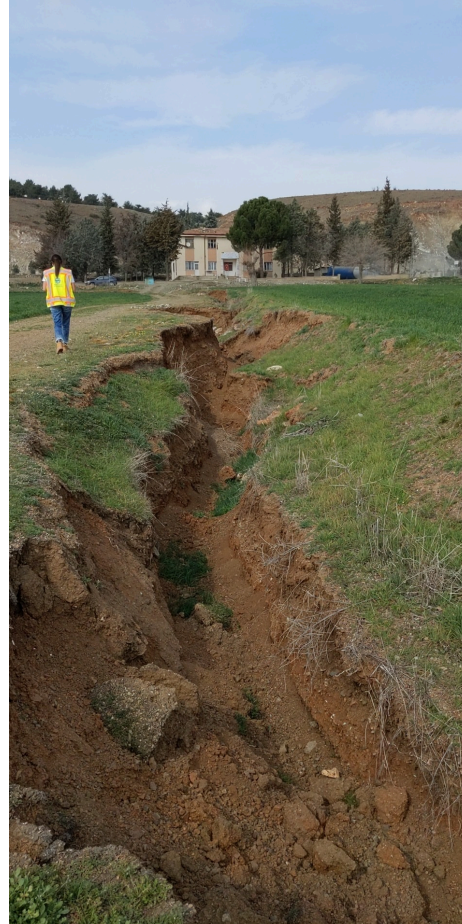
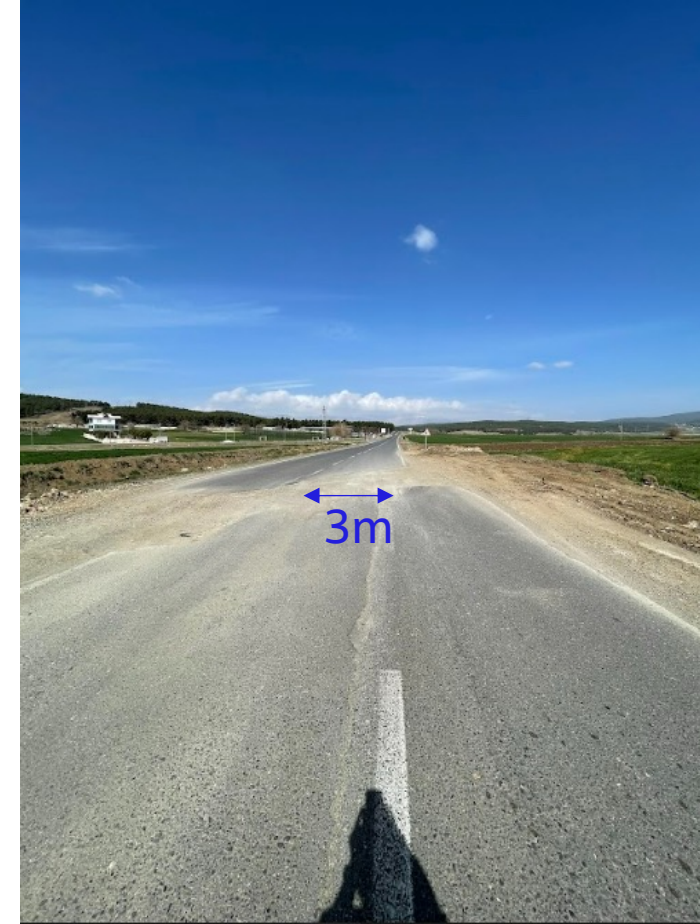
Transportation Infrastructure Performance - Roads

- Türkiye, Kahramanmaraş
