EERI Earthquake Reconnaissance Report: M_L 7.2 Earthquake of April 3, 2024 in Hualien, Taiwan

September 2024

A product of the EERI Learning From Earthquakes Program

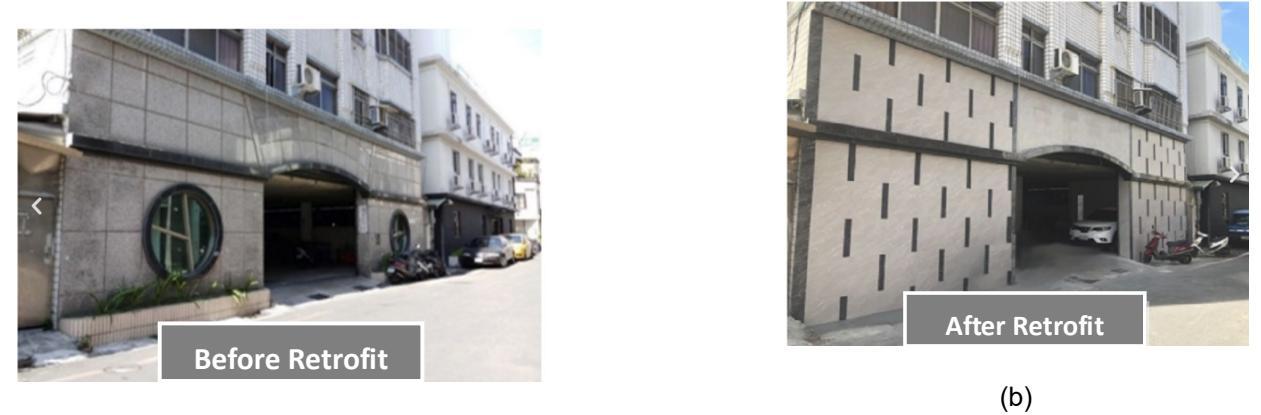
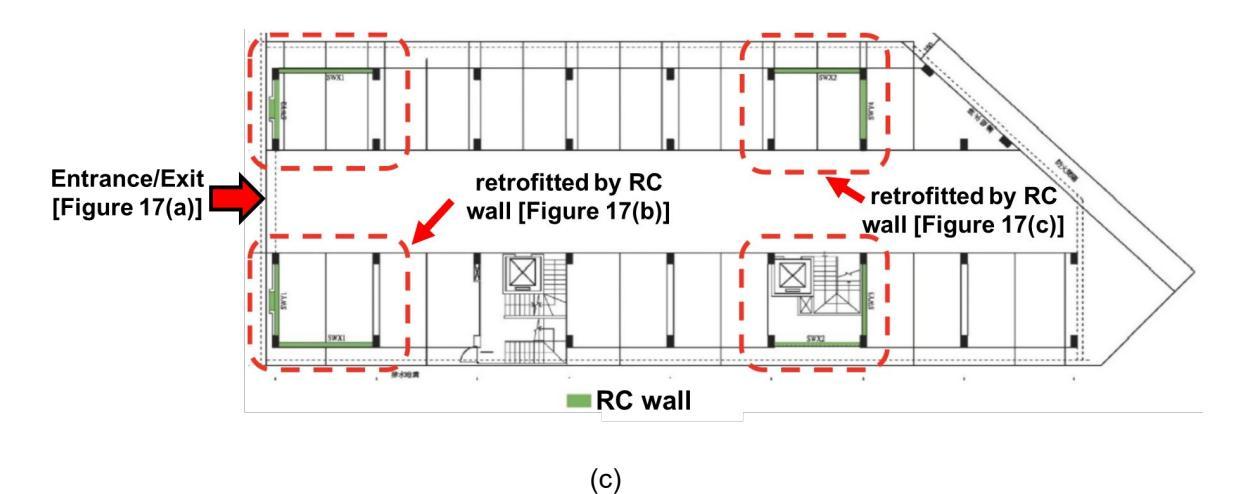
This case involves a six-story RC building completed in 1993 (Figure 24(a)). The first story serves as a parking lot, while the second to sixth stories are residential units. This building was retrofitted under Plan A, with a total cost of approximately US\$53,700 (including design and supervision) and a work period of 51 days. Shear walls were added on the first story to minimize the impact on residents. The residents reported that the retrofitting work did not disrupt their daily lives. The post-retrofit building is shown in Figure 24(b), and the strengthened locations on the structural plan are shown in Figure 24(c). On-site investigation revealed no significant damage to the main members, as shown in Figure 25.

Figure 24. Information pertinent to Retrofitted Building I: (a) before retrofit, (b) after retrofit, (c) structural plan and retrofitted locations (NCREE, 2019).

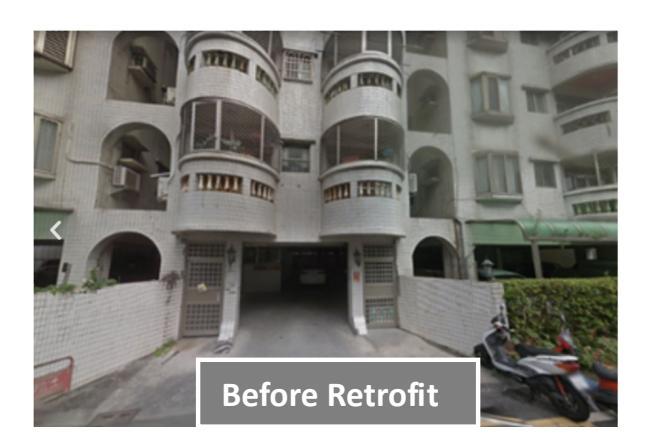
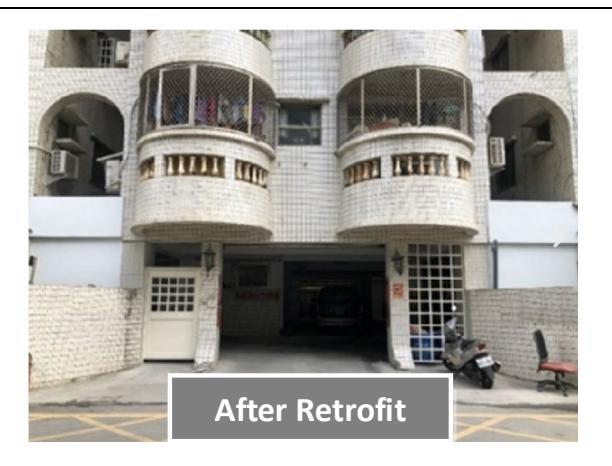
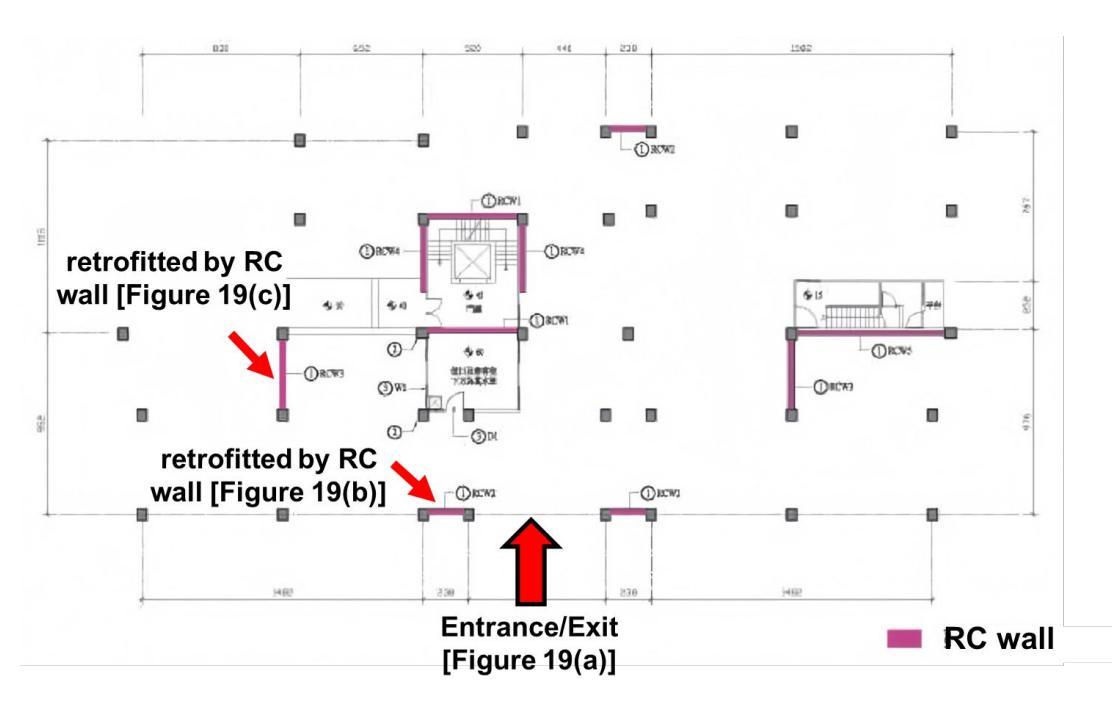
This case involves a RC building with six stories above ground and one underground story, completed in 1991 (Figure 26(a)). The underground story houses the transformer room and reservoir, the first story is a parking lot and contains a duty room, and the second to sixth stories are general residences. This building was retrofitted under Plan A, with a total cost of approximately US\$95,800 (including design and supervision) and a work period of 71 days. Shear walls were added on the first story to minimize the impact on residents. The residents reported that the retrofitting work did not disrupt their daily lives. The post-retrofit building is shown in Figure 26(b), and the strengthened locations are shown on the structural plan in Figure 26(c). On-site investigation revealed no significant damage to the main members (Figure 27).

Figure 26. Information relating to Retrofitted Building II: (a) before retrofit, (b) after retrofit, (c) structural plan and retrofitted locations (NCREE, 2019).

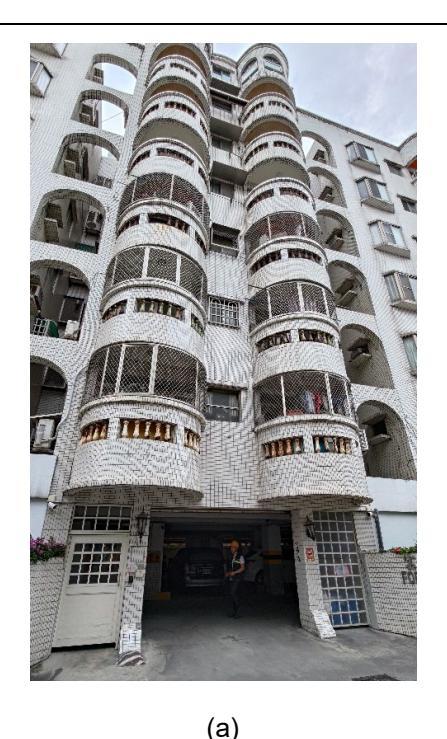
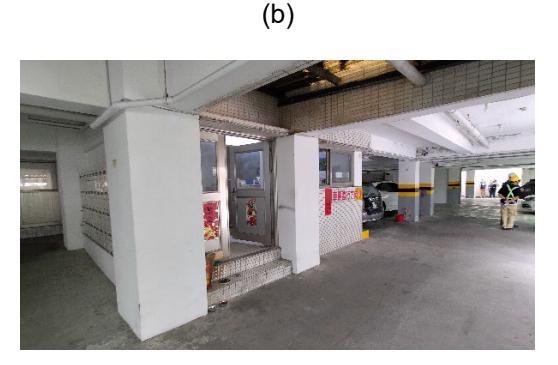
Figure 27. On-site survey status of Retrofitted Building II after the 0403 Hualien earthquake: (a) entrance/exit, (b) and (c) retrofitted with RC walls.

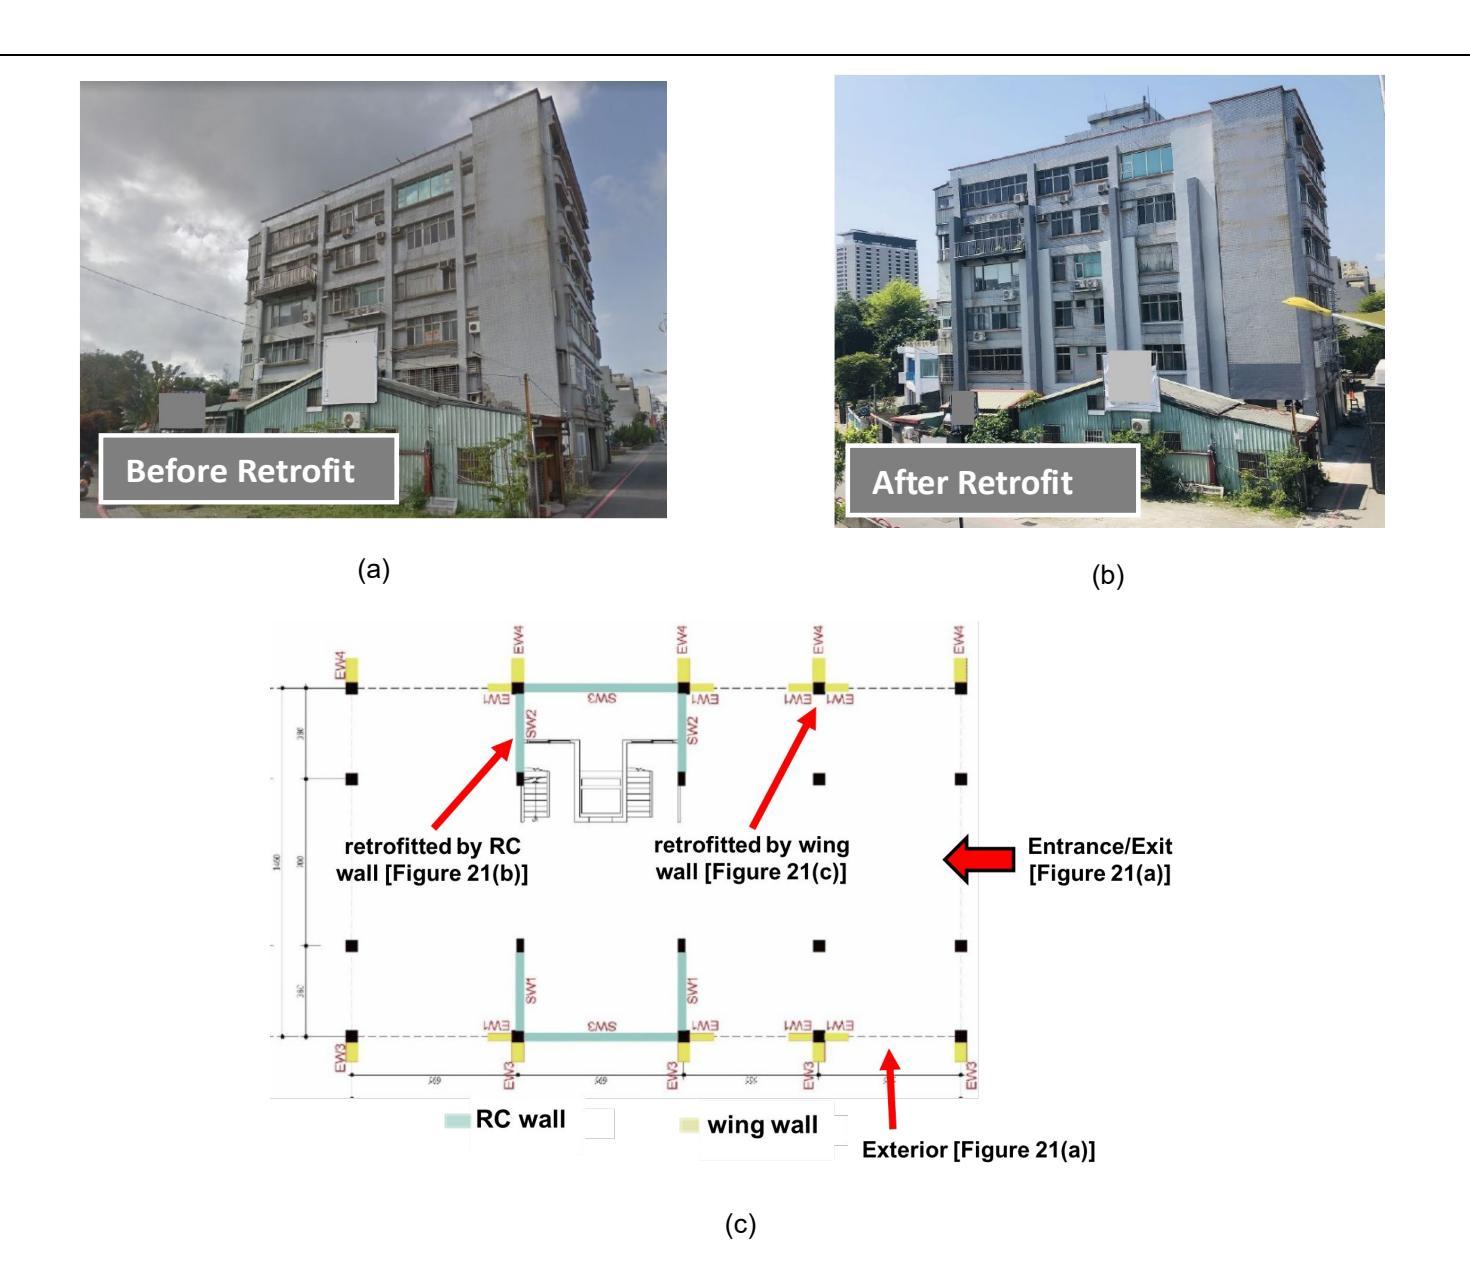
This case involves a six-story RC building, completed in 1991 (Figure 28(a)). The first story is a parking lot, and the second to sixth stories are general residences. This building was retrofitted under Plan B, with a total cost of approximately US\$257,800 (including design and supervision) and a work period of 310 days. Shear walls and wing walls were added from the first to the sixth story. The post-retrofit building is shown in Figure 28(b), and the strengthened locations on the structural plan are detailed in Figure 28(c). On-site investigation revealed no significant damage to the main members, as shown in Figure 29.

Figure 28. Information relating to Retrofitted Building III: (a) before retrofit, (b) after retrofit, (c) structural plan and retrofitted locations (NCREE, 2019).

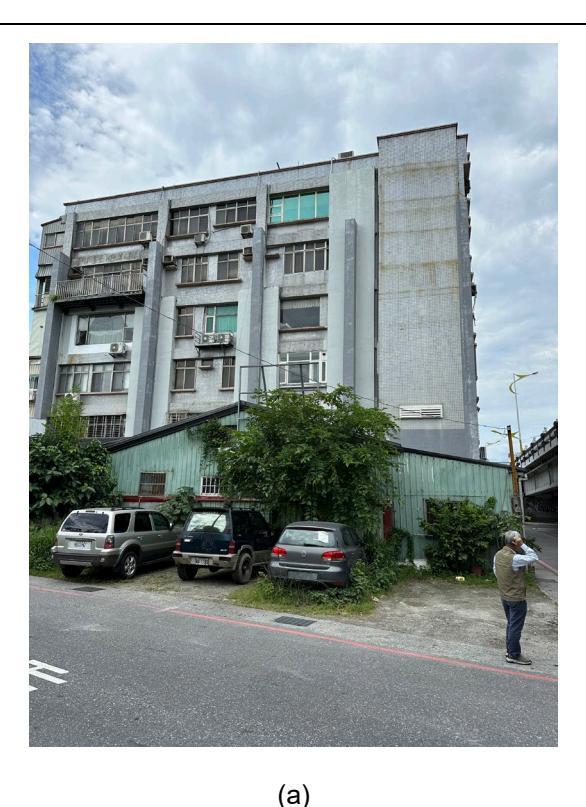
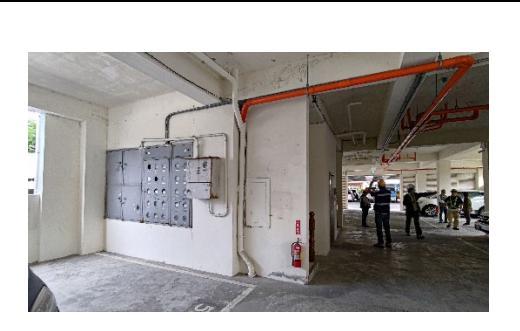
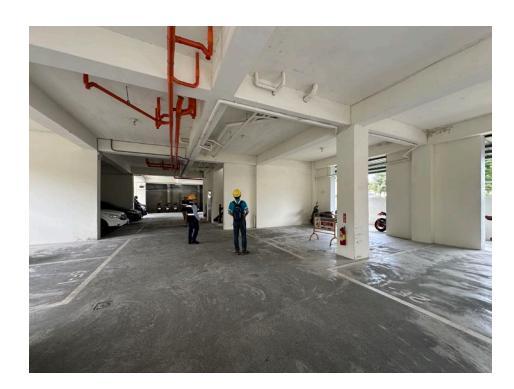
Figure 29. On-site survey status of Retrofitted Building III after the 0403 Hualien earthquake: (a) exterior, (b) retrofitted with RC walls, (c) retrofitted with wing walls.

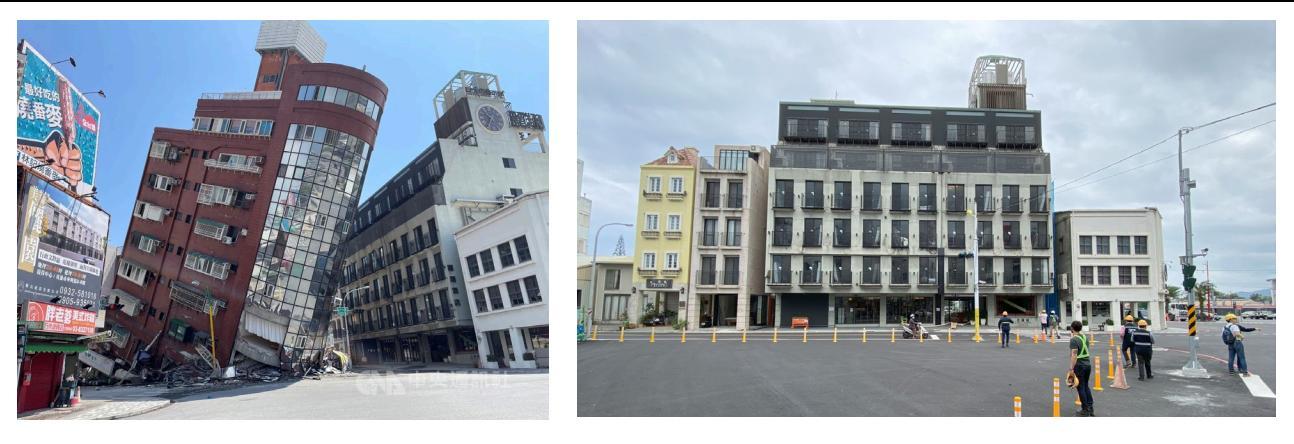
5.2.1 Retrofitted Building IV: Six-story hotel (RC building) retrofitted using steel jacketed RC columns and WES-BRBs As shown in Figure 30(a), the hotel, located next to a collapsed building that received worldwide attention and was demolished after the 0403 Hualien earthquake, exemplifies the value of seismic retrofitting. The hotel was located at Hualien City and approximately 13 km from the epicenter. Moreover, it is approximately 200 meters from nearby station HWA019. The acceleration response spectra of station HWA019 (Figure 4(a)) suggest that many old buildings, such as the collapsed building, were prone to damage or destruction during the 0403 Hualien earthquake. In comparison, the sixstory RC hotel, built at least 52 years ago and retrofitted twice (in 2010 and 2020) to upgrade seismic performance, sustained the earthquake and performed very well.

Figure 30. Photographs of the retrofitted hotel: (a) next to the collapsed building (taken by a journalist from Taiwan's Central News Agency on April 3, 2024) and (b) front view (taken on May 9, 2024) indicates that the collapsed building had been demolished.

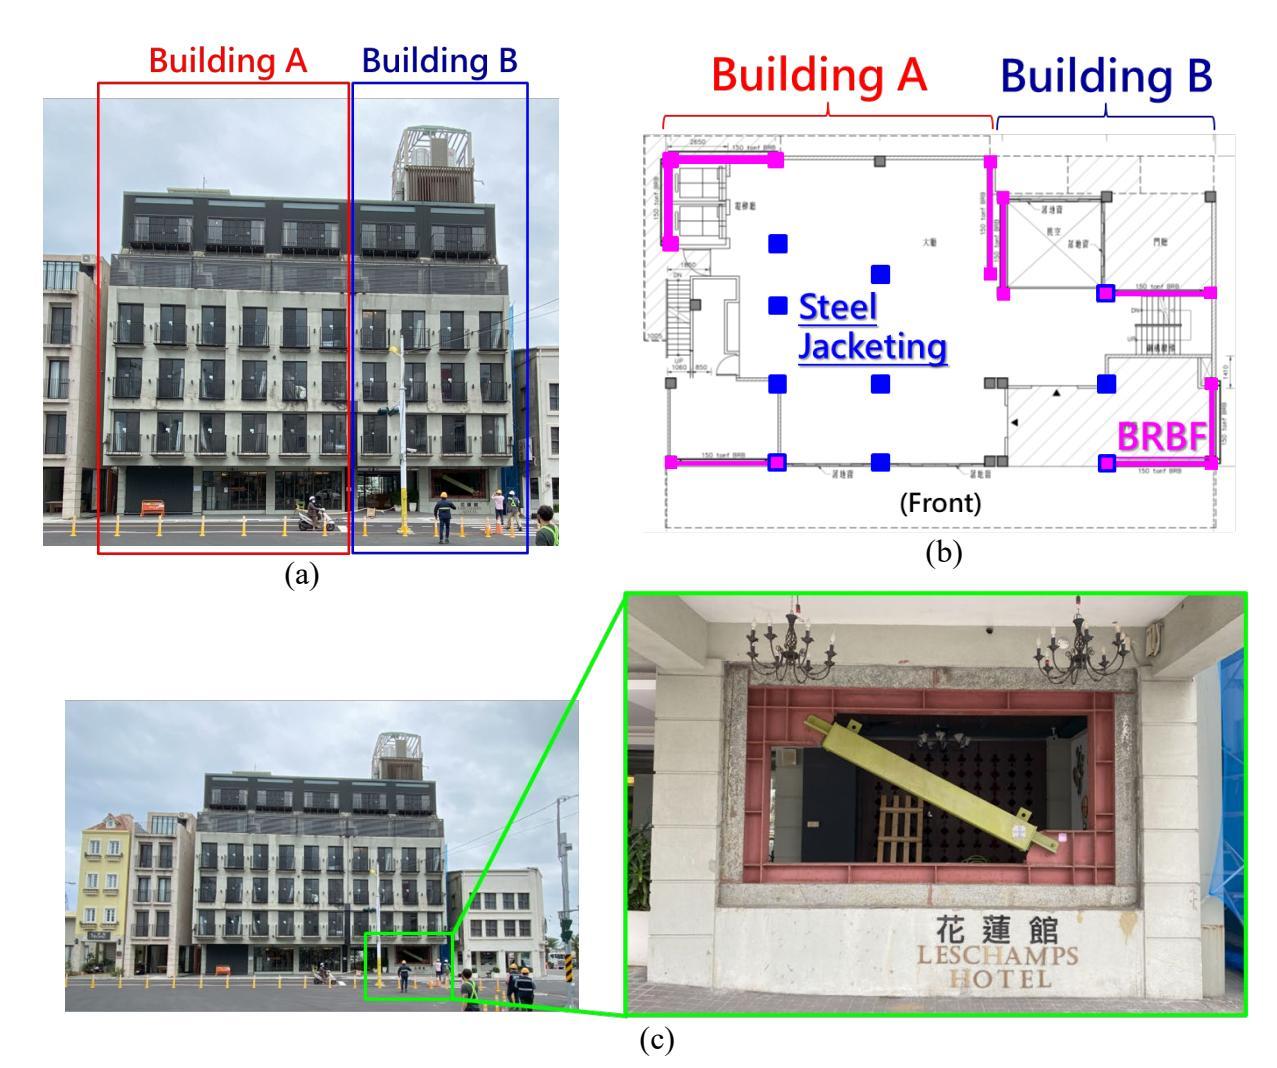
The hotel consists of two six-story RC buildings (designated as Buildings A and B) with a basement. Buildings A and B were originally constructed in 1969 and 1972, respectively (Figure 31(a)). In 2010, the current building owner strengthened the RC structures using steel-jacketed columns (Figure 31(b)). After the 2018 Hualien earthquake (Lin et al., 2020), the owner foresaw the risk of future earthquakes and decided to further upgrade the seismic performance of the hotel building. A total of twenty welded end-slot buckling restrained braces (WES-BRBs) (Tsai et al., 2014), each with a yield strength of 1,500 kN, were installed in the hotel (Figure 31(b)). Field inspections of the reconnaissance team revealed no obvious damage to the WES-BRBs, gussets, mortar, steel-to-RC interfaces, or RC members, demonstrating the effectiveness of retrofitting using steel-jacketed RC columns and WES-BRBs.

Figure 31. (a) Photograph of the two buildings of the hotel, (b) first-floor framing plan (credit: Mr. An-Chien Wu, NCREE), and (c) BRB frame (photographs taken on May 9, 2024).

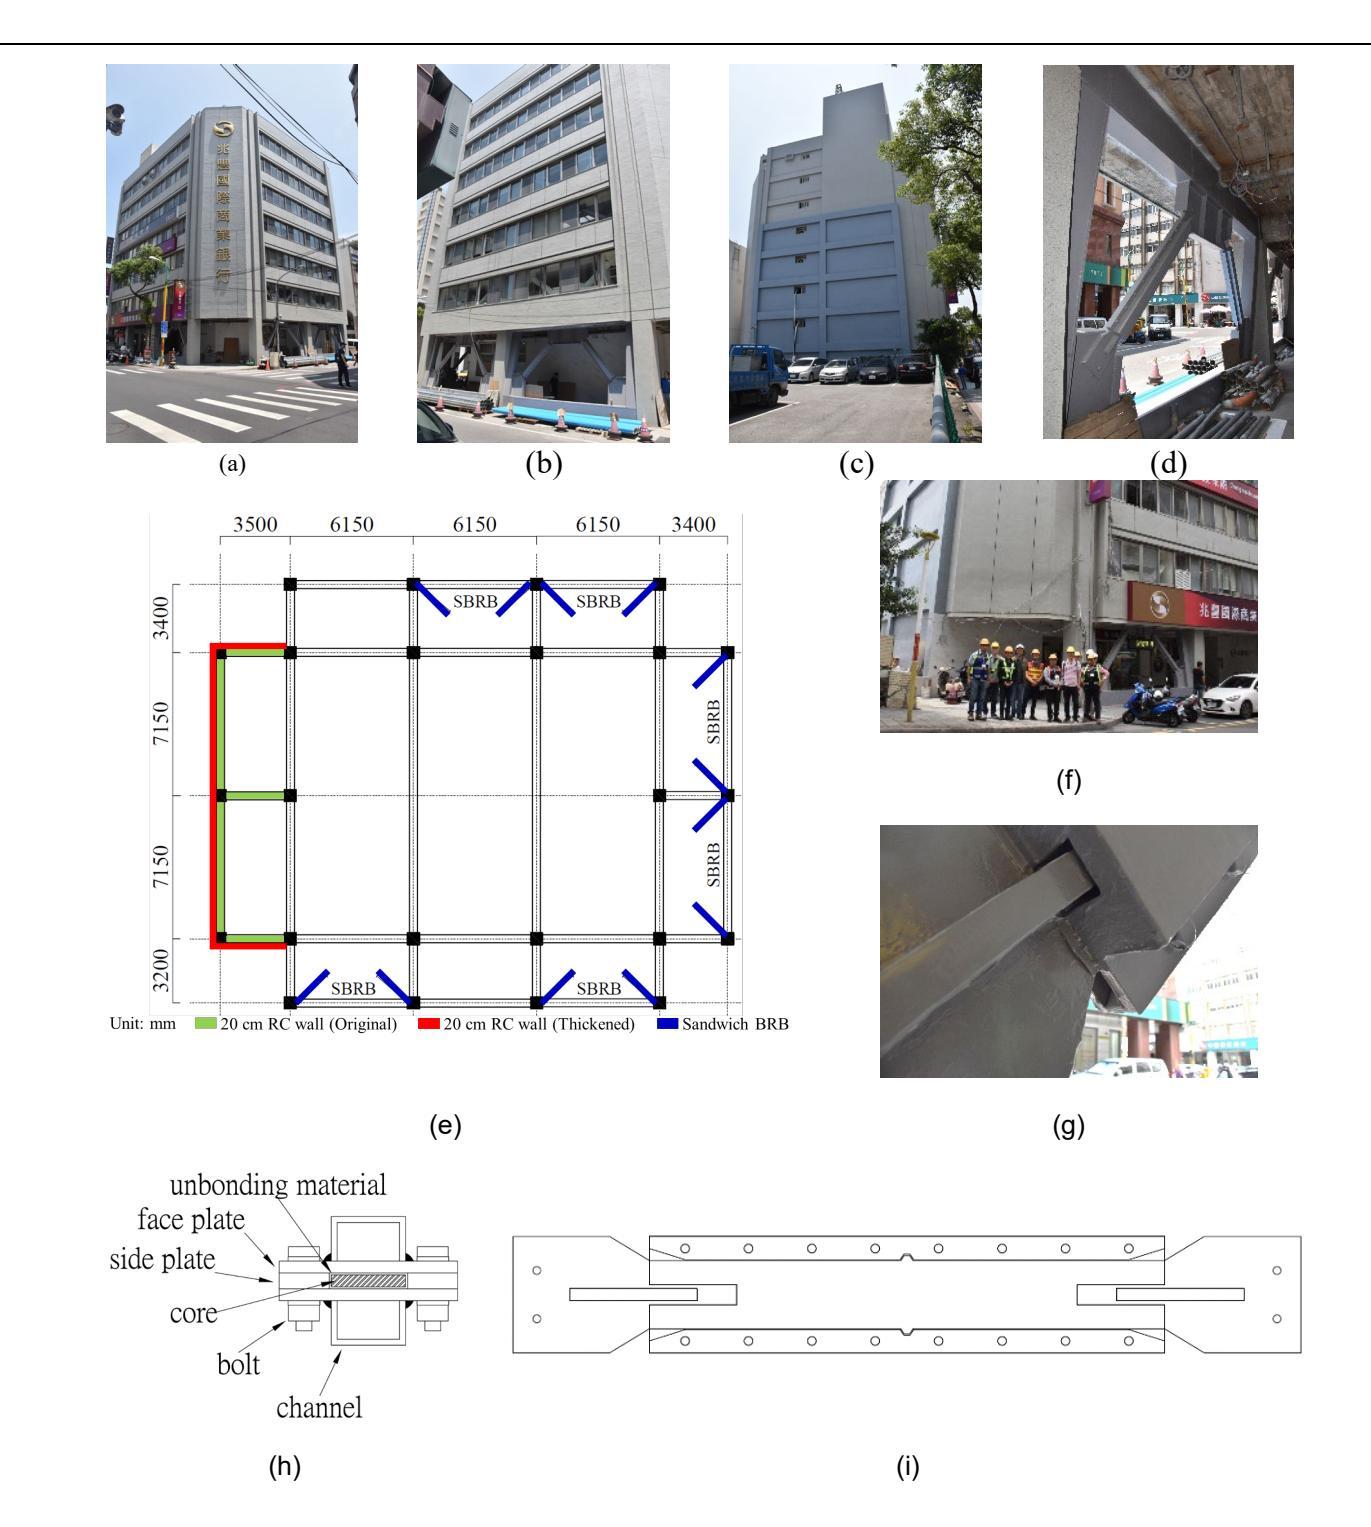
The bank building is an eight-story RC structure with a basement (Figure 32(a)), the building construction completed in 1982. Its floor plan measures approximately 26 m × 21.5 m, with heights of 3.75 m for the first floor and 3.1 m for the second to eighth floors. The RC exterior wall thickness is 12 cm at the rear facade, while the indoor stairs and elevator walls on the same side have 20 cm RC walls. The front facade serves as the entrance facing the road, with fewer walls, leading to noticeable asymmetry in the overall structure. The structural retrofit of this building was completed in early 2024, before the 0403 Hualien earthquake. Because the interior continued to be used as a bank during the retrofit period, the methods and locations of the retrofit differed from those of conventional RC retrofitting. The retrofit involved installing allsteel Sandwiched Buckling-Restrained Braces (SBRBs) (Chou et al., 2010; Chou et al., 2024) and thickening existing walls with 20 cm RC walls from the basement to the fifth floor. A total of 25 sections of 20 cm RC walls and 52 sets of allsteel SBRBs were added (Figure 32(b) and (c)). The SBRB was composed of a steel core plate, sandwiched by a pair of restraining members without concrete infill. The SBRB retrofit method entails adding a steel boundary frame within the existing RC frame, including the steel top and bottom beams and columns on both sides (Figure 32(d)) The boundary frame are chemically anchored to the existing RC structure, while thickening the RC walls also reinforces the surrounding beam and column sections. Retrofit locations were selected around the perimeter of the building to provide structural strength and promote symmetry in the structural system, thus reducing torsional effects (Figure 32(e)). During the site inspection (Figure 32(f)), the building exhibited no damage, and no structural cracks were observed in the retrofit building after the 0403 Hualien earthquake. At the SBRB on the first floor, the debonding material was slightly deformed, leading to minor paint peeling on the outer layer (Figure 32(g)). This indicates the SBRB deformation during the earthquake, although the deformation was not substantial.

SBRBs are effective seismic energy dissipation components, comprising a core steel plate and surrounding restraining members (Figure 32(h) and (i)) (Chou et al., 2010; Chou et al., 2024). The restraining members consist of upper and lower units welded from steel plates and steel channels, bolted on both sides of the weak axis of the core plate. Its all-steel construction facilitates quick manufacturing and installation, with stable seismic performance. It has already been used in several newly constructed high-rise buildings. The eight-story bank building is the first building to be retrofitted using all-steel SBRBs. This building is approximately 250 meters from the collapsed building (Figure 30(a)) and has a similar height. Additionally, it was constructed before the collapsed building. Based on the results of on-site microtremor measurements and covariance-driven stochastic subspace identification (SSI-COV) analysis, the building's period was 0.36 s. Comparing this with the response spectrum recorded from the nearest station (HWA019, approximately 200 meters away) (Figure 4(a)), the corresponding maximum acceleration in the north-south direction was 1 g. Although the ground motion had a very high acceleration demand on the retrofitted building, the retrofitted bank building performed very well during the 0403 Hualien earthquake, demonstrating the effectiveness of the retrofit using all-steel SBRBs and thickened walls.

Figure 32. Eight-story bank building: (a) overall view, (b) retrofitting with SBRBs, (c) retrofitting with RC wall, (d) added steel frame and SBRB, (e) plan drawing, (f) reconnaissance team member and building, (g) deformation track, (h) SBRB cross section, (i) SBRB lateral view.
