**IMPRESSIONS OF THE
GUERRERO-MICHOACAN, MEXICO
EARTHQUAKE OF 19 SEPTEMBER 1985**

A PRELIMINARY RECONNAISSANCE REPORT

**Committee on Natural Disasters
Commission on Engineering and Technical Systems
National Research Council**

**October 1985
Publication No. 85-05**

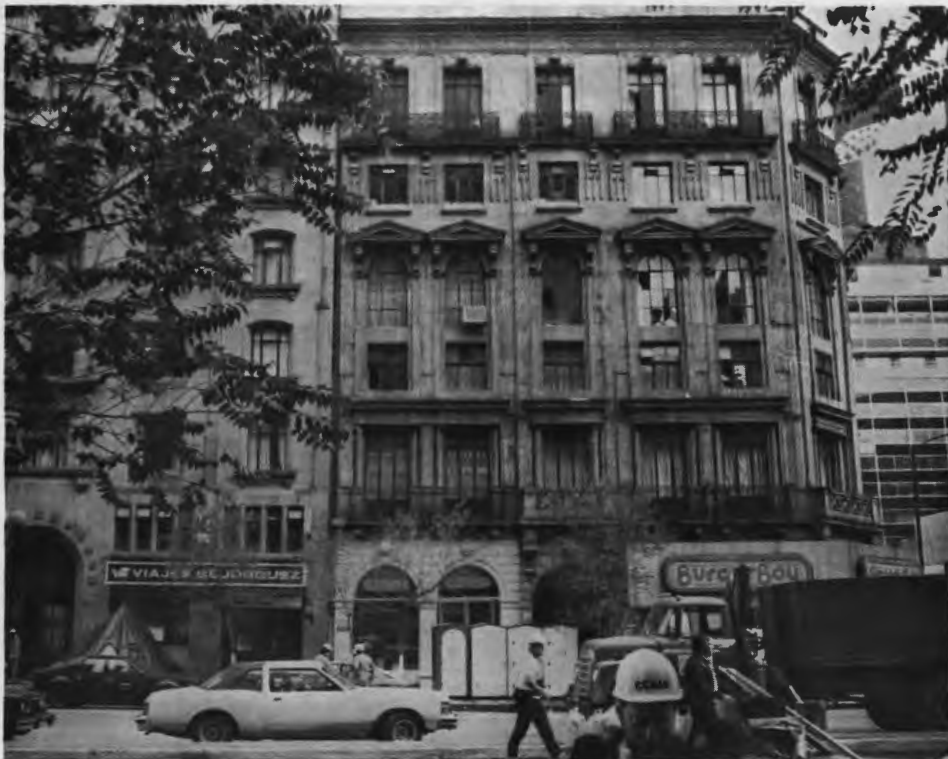
Intact older building 1 block from Regis Hotel

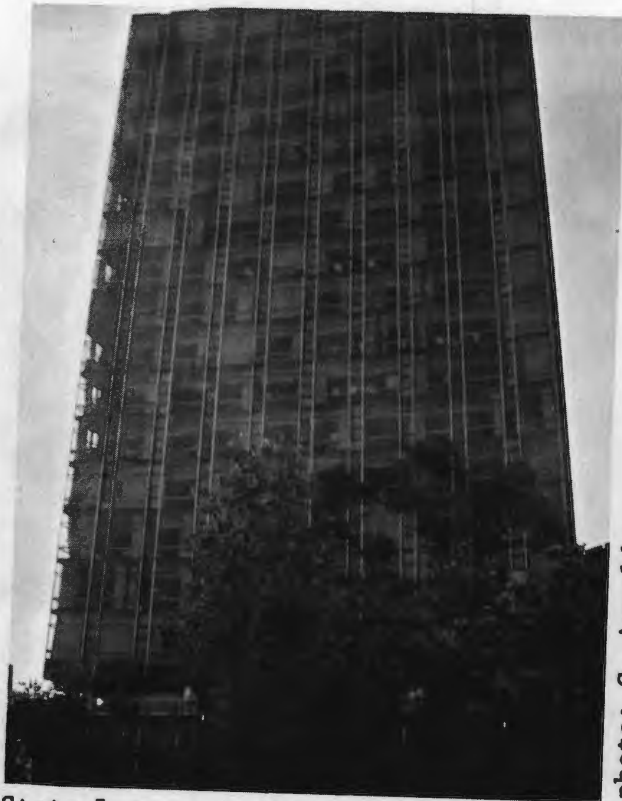
State Lottery building -- undamaged.
This steel frame structure is located
1 block from Regis Hotel.

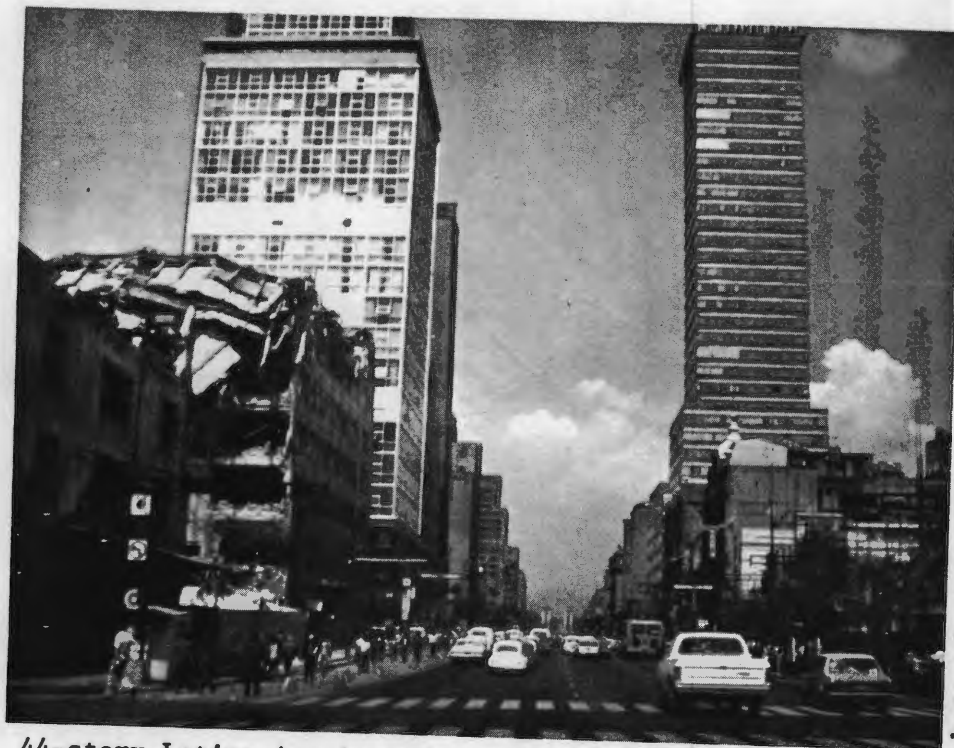
44-story Latino-American Tower (built 1948) -- undamaged

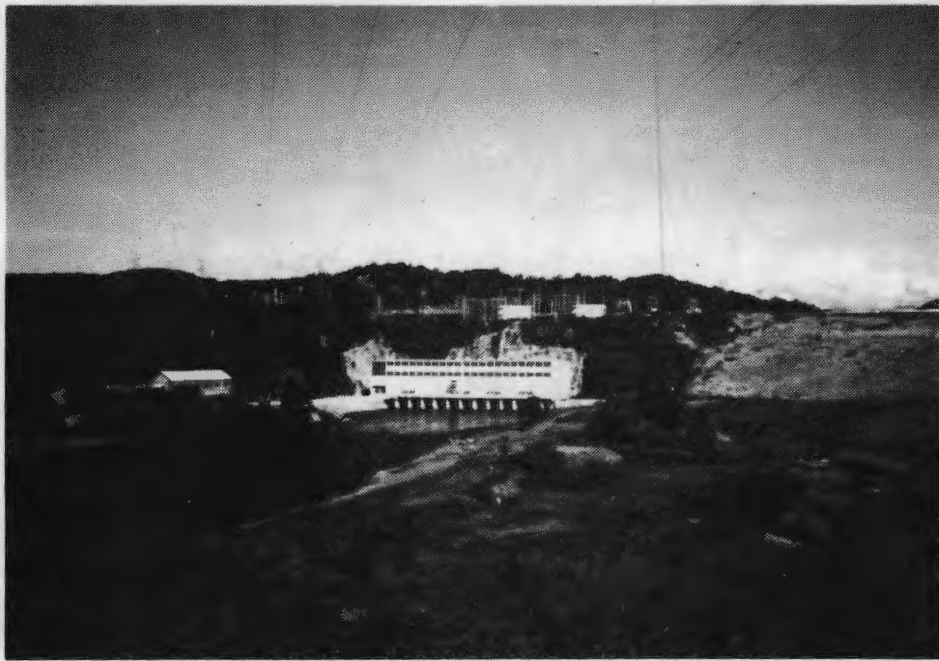
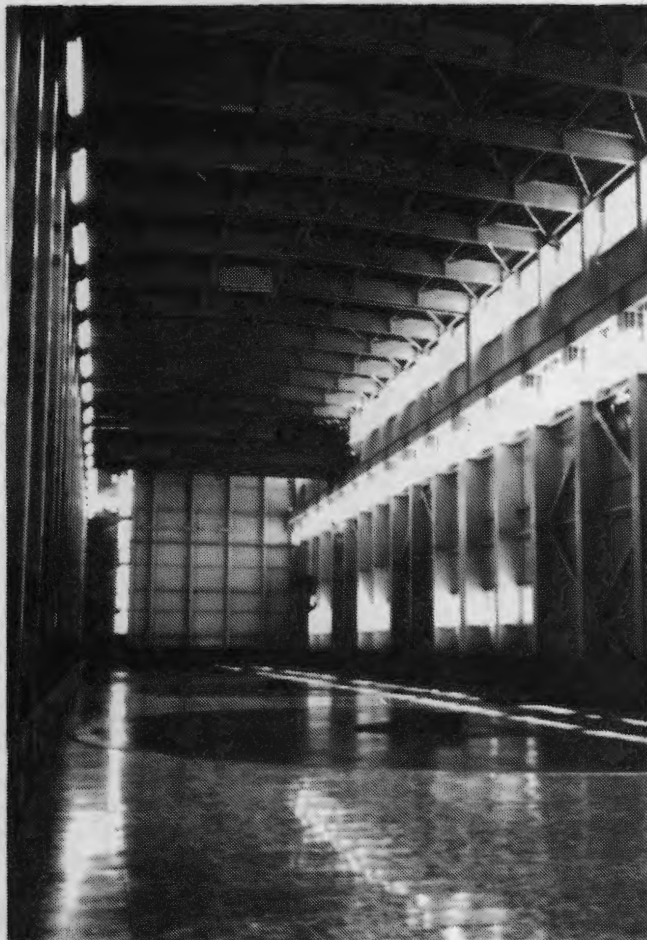
Jose Maria Morelos Dam. The dam and La Villita power station are located near the mouth of the Rio Balsas. The earth-filled dam is approximately 150 feet high by 1,000 feet long. The large array of high voltage equipment in the station switchyard (adjacent to the dam crest) was unaffected by the earthquake, even though this type of equipment is often susceptible to seismic damage. The power station is housed in a large steel frame building and consists of four 76 megawatt units, completed in 1973. Mechanical and electrical equipment in the station were undamaged by the earthquake. Protective relays disconnected the station from the power grid during the earthquake.

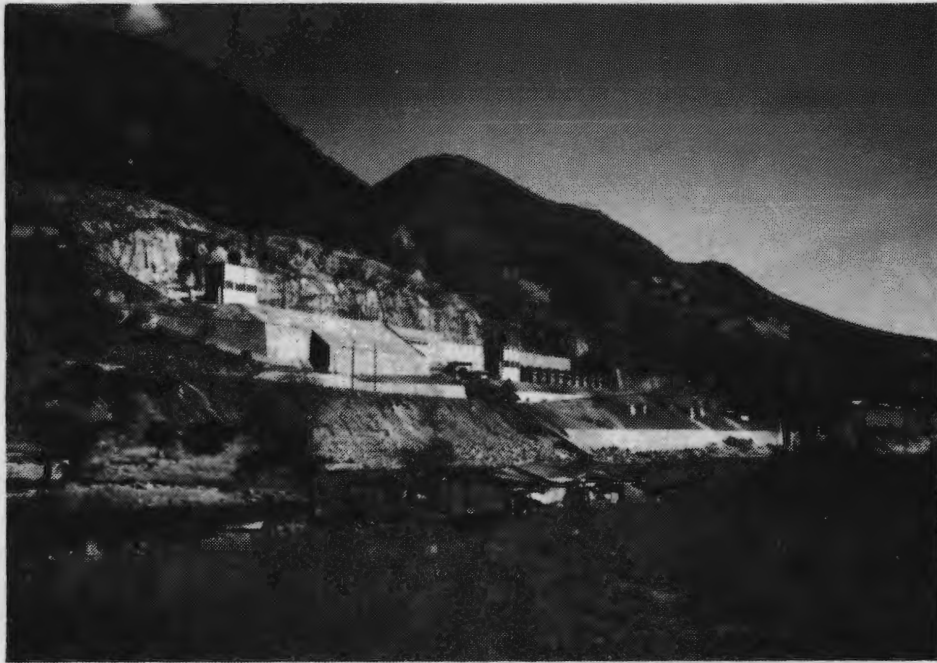
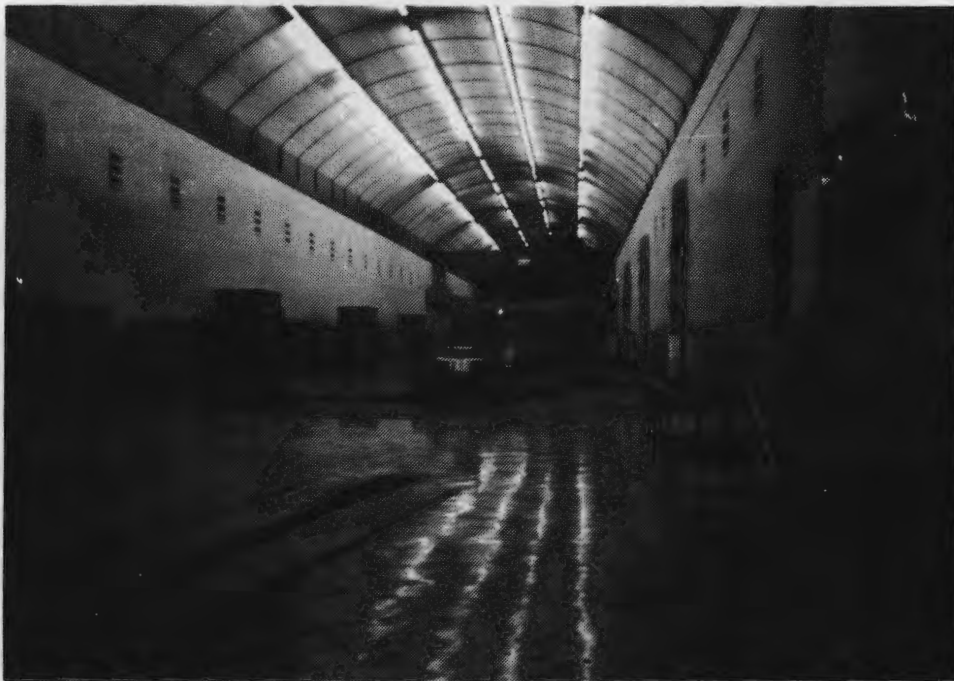
El Infiernillo Dam and Power Station. Located on the Rio Balsas about 20 miles from the Pacific coast, El Infiernillo is an earth-filled dam about 500 feet high by 1,000 feet long. The power station is located at the discharge of the penstock about 1/2 mile downstream of the dam. Built into the rock face of a hillside, the power station includes four 160 megawatt units and two 180 megawatt units. It was constructed in the mid 1960's. The station disconnected from the power grid during the earthquake due to protective relay action.

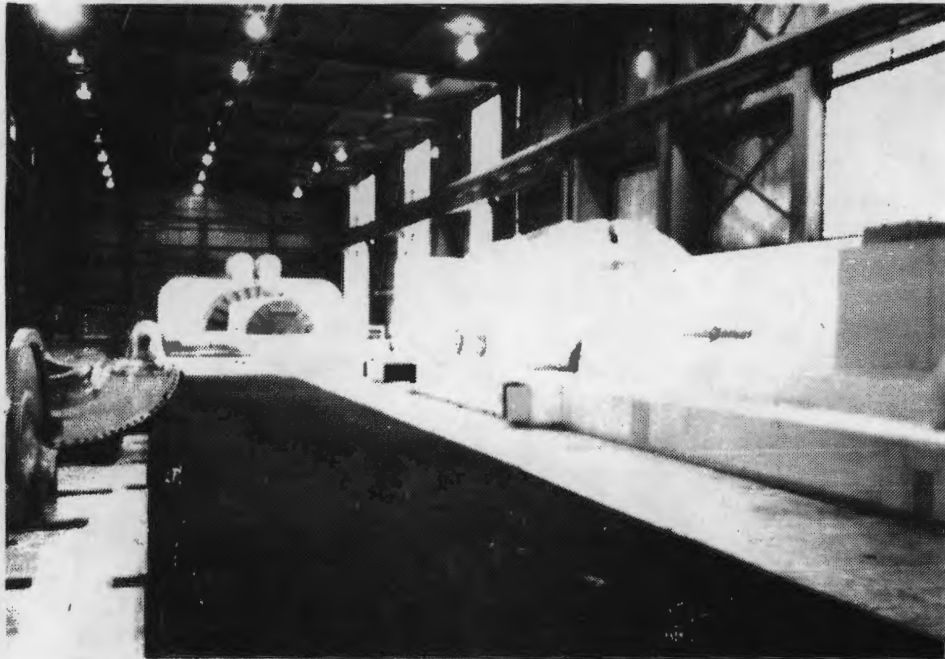
Valle de Mexico Power Plant. The operating floor of this fossil power plant is shown. It is located about 20 miles west of Mexico City and is built on a rock site. The plant includes three 150 megawatt units and one 300 megawatt unit. Plant personnel reported minor shaking from the earthquake. Three units were operating at the time of the earthquake; two remained on-line and one disconnected from the power grid due to relay actuation caused by loss of load in Mexico City. There was no damage to the plant.
