# Virtual Earthquake Reconnaissance Team (VERT): Phase 1 Response to M7.0 Izmir, Turkey October 30, 2020

**By:** Yolanda Alberto, Jaskanwal Chhabra, Erica C. Fisher, Manny Hakhamaneshi, Brisid Isufi, Amory Martin, Tonatiuh Rodriguez-Nikl, Sissy Nikolaou, Deniz Ay, Elmon Toraman, Mehmet Unal, Kai Wu

# Topic: Soft story buildings

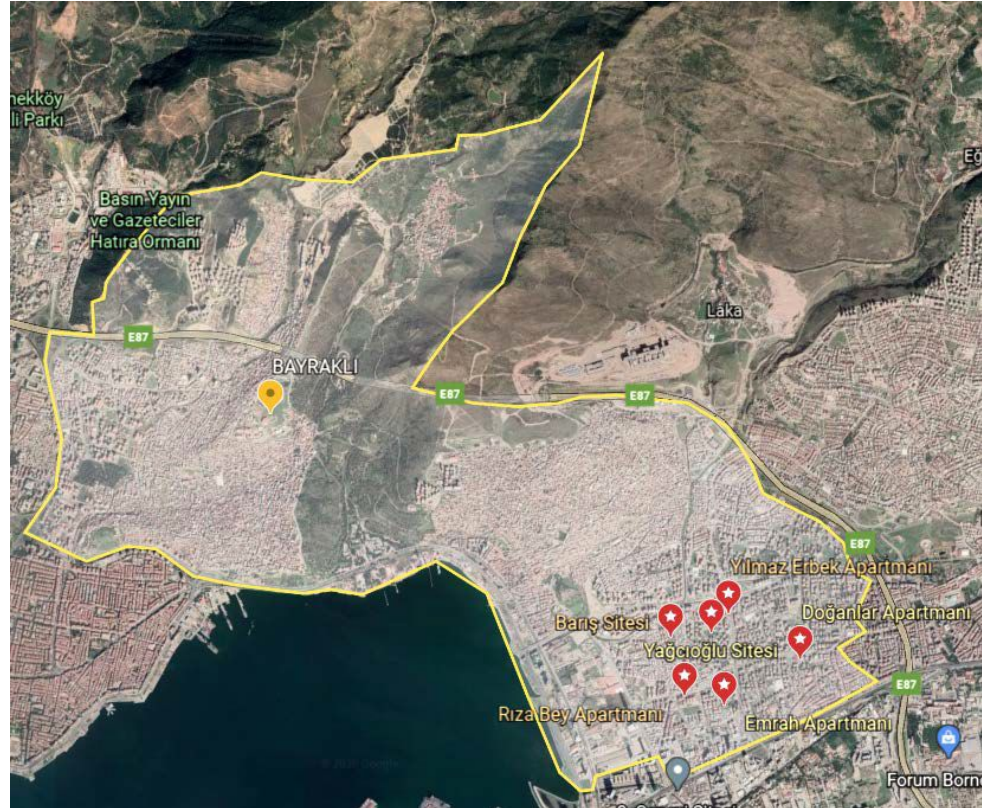
- Most of the collapsed buildings were concentrated in the Bayraklı District.<sup>3</sup>

Map of collapsed buildings in the Bayraklı district<sup>3</sup>

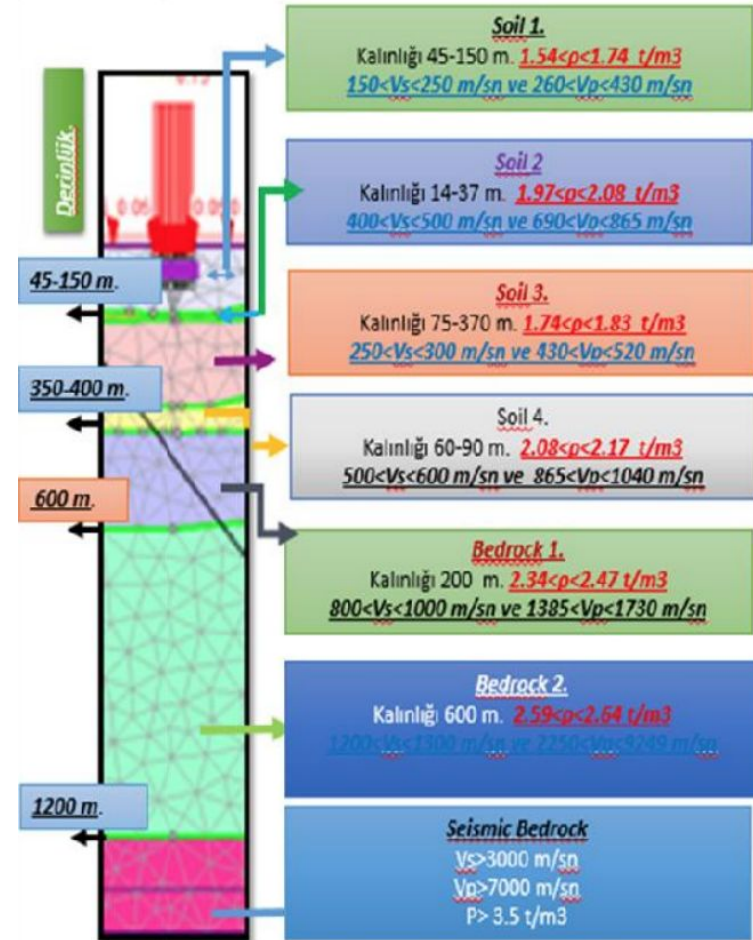
Soil Layers in Bayrakli region<sup>6</sup>

Based on site observations and reports published on the area, it can be understood that Bayrakli is sitting on a thick alluvial layer<sup>6</sup> (see Figure). **The bedrock depth is very deep and the groundwater level is high with the potential of liquefaction.** The existence of alluvium layers led to the potential of liquefaction and bearing capacity loss due liquefaction and ground deformation due to lateral spreading.

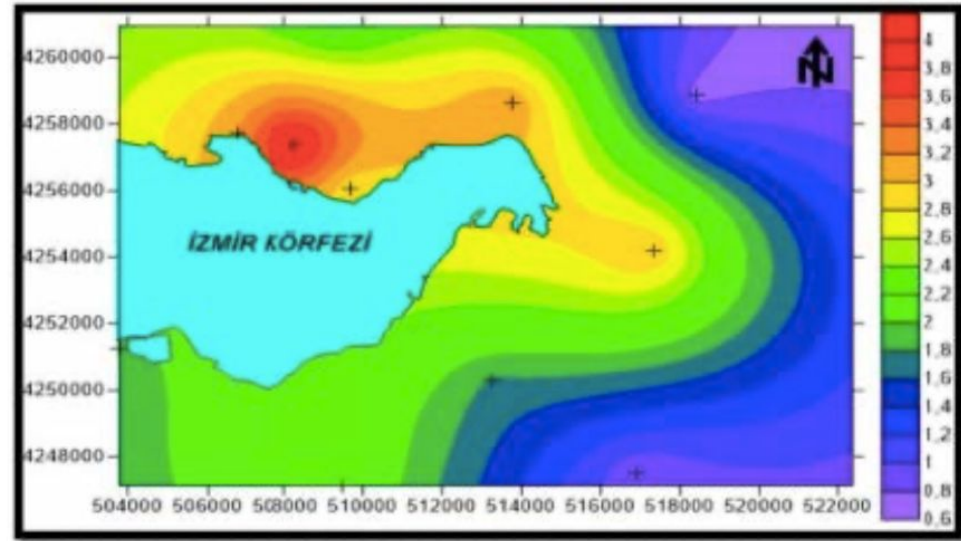
Summary of soil amplification<sup>6</sup>

- The closest residential area is Seferihisar, 35 km away with PGA of 0.050 g,
- Menderes is 51 km away from the epicenter with PGA 0.075 g,
- Bayraklı is 69 km away from the epicenter with PGA 0.108 g.

- Based on this data, it can be seen that amplification effect for Bayrakli region of Izmir is much lower than the predicted design acceleration.
- Damaged building inspection in the area shows that *spread foundations are mostly preferred whereas basement floor is uncommon*. Ground settlement is not observed in the examined buildings.

- Although numerically amplification effects exist in the area, as the measured ground acceleration is much lower than highest predicted design acceleration *we cannot conclude that the damage is associated to this effect*.

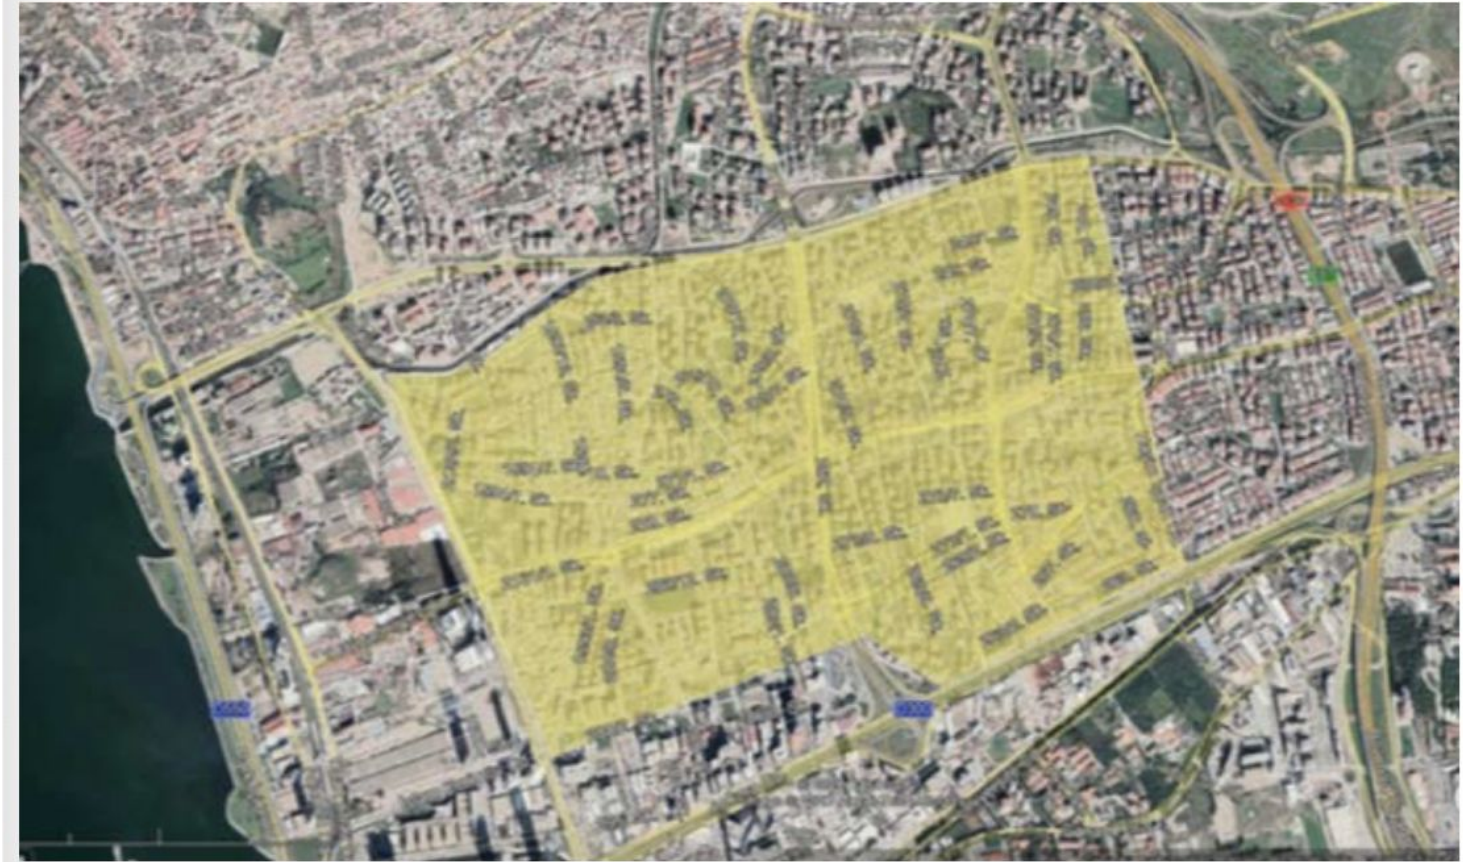
Region with extensive damage and fatalities <sup>7</sup>

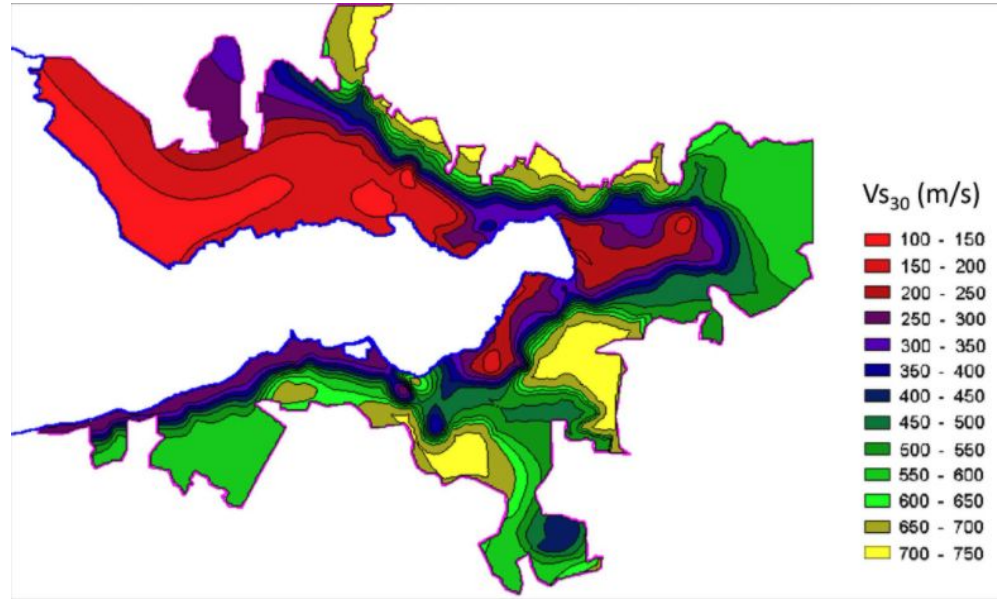
- The expected amplification of seismic shaking is generally inferred by the average seismic shear wave velocity in the upper 30 m ('Vs30').
- Most of the heavily built areas are located on the soft sediments of the city located in Karşıyaka, Bayraklı, Bornova and Konak districts<sup>7</sup>.

The distribution of Vs30 (average shear wave velocity in the upper 30m) map of the Inner İzmir Bay Basin <sup>7</sup>
