Post-Earthquake Data Collection Workshop

Executive Summary

Anchorage, Alaska

July 20-22, 2014

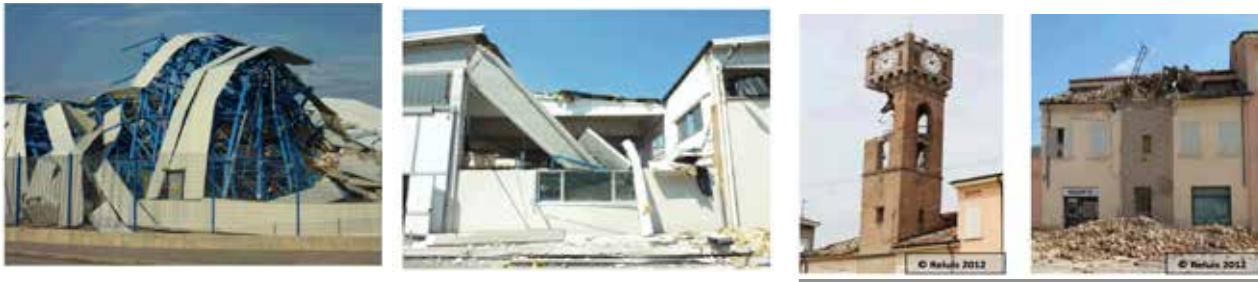
➤ Emilia-Romagna Earthquake – 20-29 May 2012 (Mw=5,9; 5,8)

- Damages mainly on industrial buildings - Business interruption;
- additional damages provided by the earthquake of 29 may .
- Need to refine Usability form for precast buildings

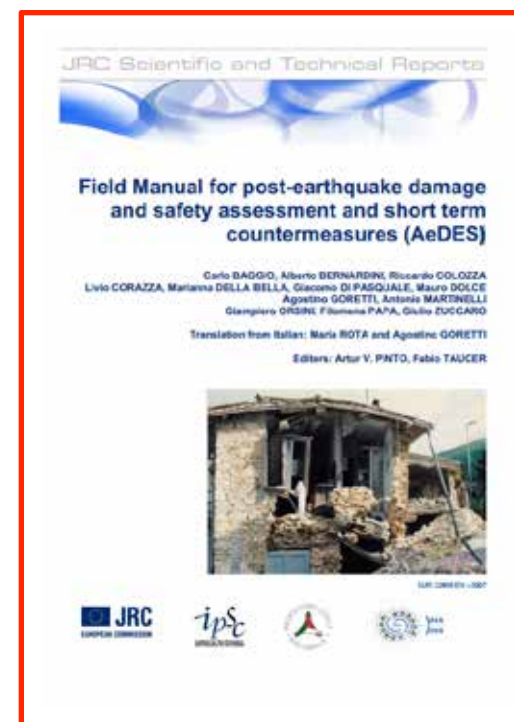
The form and its manual derive from the experience gained in several earthquakes since earthquake in Umbria and Marche in 1997.

Updates were made after the earthquakes of Pollino 1998 and Molise in 2002.

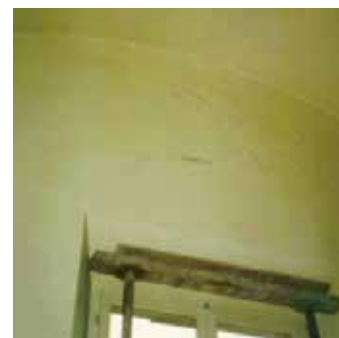
D1 slight damage:

The damage not affect significantly the capacity of the structure; the damage is slight when the falling of objects can immediately be avoided.

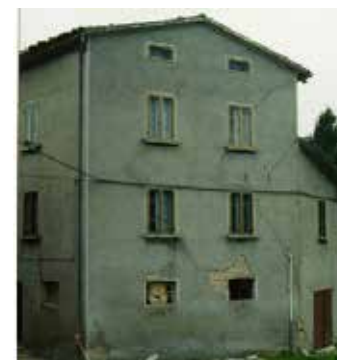
D2-D3 medium-severe damage:

The damage changes significantly the capacity of the structure, without getting close to the limit of partial collapse of the main structural components.

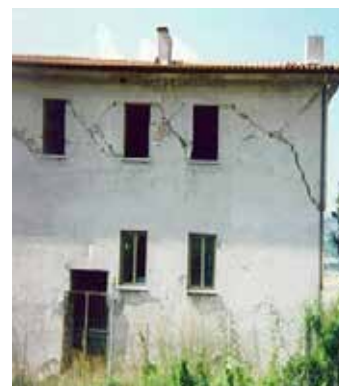
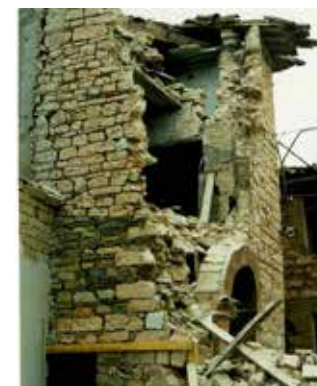
D4-D5 very heavy damage:

The damage significantly modifies the capacity of the structure, bringing it close to the limit of partial or total collapse of the main structural components – including collapse

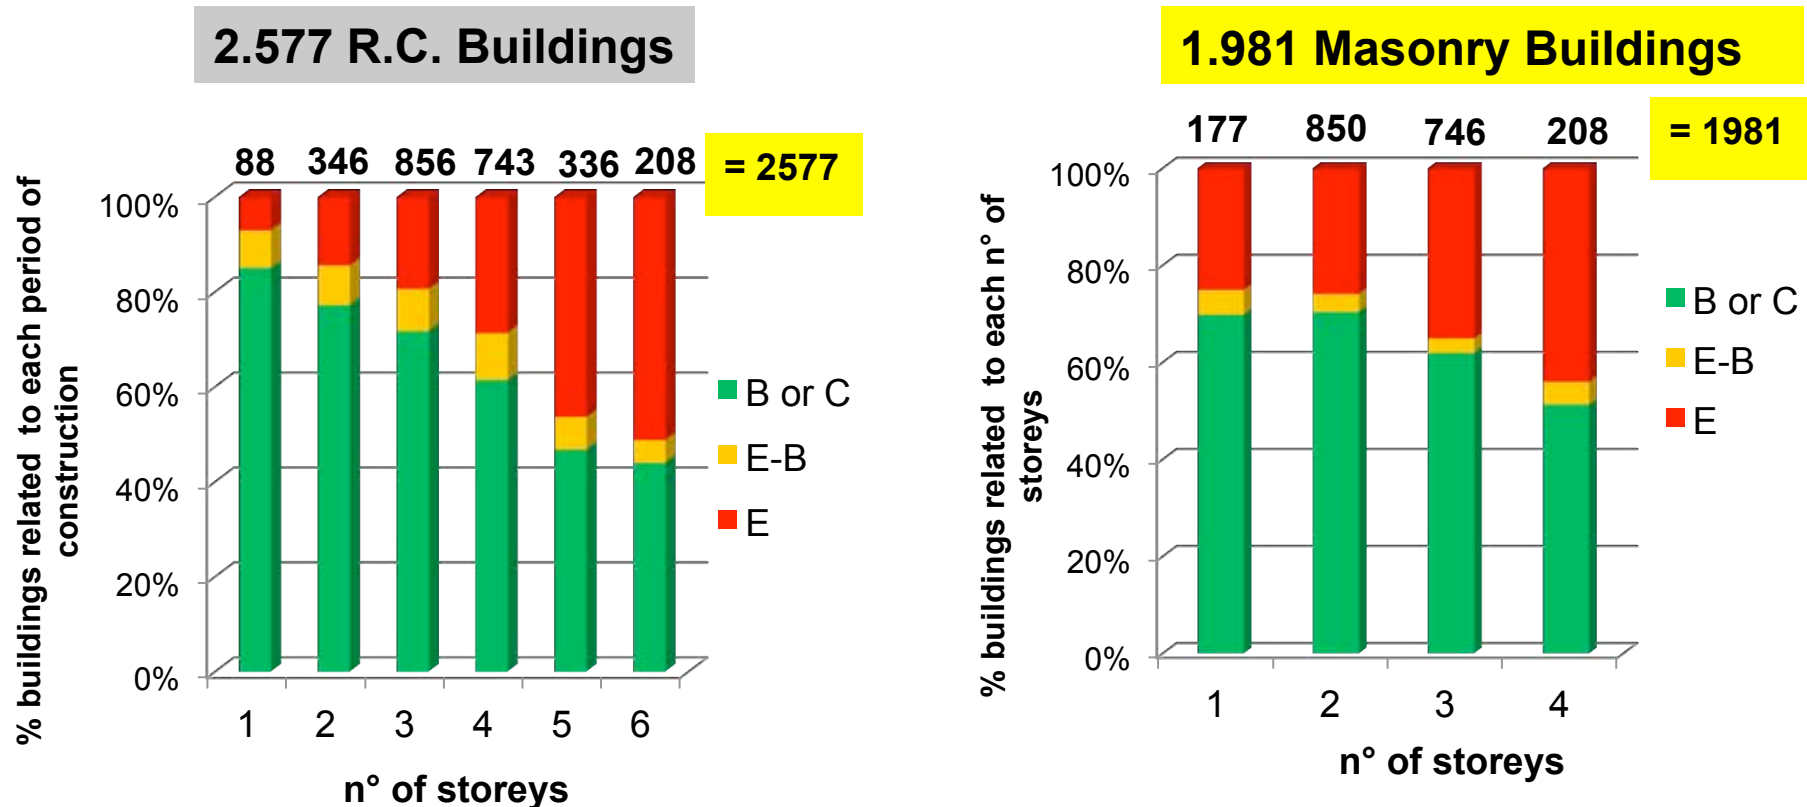
- Usability rate vs. structural type *n° of stories***

- ✓ **RC structures:** E rate buildings increase with number of stories (from about 10% to about 50%)
- ✓ **Masonry structures:** E rate buildings increase with number of stories (from about 25% to about 45%)

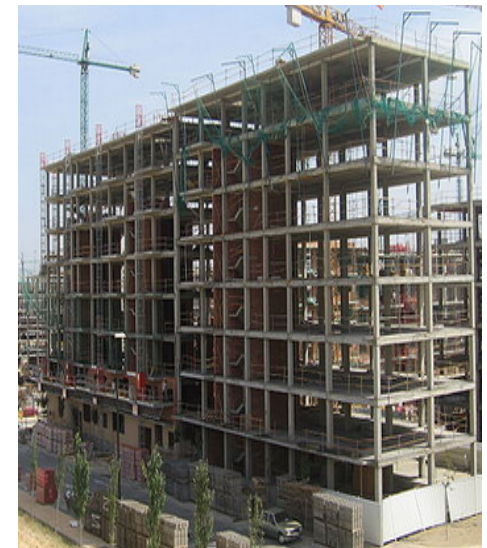
n° of Buildings [-]	1599
Mean [€/m²]	246,78
Median [€/m²]	216,47
Minimum [€/m²]	41,03
Maximum [€/m²]	1.090,78
Range[€/mq]	1.049,75
16° Percentile	101,47
84° Percentile	390,74
Standard Dev.[€/m²]	154,57
CoV [%]	63
Asymmetry [-]	1
Kurtosis [-]	2
Total grant [€]	375.866.841,96
Mean grant [€]	235.063,69
Mean Surface [m²]	898,28

- ✓ **Buildings grant:** Mean value of 246 €/mq. , corresponding to a mean grant of about € 235.000, 00 for each building, mean surface of about 900 mq.

- 1.599 R.C. buildings - mean grant: 246 €/m²

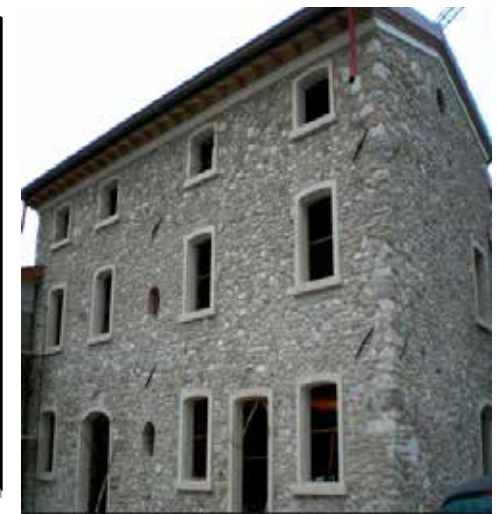
n° of Buildings [-]	902
Mean [€/m²]	318,22
Median [€/m²]	292,26
Minimum [€/m²]	32,20
Maximum [€/m²]	962,36
Range[€/mq]	930,16
16° Percentile	147,45
84° Percentile	488,10
Standard Dev.[€/m²]	172,16
CoV [%]	54
Asymmetry [-]	1
Kurtosis [-]	1
Total grant [€]	103.418.291,36
Mean grant [€]	114.6543,0
Mean Surface [m²]	377, 35

- ✓ **Buildings grant:** Mean value of 318 €/mq. , corresponding to a mean grant of about € 115.000, 00 for each building, mean surface of about 377 mq.

- 902 masonry buildings mean grant : 318 €/m²

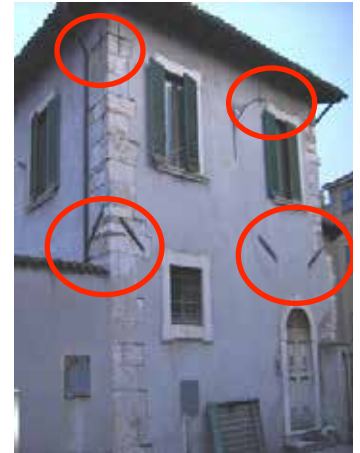
STEEL TIES

✓ **Local strengthening costs:** doubled with respect to RC buildings (in any case lower than maximum allowable 150 €/mq)

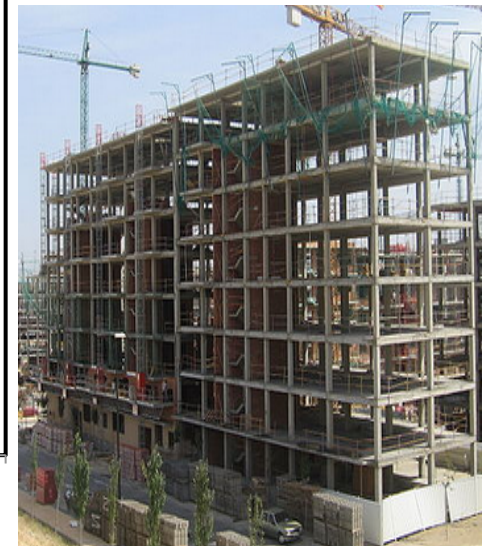
n° of Buildings [-]	448
Mean [€/m²]	1.030,4
Median [€/m ²]	1.057,4
Minimum [€/m ²]	168,0
Maximum [€/m ²]	1.826,96
Range[€/mq]	1.658,65
16° Percentile	806,41
84° Percentile	1.258,2
Standard Dev.[€/m ²]	240,68
CoV [%]	23
Asymmetry [-]	0
Kurtosis [-]	0
Total grant [€]	805.129.213,53
Mean grant [€]	1.797.163,0
Mean Surface [m²]	1.733,8

- ✓ **Buildings grant:** Mean value of 1.030 €/mq. , corresponding to a mean grant of about € 1.800.000, 00 for each building, mean surface of about 1.700 mq.

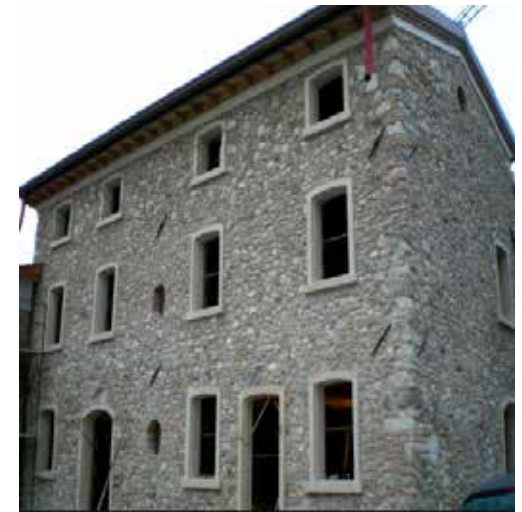
n° of Buildings [-]	314
Mean [€/m²]	934,97
Median [€/m ²]	941,8
Minimum [€/m ²]	312,00
Maximum [€/m ²]	1.740,68
Range[€/mq]	1.428,58
16° Percentile	722,00
84° Percentile	1.148,63
Standard Dev.[€/m ²]	227,38
CoV [%]	24
Asymmetry [-]	0
Kurtosis [-]	-
Total grant [€]	180.718.716,58
Mean grant [€]	575.537,3
Mean Surface [m²]	608,7

- ✓ **Buildings grant:** Mean value of 935 €/mq. , corresponding to a mean grant of about € 575.000, 00 for each building, mean surface of about 610 mq.

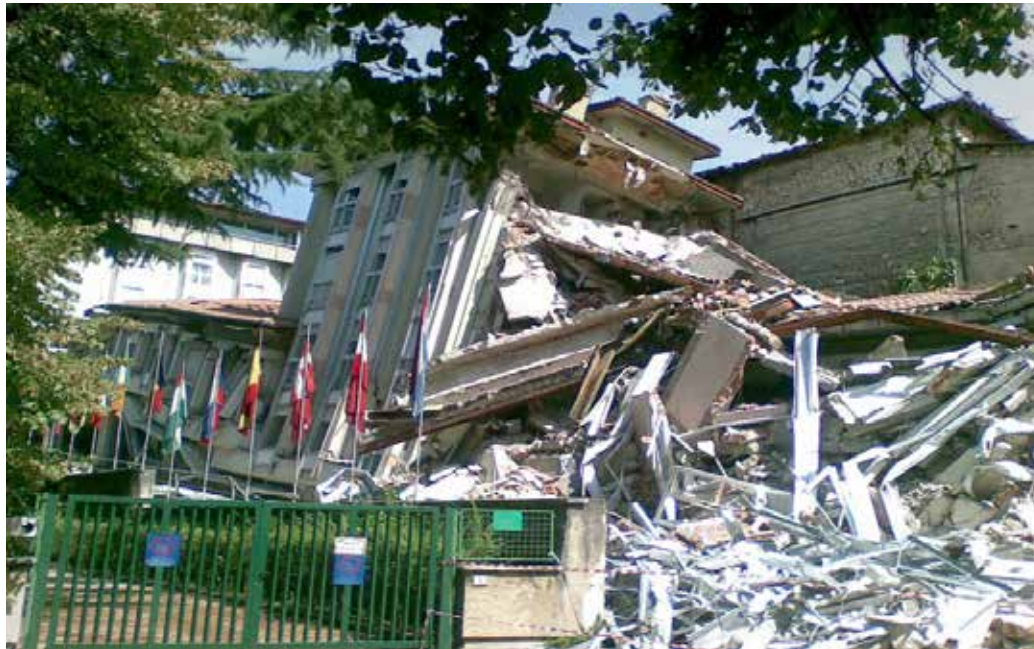
**Hotel Duca degli Abruzzi collapse,
L'Aquila 2009.**

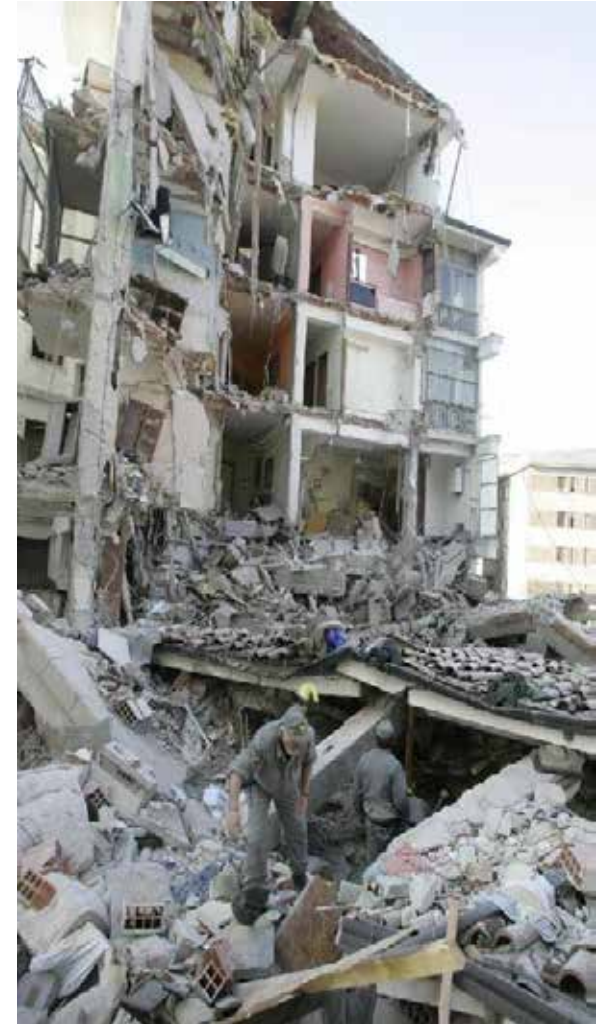
**Student's Home
collapse, L'Aquila 2009.**

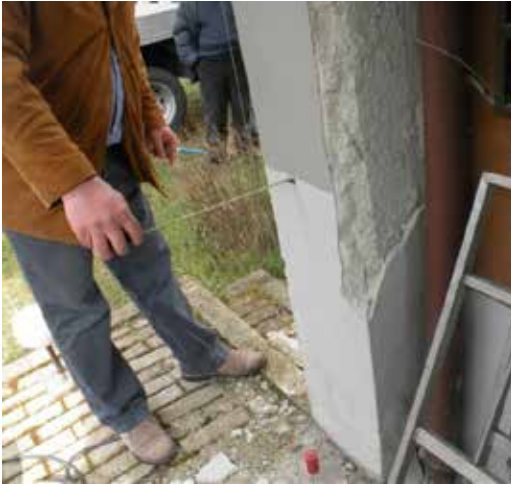
plumb line

The simplest and more economic technique, may be applied only for accessible elements and is sensible to external interferences (e.g. wind)

Reluis has **measured permanent drifts** for two damaged buildings in L'Aquila confronting the efficacy of **traditional and innovative techniques**

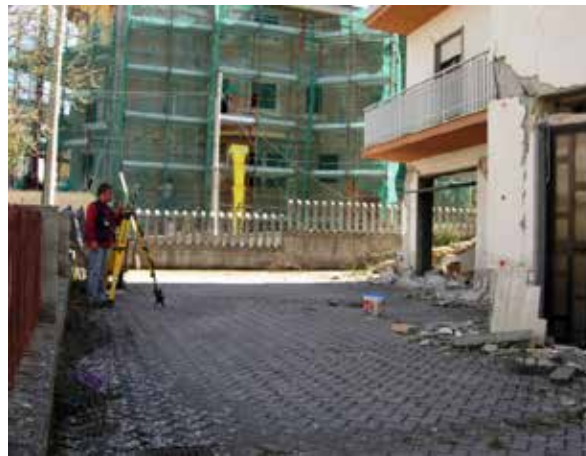
total station

Traditional topographic technique, very precise (tolerance $\pm 2\text{mm}$). Allows measuring discrete points, that have to be established a priori, on the element

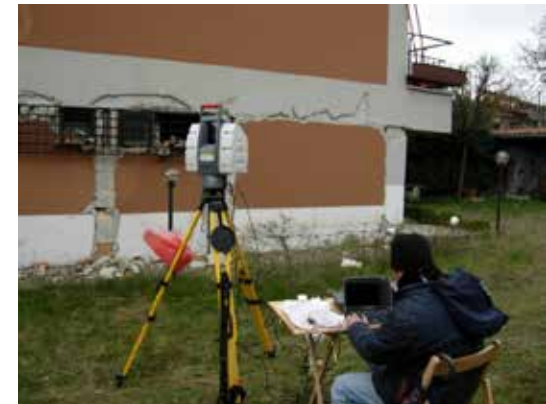
laser-scanner 3D

Innovative technique, very precise (tolerance $\pm 2\text{mm}$). Allows reconstructing the spatial coordinates of the surveyed object with a dense DEM. Specific points to be measured can be decided also a posteriori.

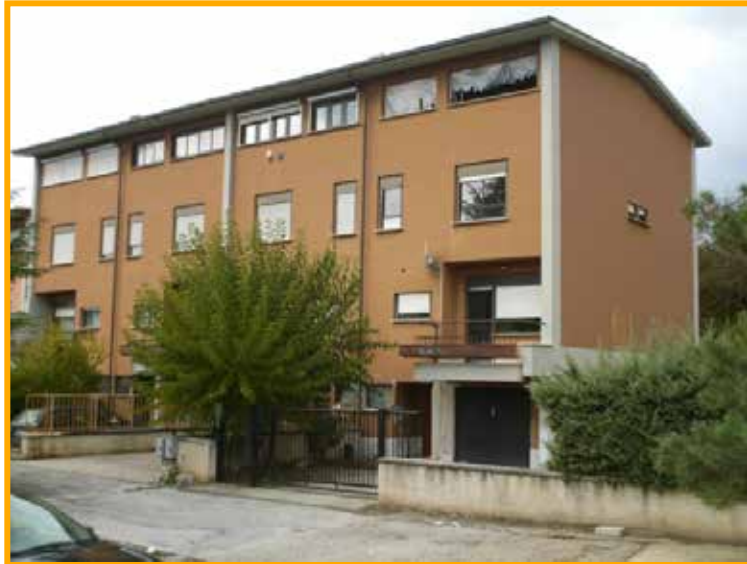
4 storey building in Pettino (AQ)

Building damage: a **soft storey** mechanism at the first level is activated.

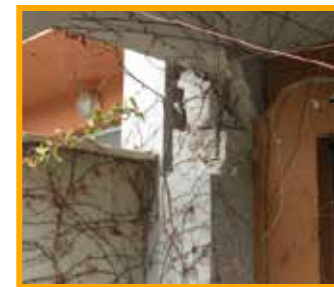
Example of damage on some of the columns at the first storey

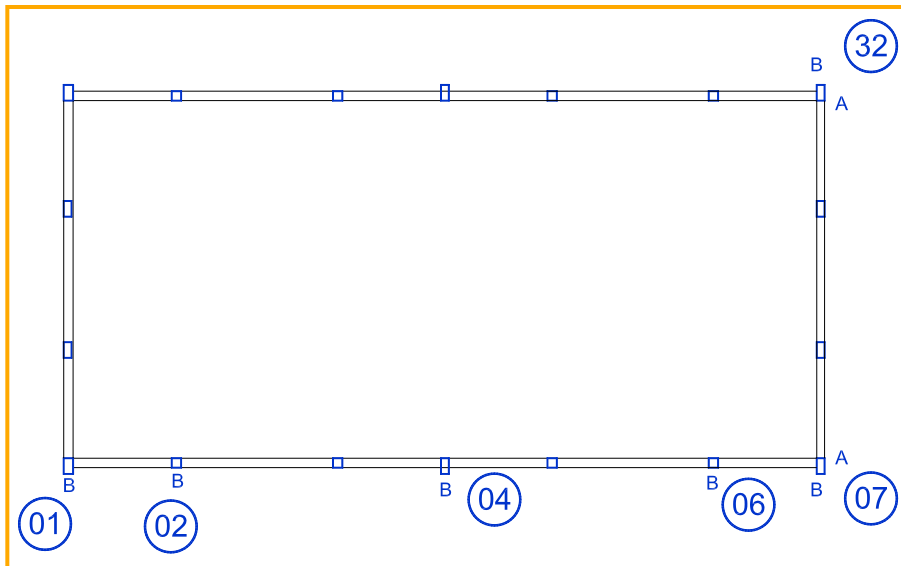
The measured columns

For security reasons, only accessible or visible columns on the perimeter, circled in the bottom figure, were measured

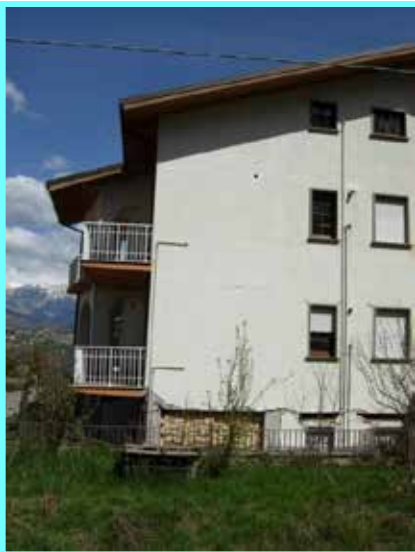
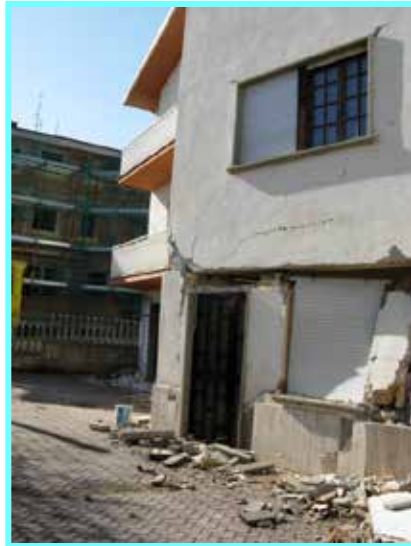
4 storey building in Pianola (AQ)

Building damage: a **soft storey** mechanism at the first level is activated.

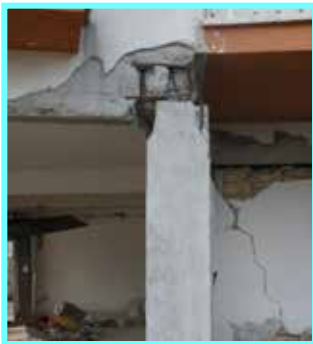
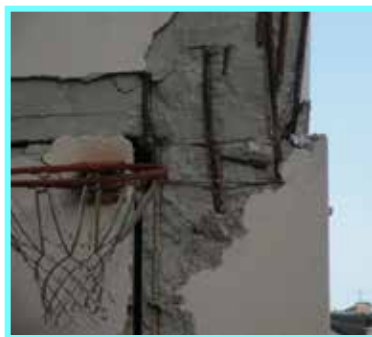
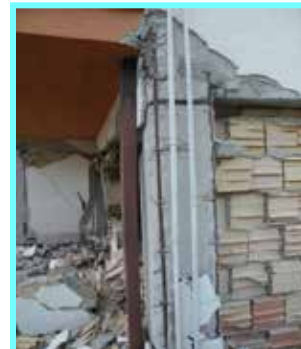
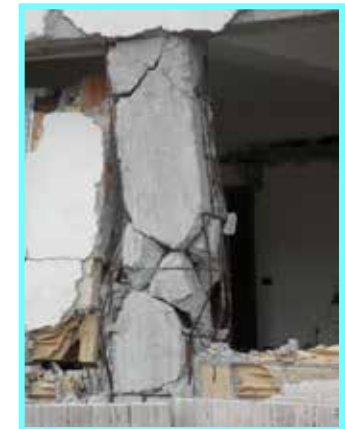
Example of damage on some of the columns at the first storey

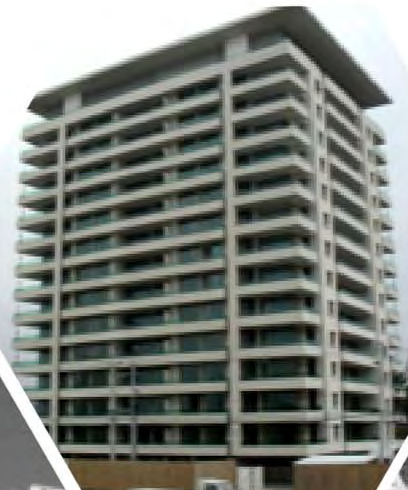
A

Residential Buildings

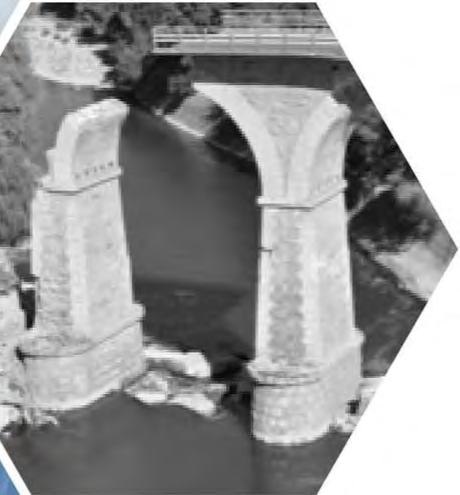
C

Infra-structure

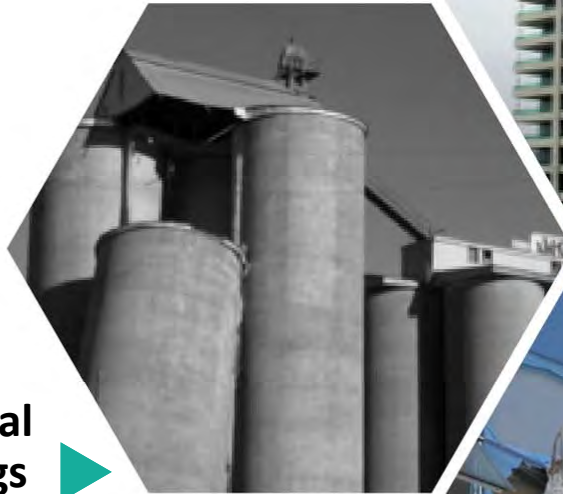
B

Industrial
Buildings

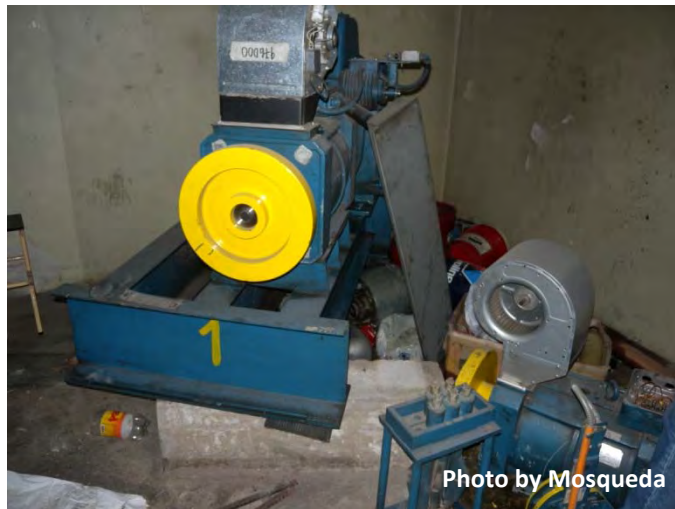
Elevator Damage

- ▶ Significant failures; most due to derailed counterweights
- ▶ In every building evacuated, elevators were inoperable, requiring patients to be carried down stairs or ramps
- ▶ Elevator machine rooms and shafts are typically accessible only by elevator maintenance service or one person on site

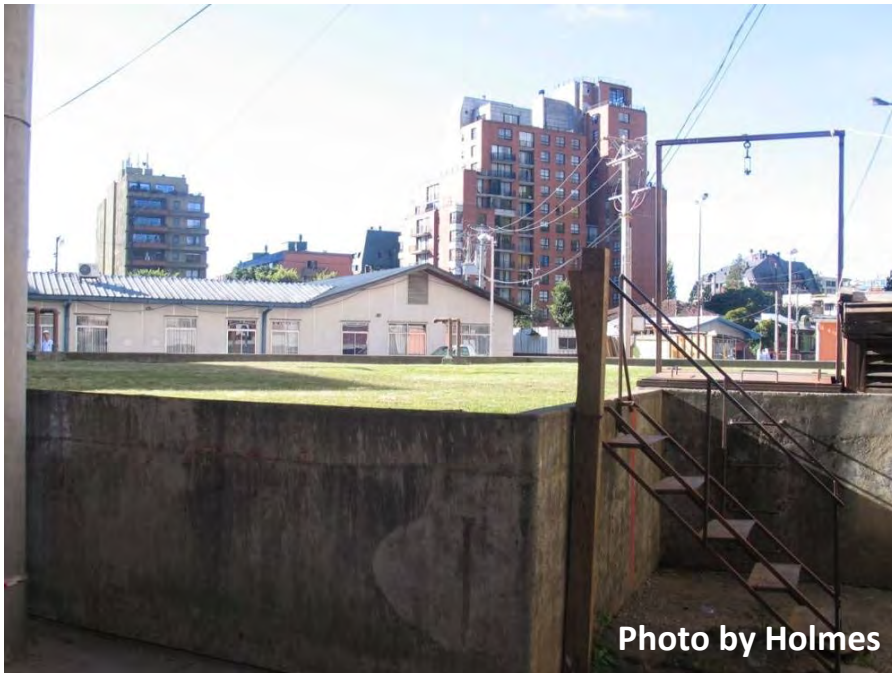
Water storage tank at Concepcion.

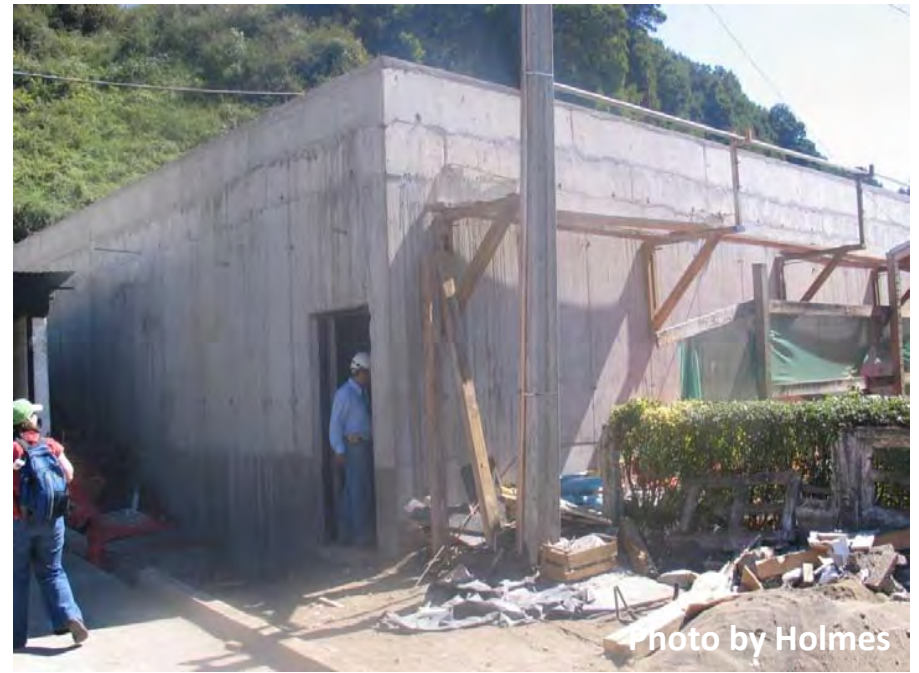
New tank under construction at Talcahuano—not quite in time

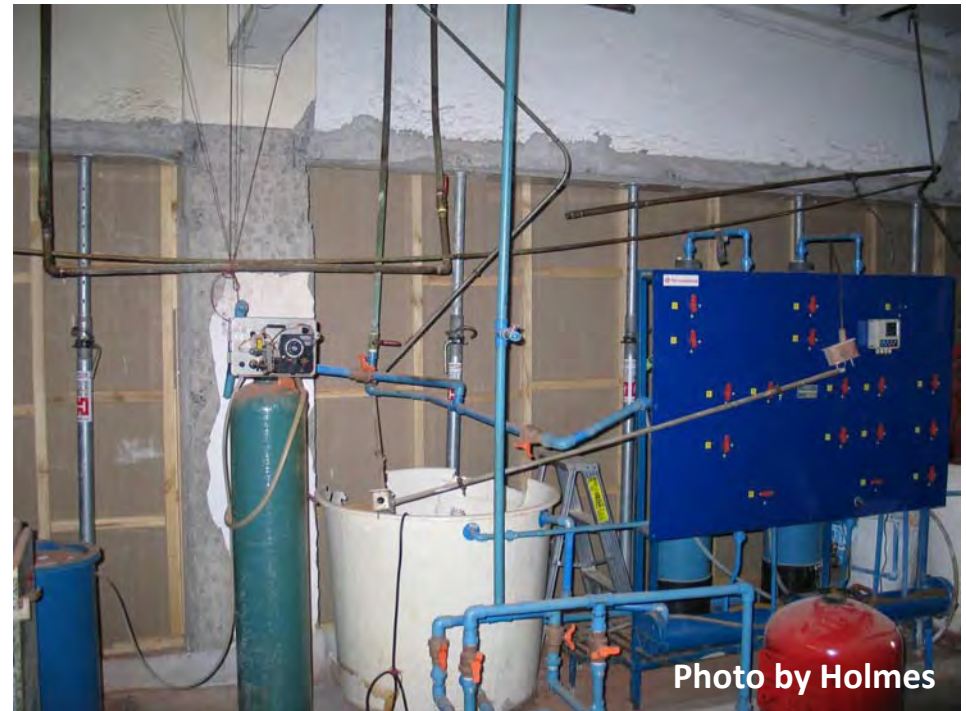
Water Damage

- ▶ 2005 building in Los Angeles Hospital: brick in-fill wall collapsed onto a water tank holding roughly 150 gallons of distilled water; water traveled through joints damaging hallway in front of surgical ward and shutting down 50% of the ward.

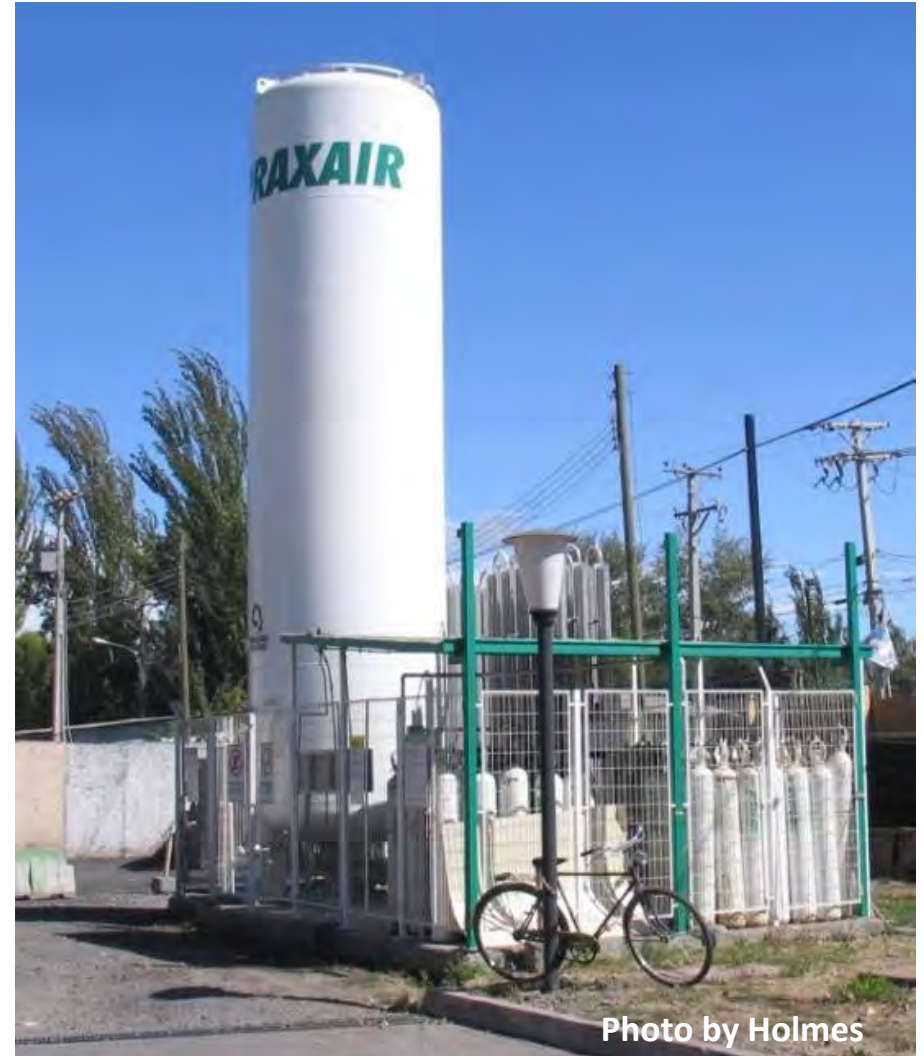
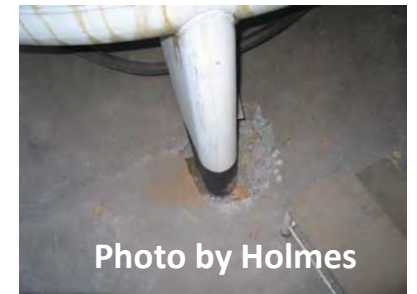
Oxygen Systems Hospital Functions

- ▶ Some hospitals lost internal systems
- ▶ Bulk oxygen storage tanks
 - Standard of practice is to anchor: **no overturning** reported.
 - Tensile yield failure of threaded fasteners.
 - Punching shear failure of tank leg.

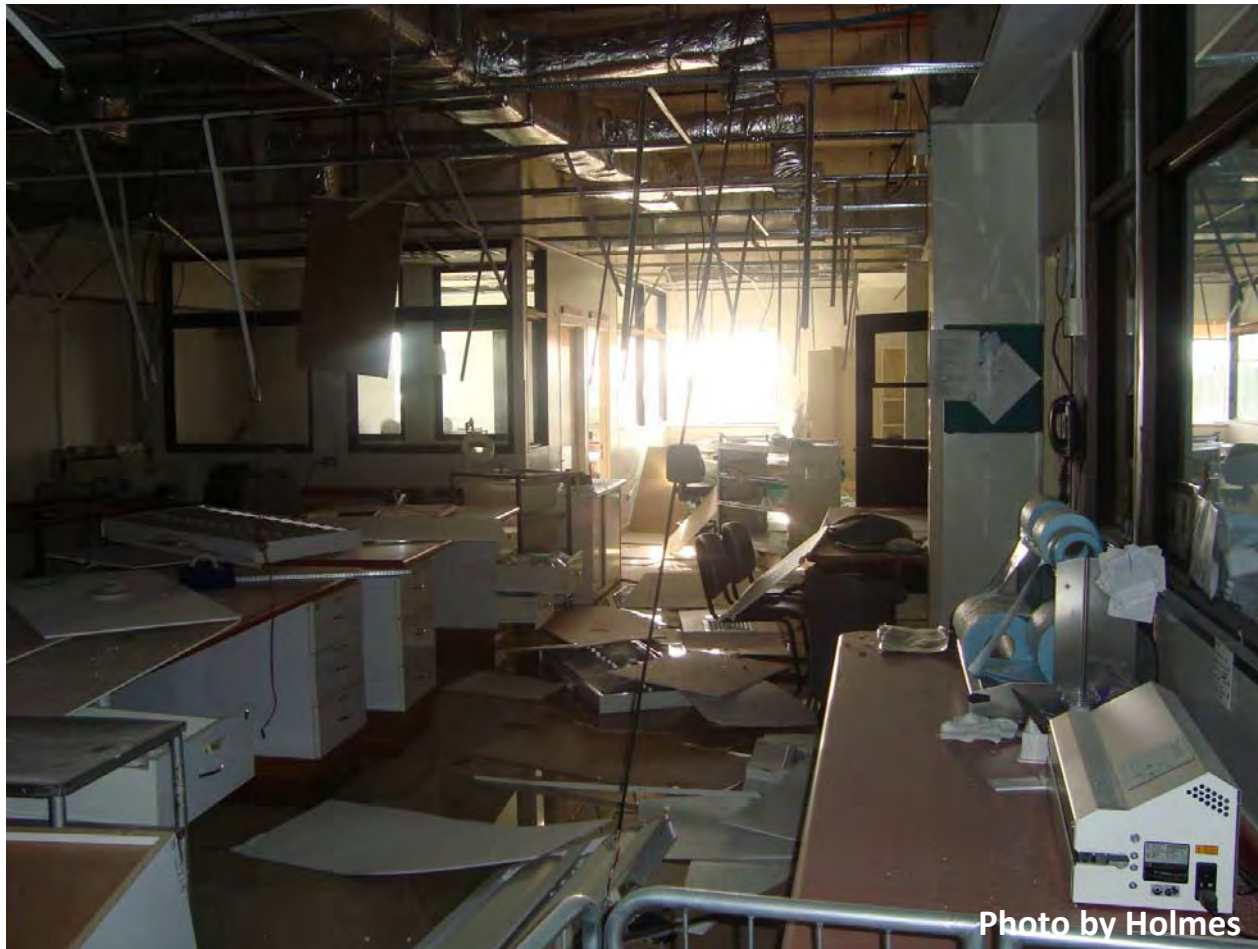
Non-Structural Damage

- ▶ Los Angeles Hospital: fallen light fixtures and mechanical registers, in addition to ceiling panels

- ▶ **Suspended lay-in ceilings** - Generally without any seismic detailing.
 - Most consistent failure.
 - Often causes little real damage but great fear and disruption
 - Fallen light fixtures and air registers can be life safety issue
 - Older ceilings drop dust and other debris (in the US, often asbestos)

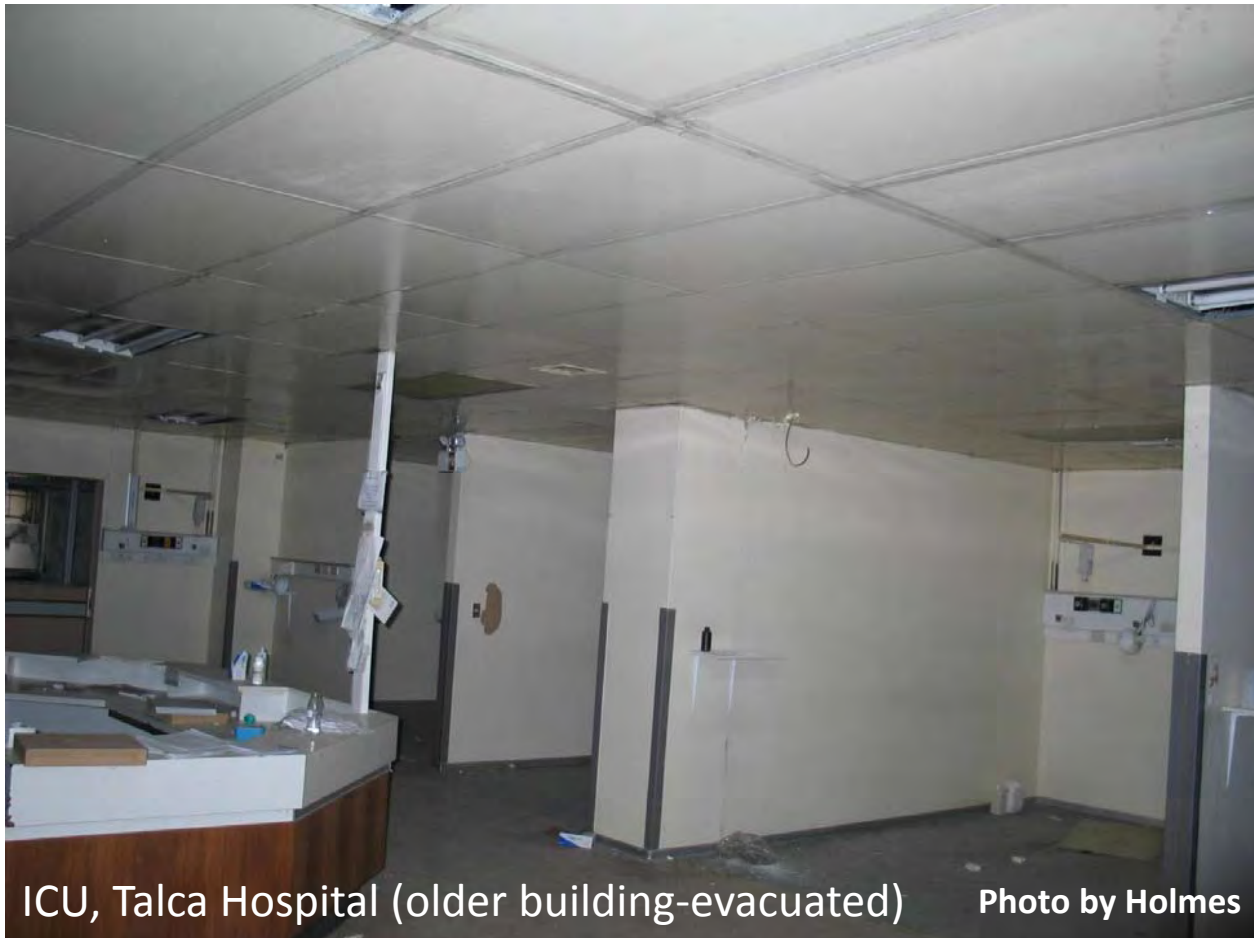
- ▶ Retrofit: packing tape used to keep dust out of ICU showed excellent seismic performance!

ICU, Talca Hospital (older building-evacuated)

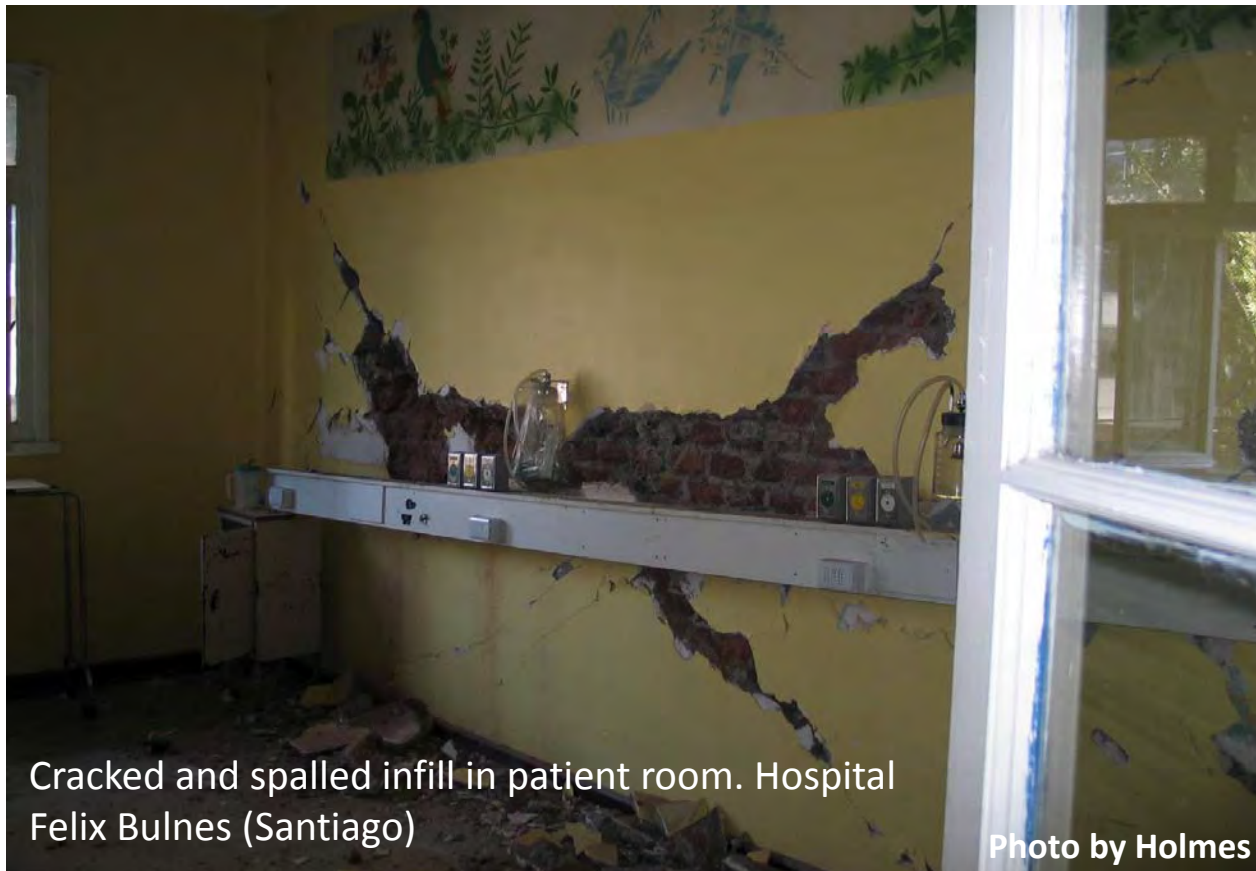
Non-Structural Damage

- ▶ Infill masonry/heavy partition damage
 - Considered “nonstructural” but, like ceilings, causes fear, creates dust and occasionally risk of injury.

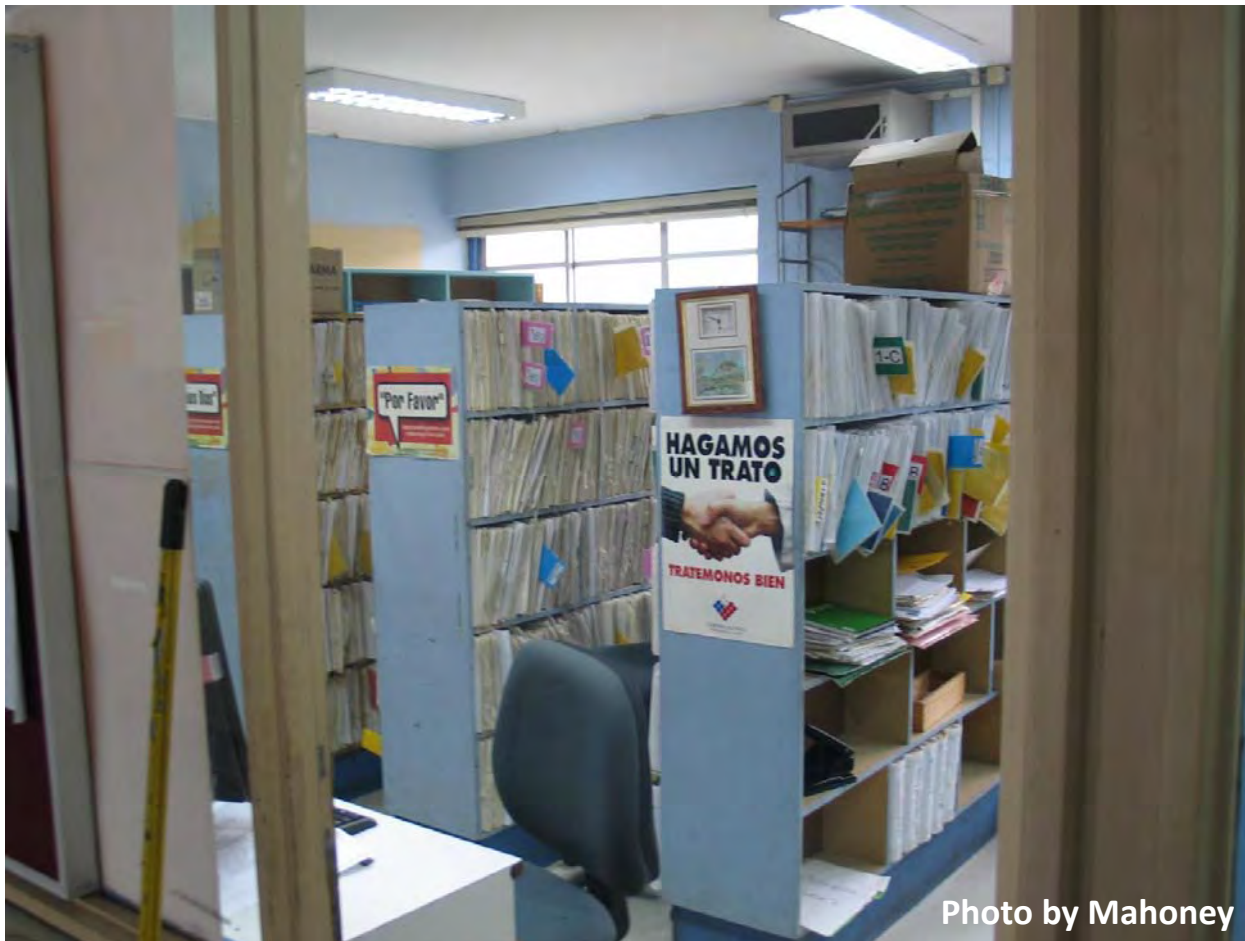
Non-Structural Damage

- ▶ Essentially unstable medical record storage—undamaged. Nacimiento.

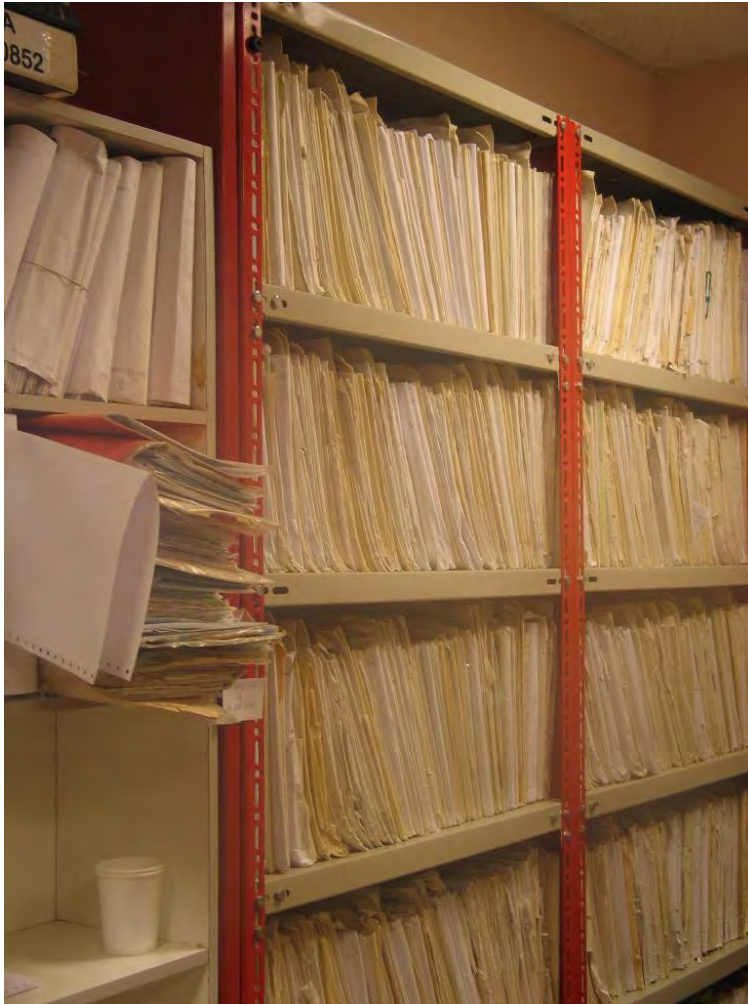
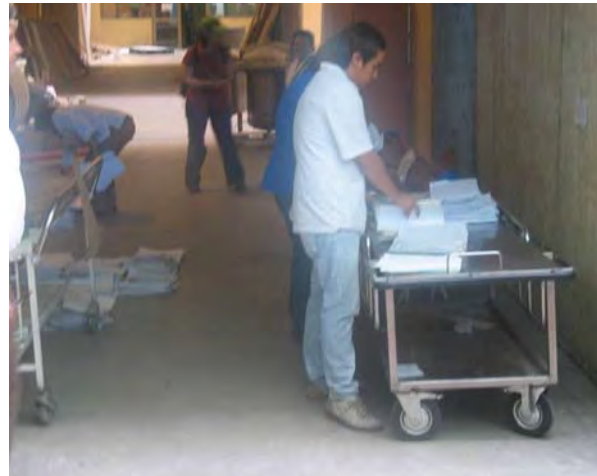
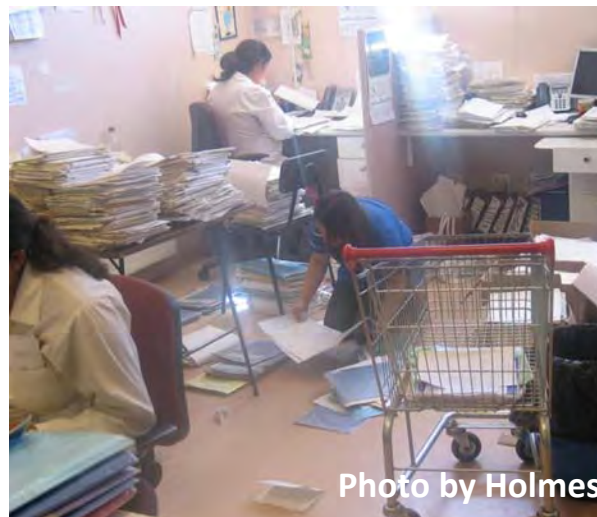
Non-Structural Damage

- ▶ Still working on straightening out Talcahuano medical records after 3 weeks

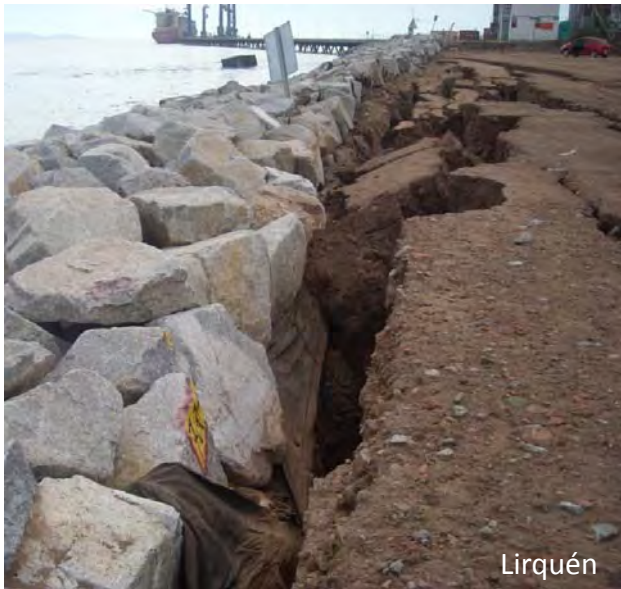
Liquefaction

- Saturated and loose sands ($\sigma_n = \sigma'_n + u_w$)
- Consequences:
 - Temporary loss of support and stiffness

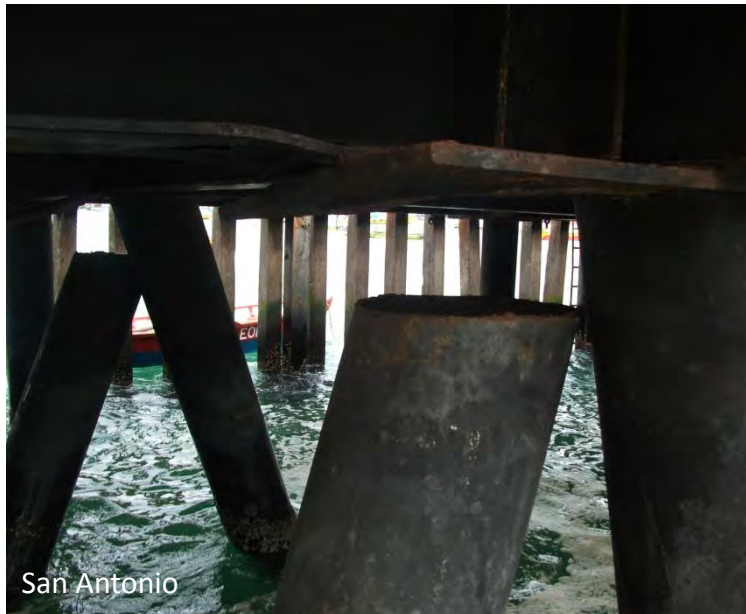
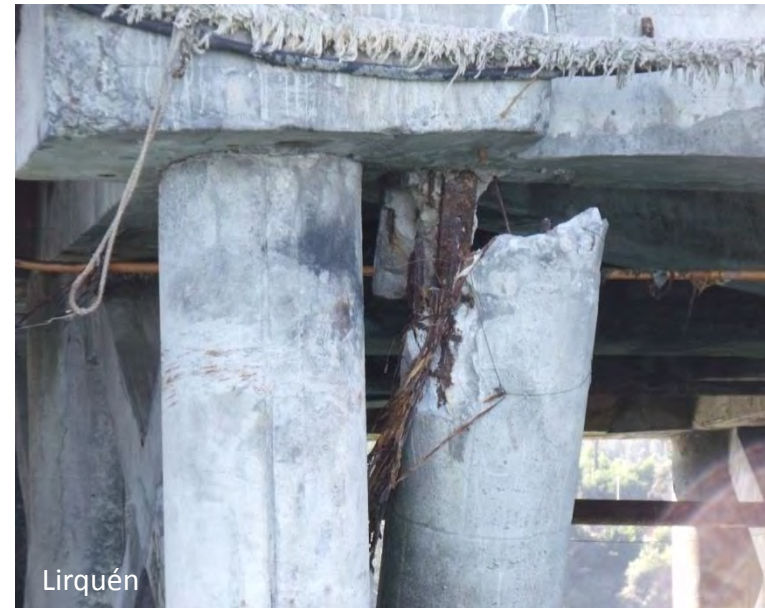
Beam-pile connection

- Slanted piles are laterally very stiff

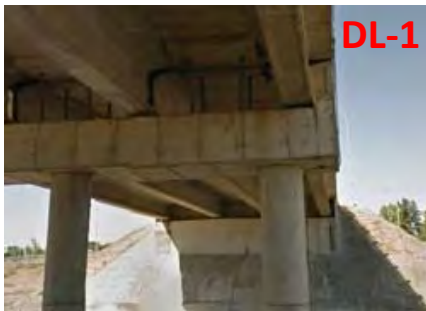
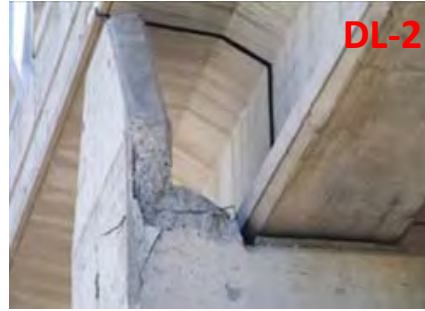
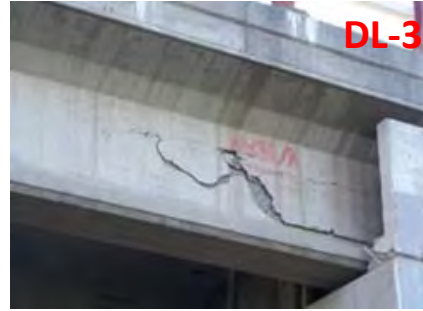
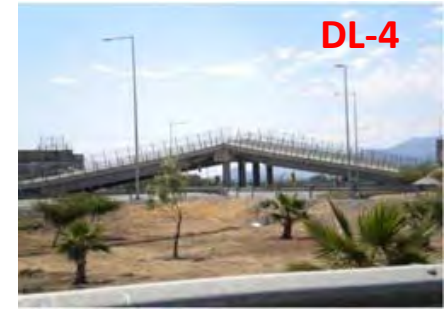
Bridge Damage Level

- DL-1: No damage
- DL-2: Low damage that required minimum or no repair
- DL-3: Damage that required repair
- DL-4: Collapse

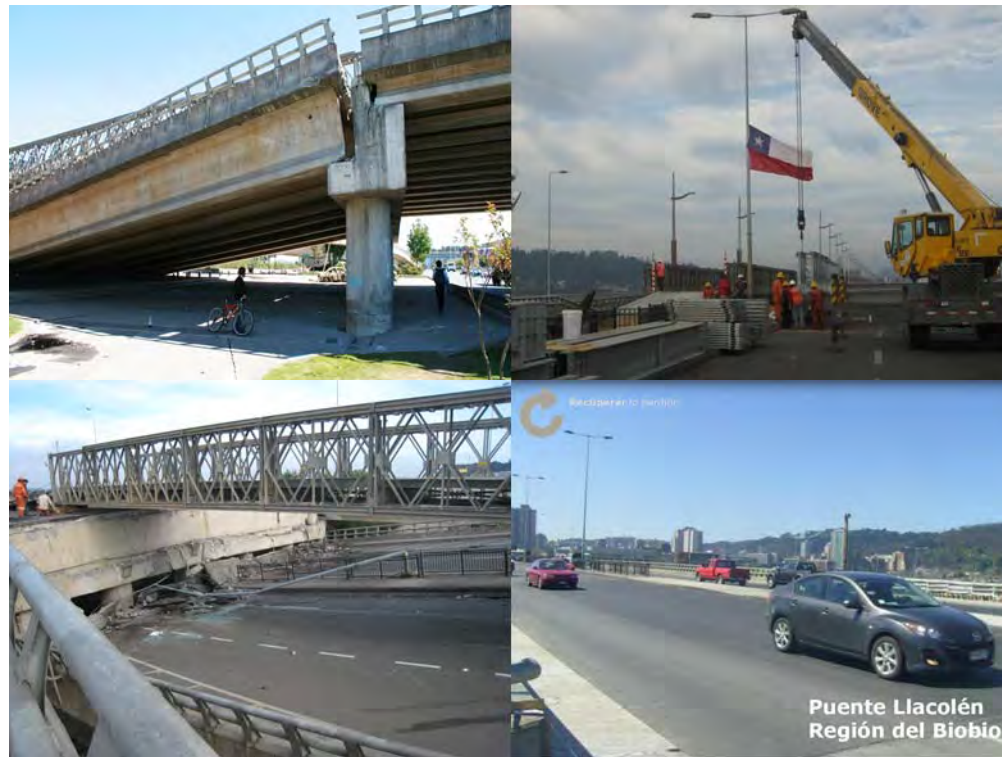
► Failure and solution process Llacolén Bridge, BíoBío Region
