Post-Earthquake Data Collection Workshop

Executive Summary

Anchorage, Alaska

July 20-22, 2014

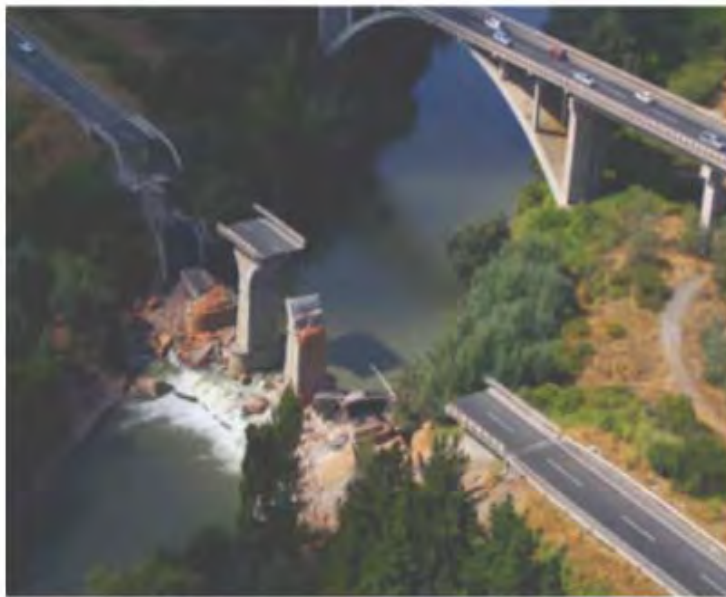
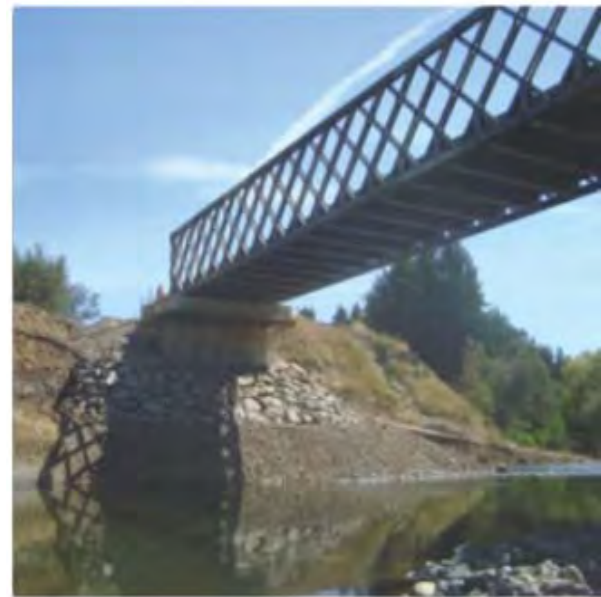
► Failure and solution process Claro River bridge

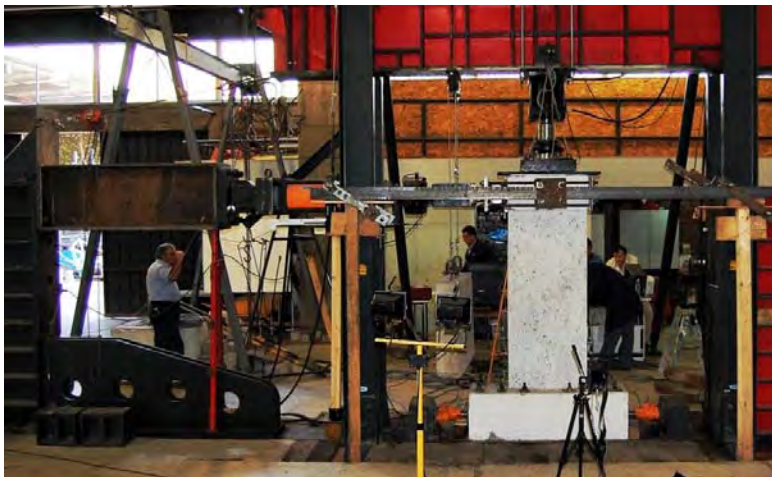
RC Wall Test

Experimental and modeling

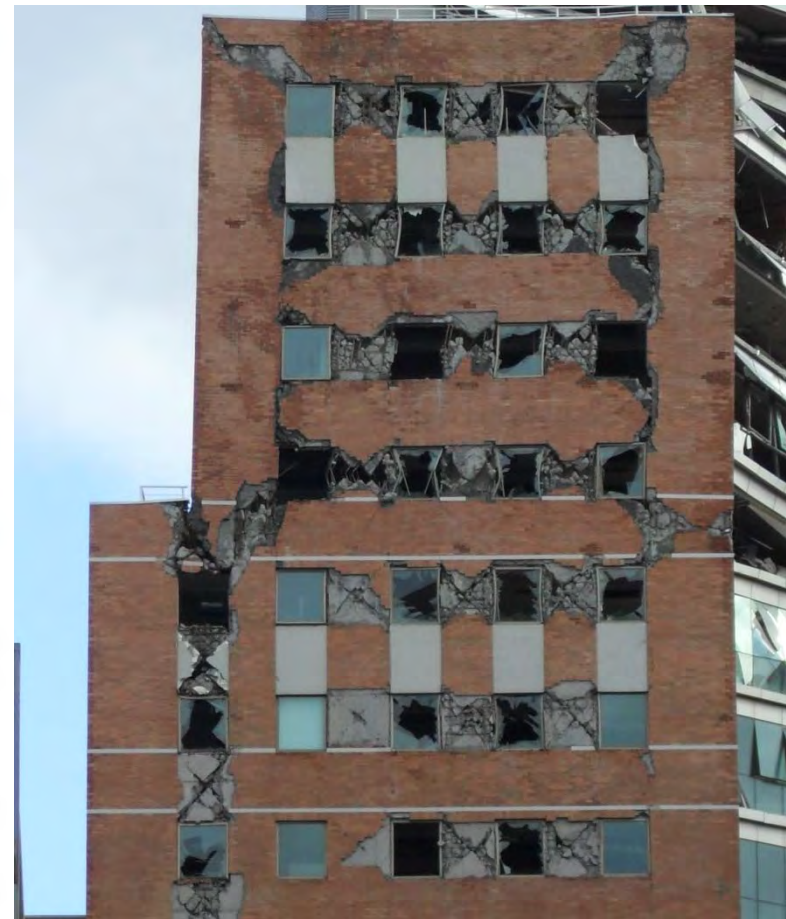
TO: Axis 1A

Damage level representation

Light damage

Moderate damage

Severe damage

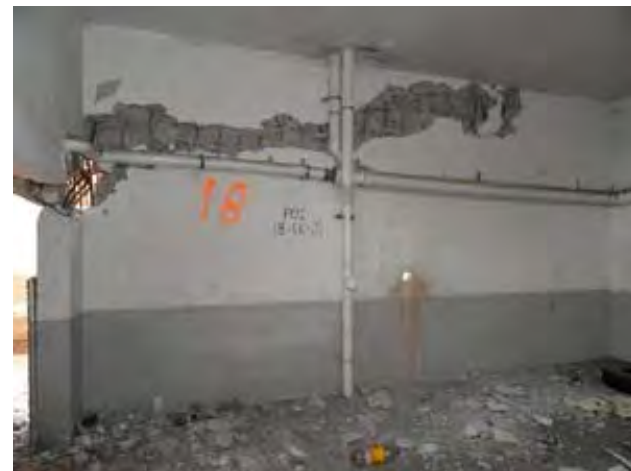
AA Building

“Flag-shaped” walls

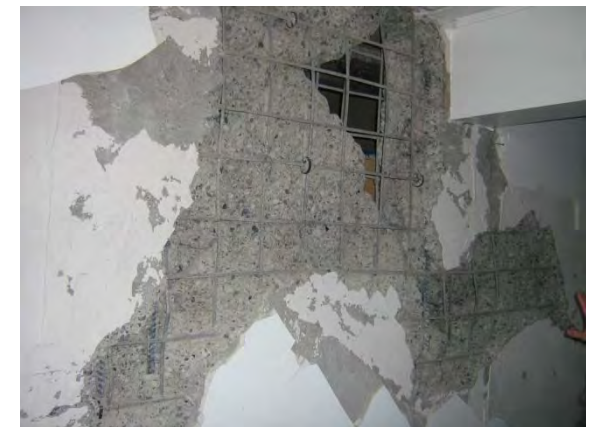
Chillán building

Irregularities

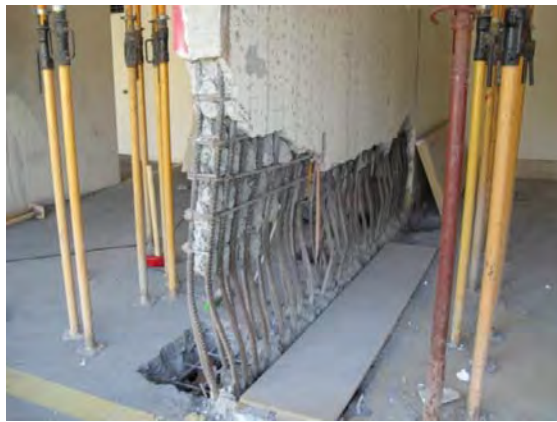
AH

Thin walls with high axial load were unable to confine the concrete core

- Spalling of the concrete cover
- Buckling of longitudinal reinforcement
- Brittle collapse of the wall

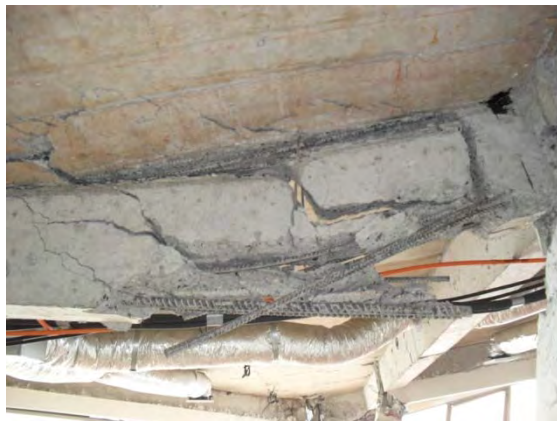
Serious detailing and construction issues are observed in the inspected buildings (specially in Torre O'Higgins)

- Bad anchor between beam-wall joints
- Cut stirrups and outside the confined area
- Absence of confinement in the wall boundaries

Lack of stirrups

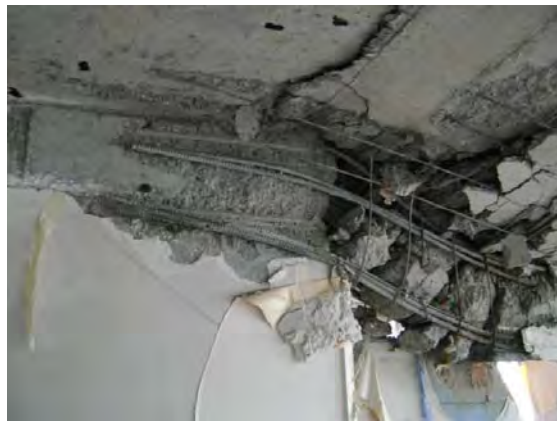
Reinforcement outside the confined area

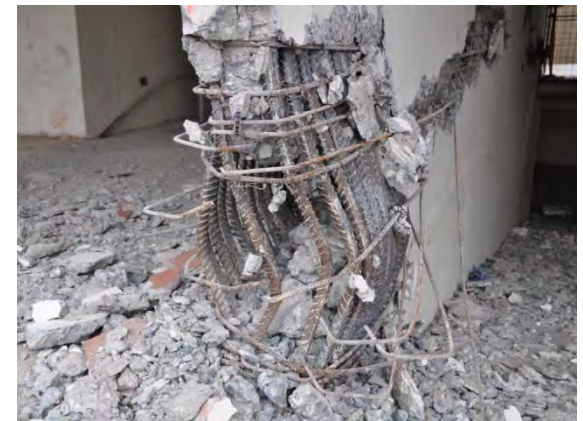
Typical confinement detail

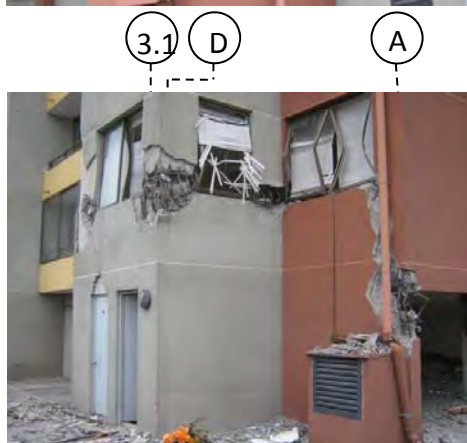
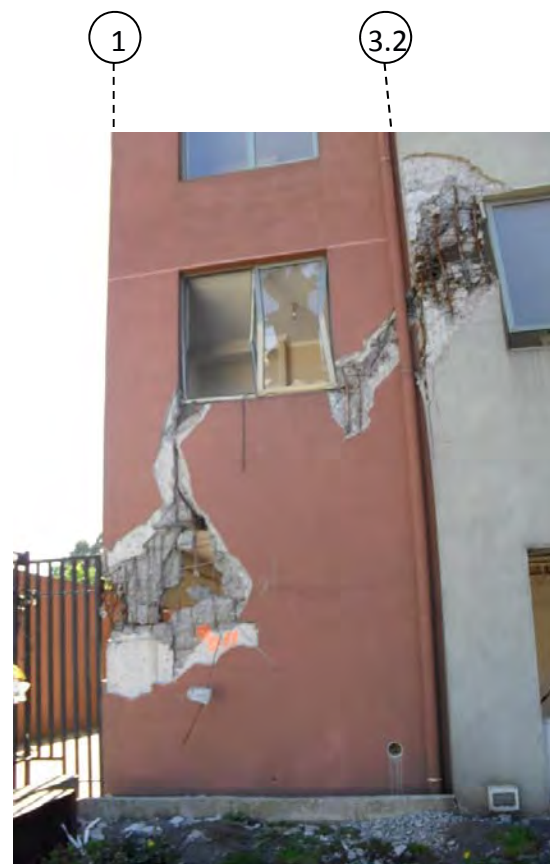
There is damage propagation between floors

CM building: propagation of damage between stories

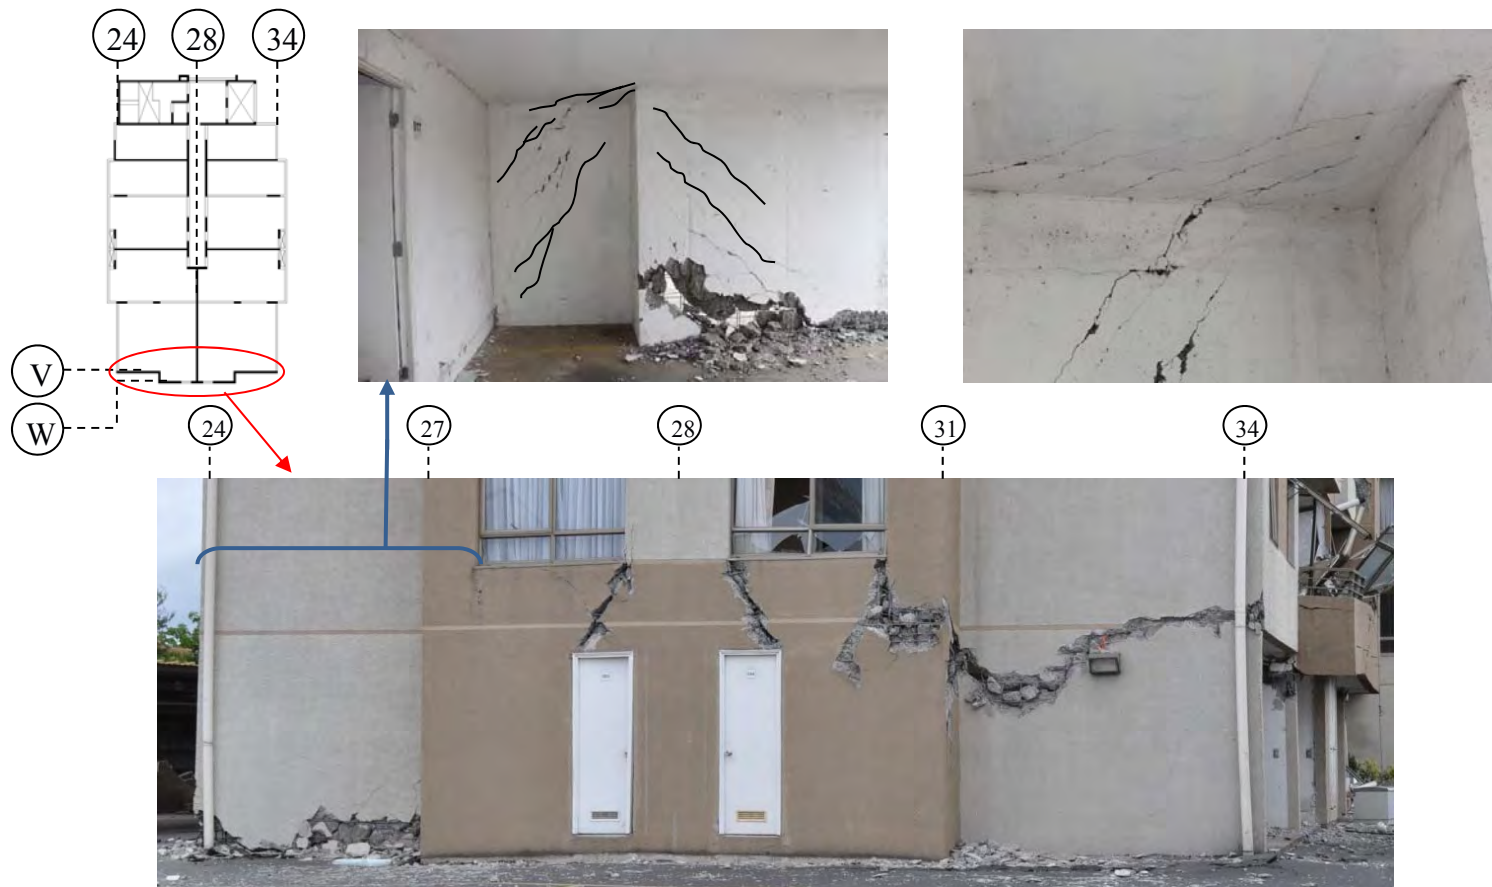
Damage propagation between stories and elements

PdR building: damage propagation

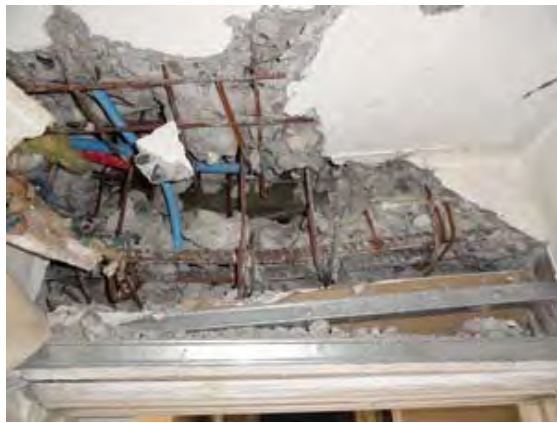
AA

Since 1985 the buildings have changed continuously:

- Less wall thickness, less wall densities, bigger axial loads and elimination of lintels
- An important source of energy dissipation is eliminated —→ **Modify R factors!**

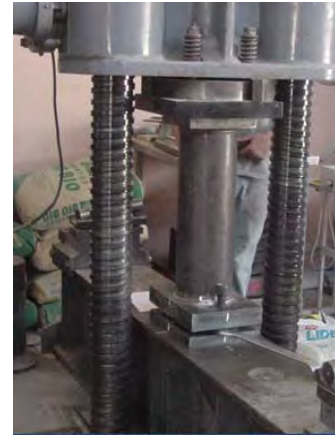
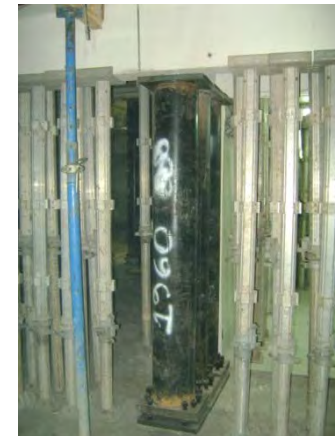
Stabilization process

EM Building

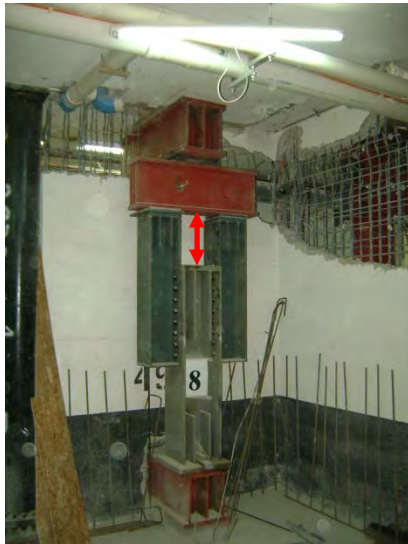
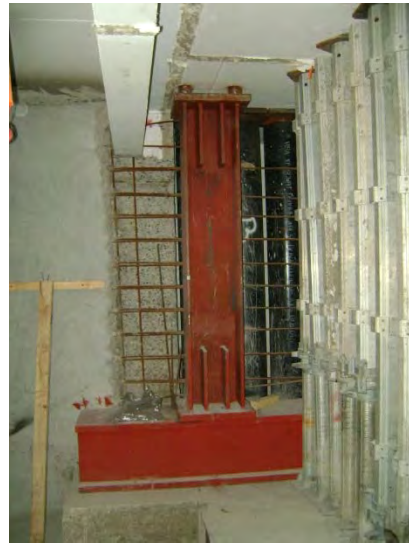
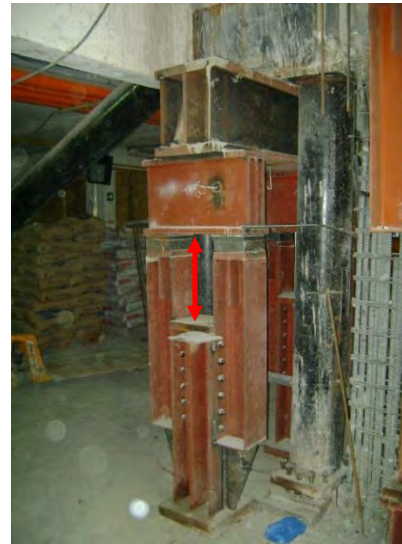
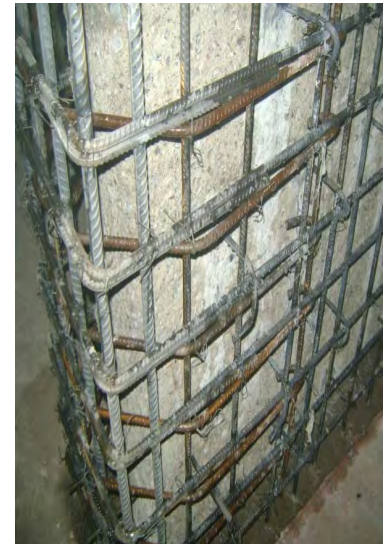
Stabilization process

EM Building

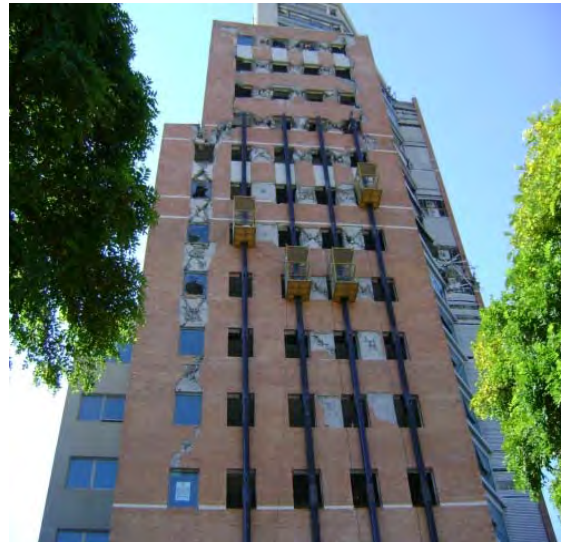
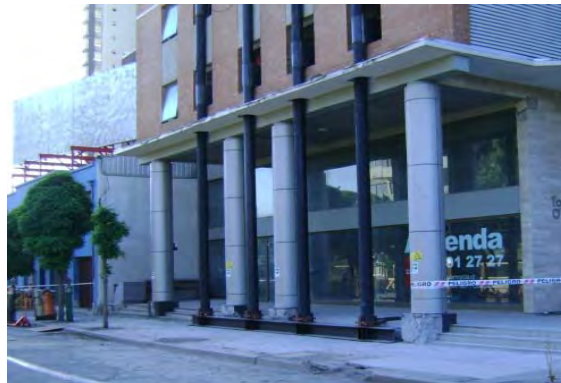
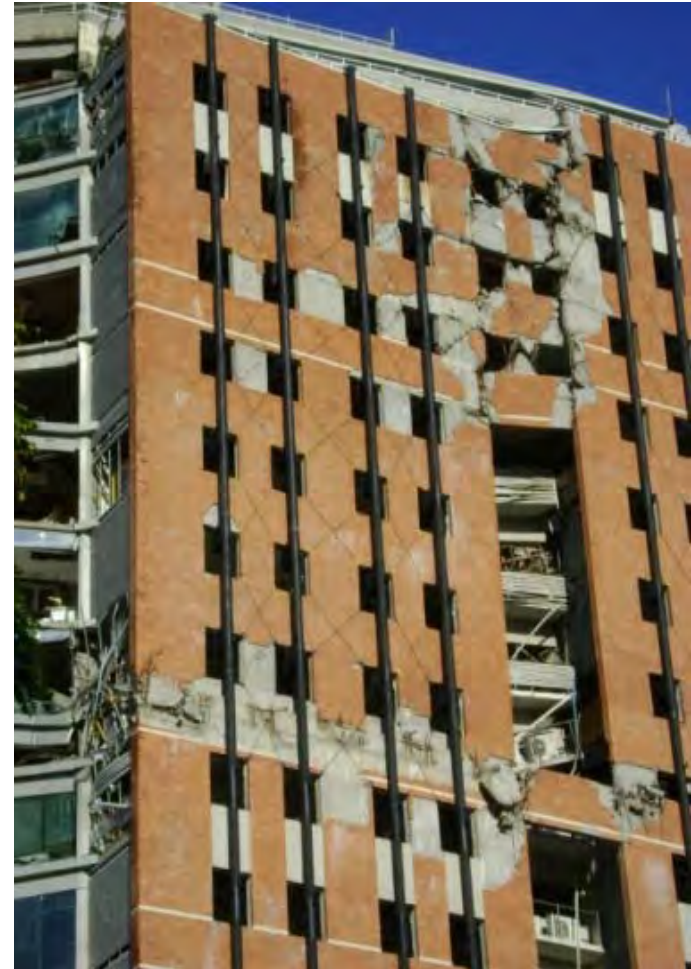
Stabilization process

TO Building

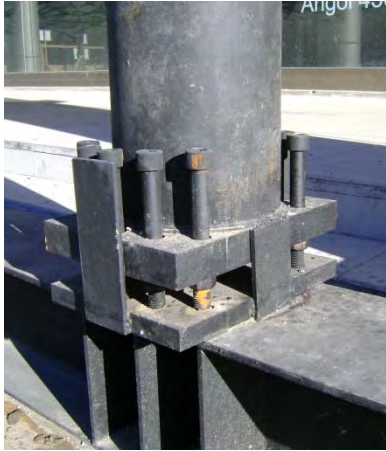
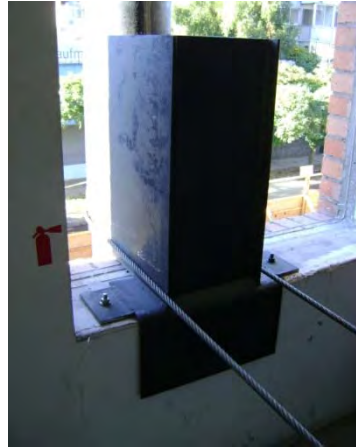
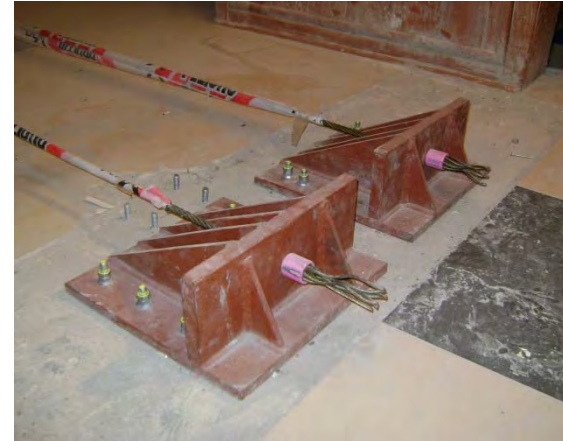
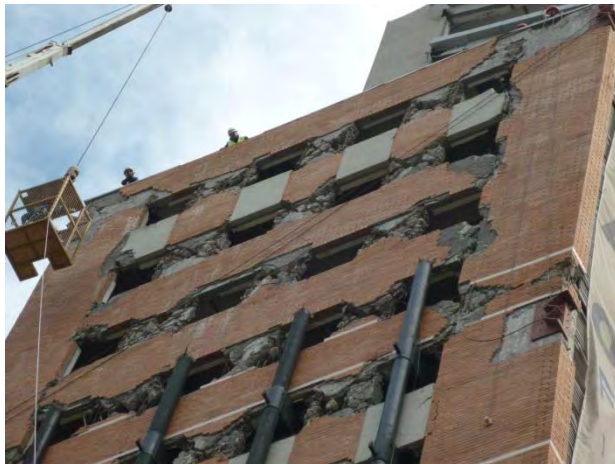
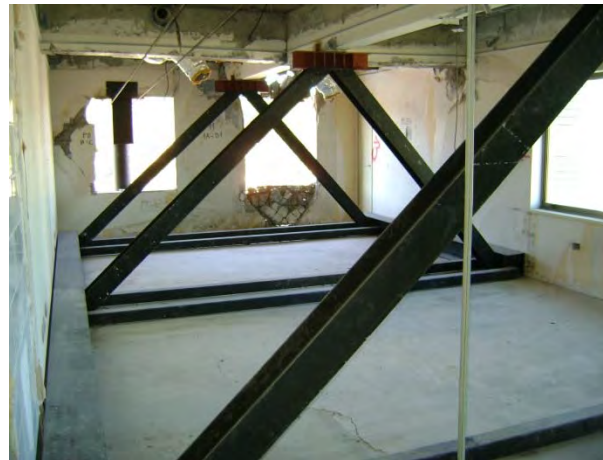
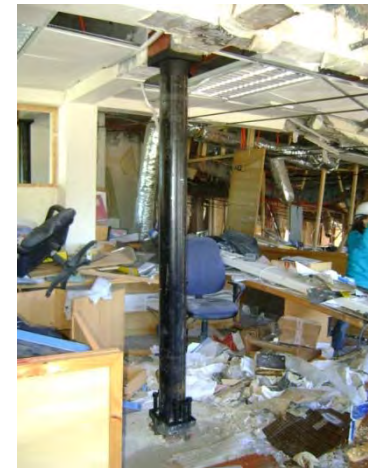
TO Building

Stabilization process

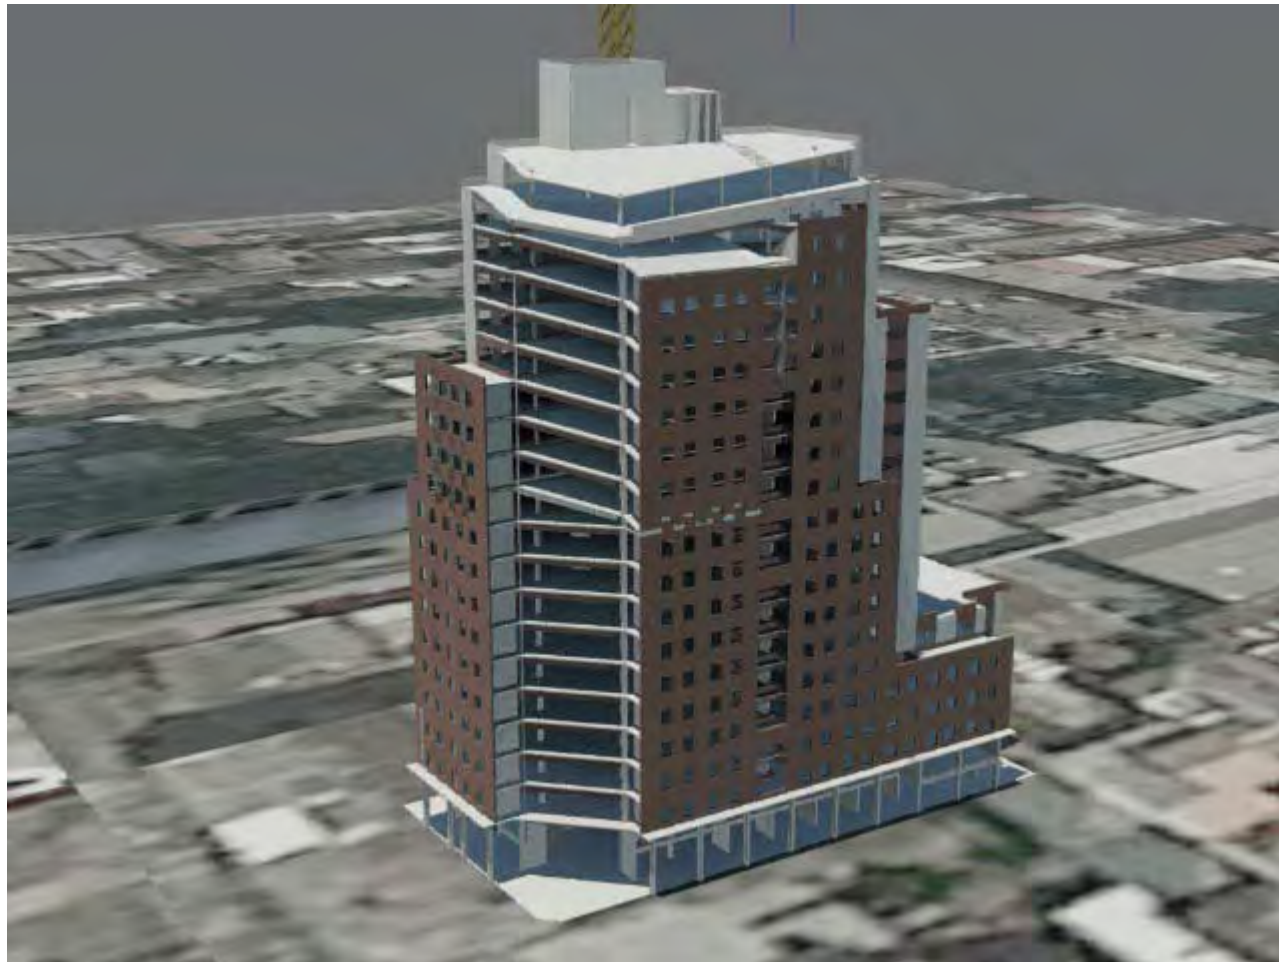
Repair, Stabilization and demolition of buildings

TO building: Temporary stabilization

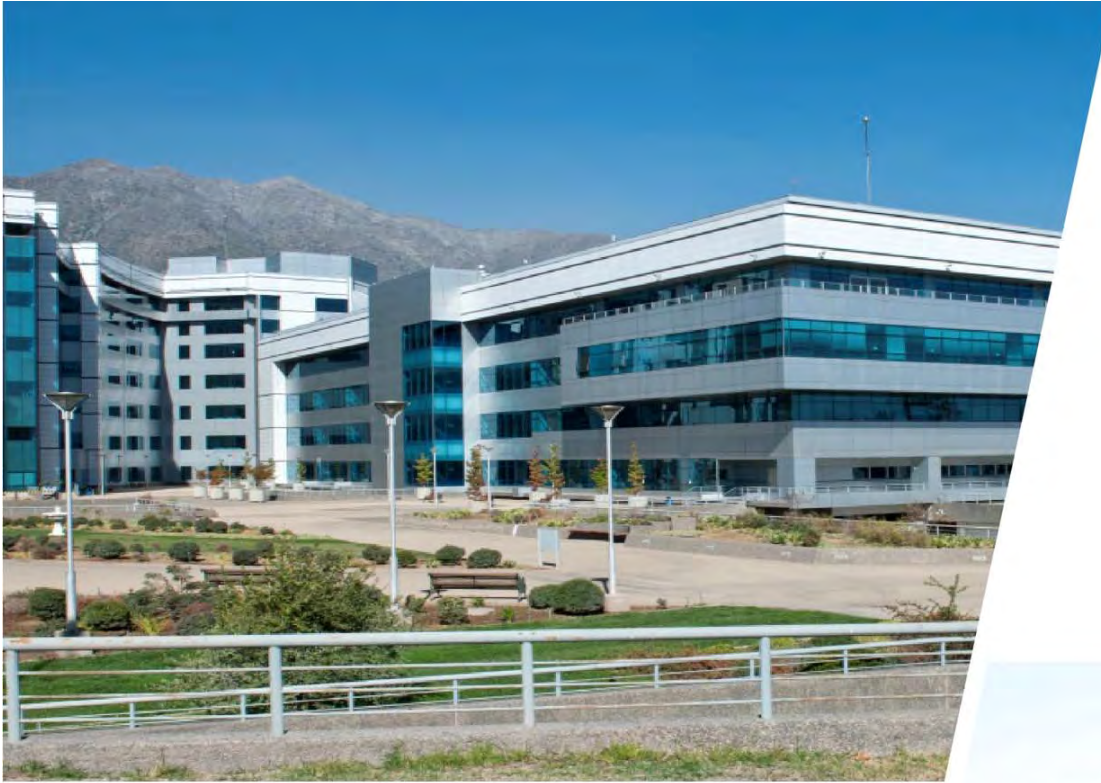
**Military
Hospital**

EXAMPLE: PERFORMANCE OF SEISMICALLY PROTECTED BUILDINGS

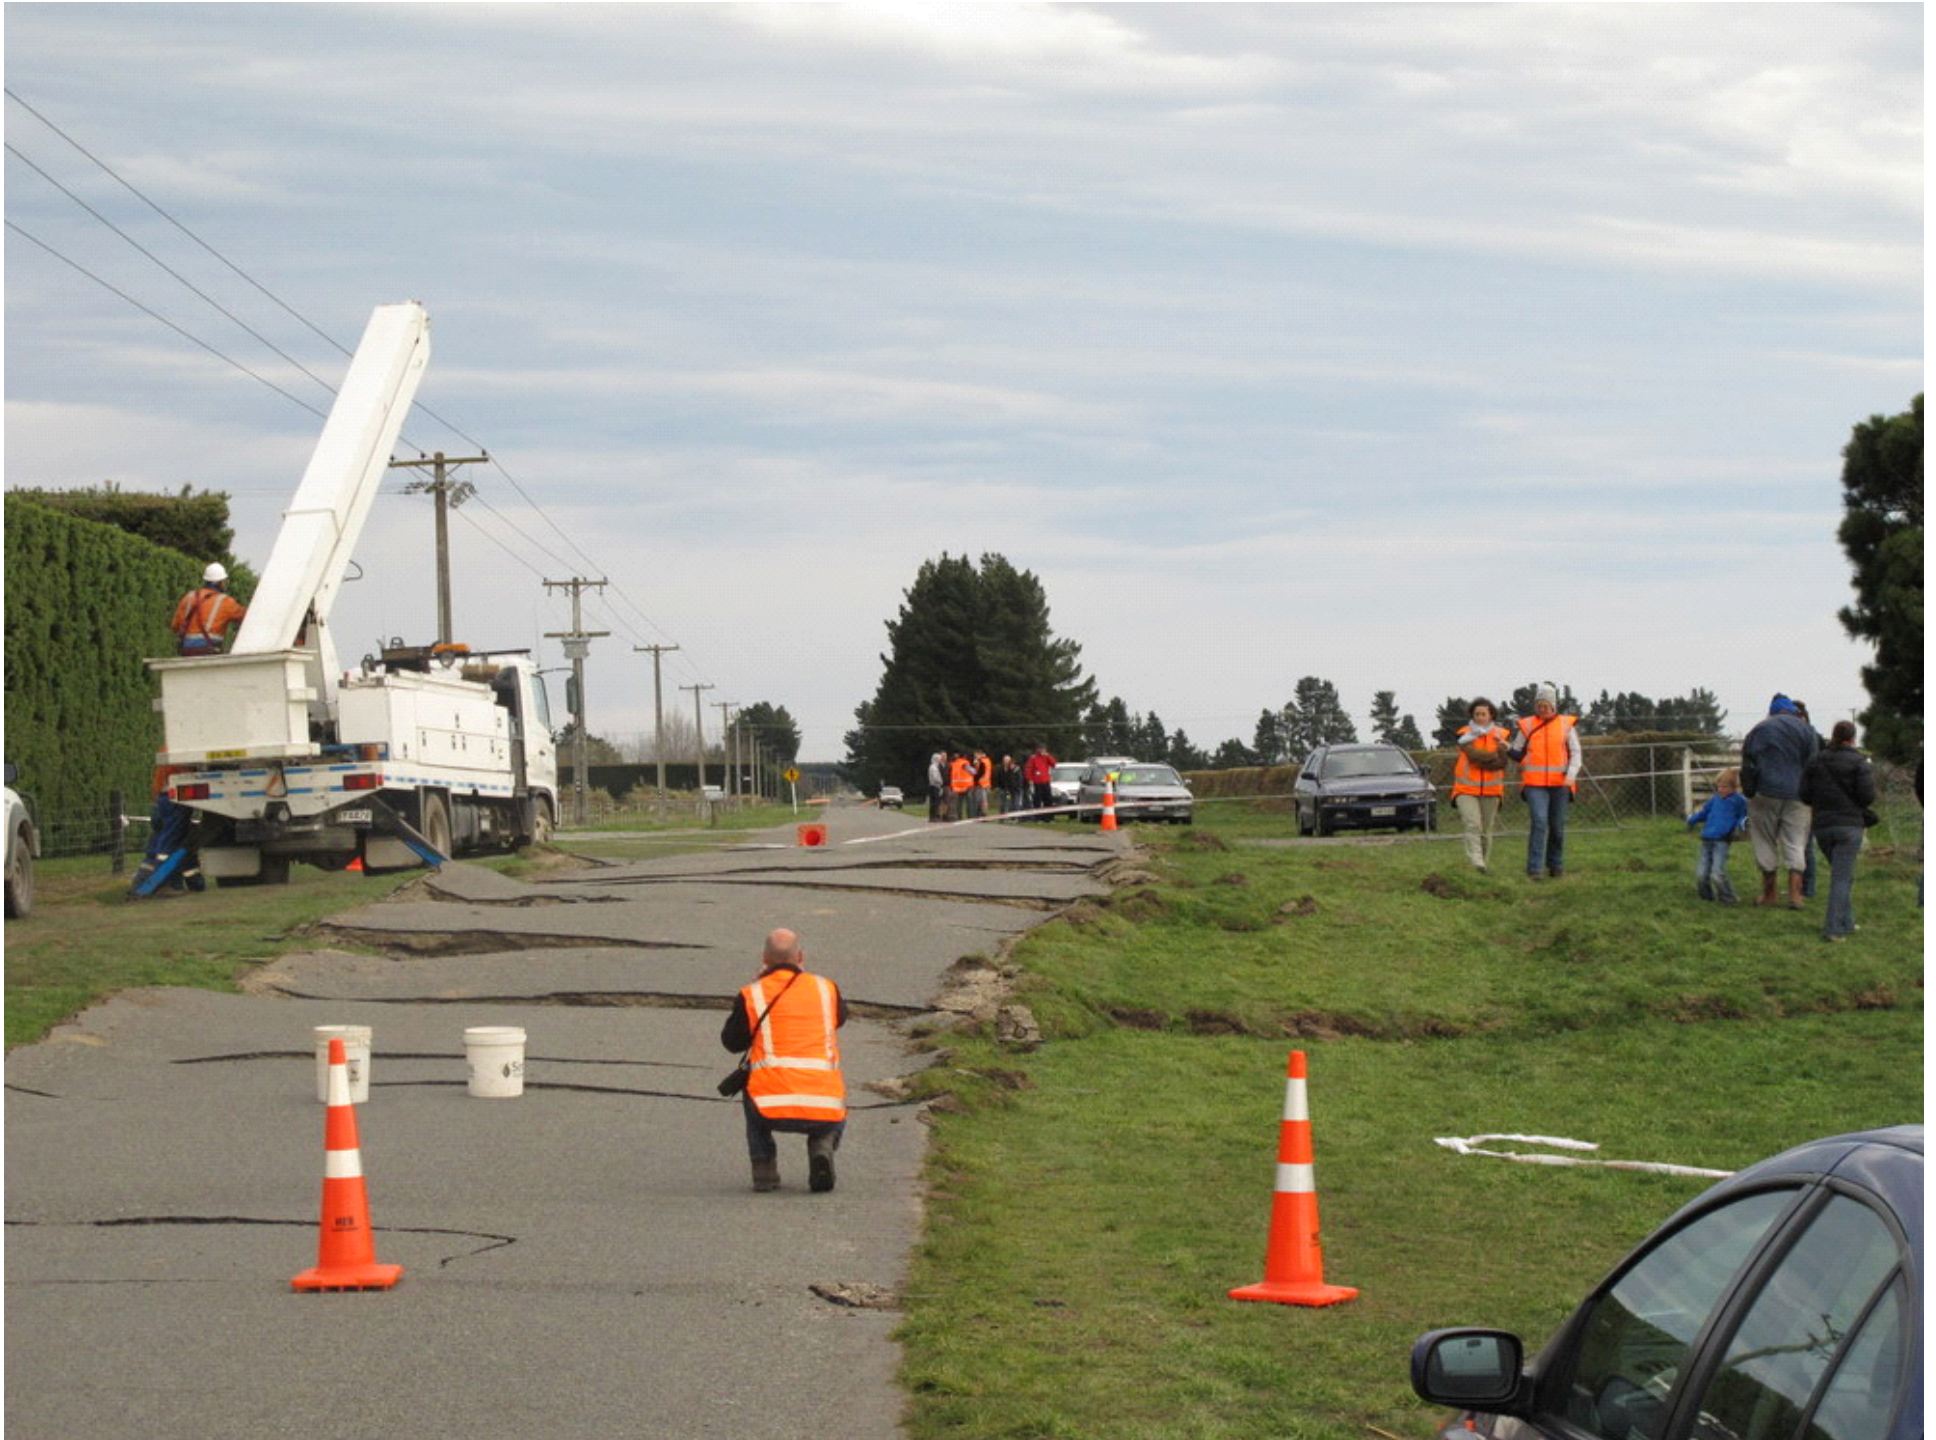
Aerial photography - Liquefaction (NZAM)

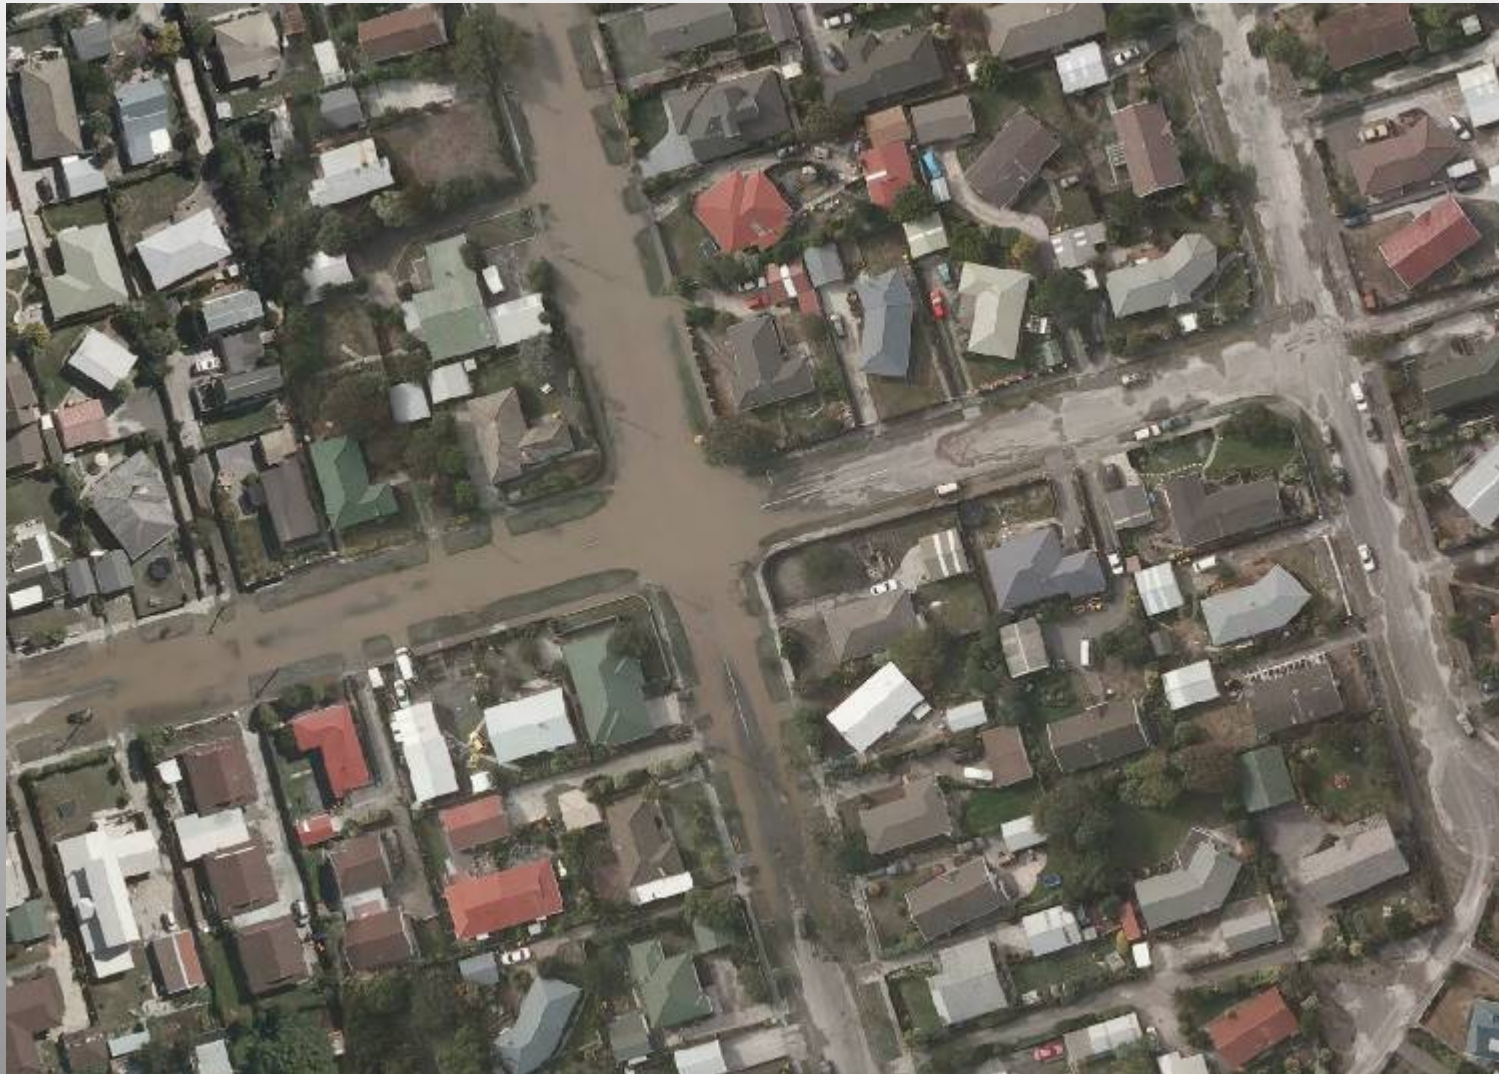
Cosmo SKYMed coherence

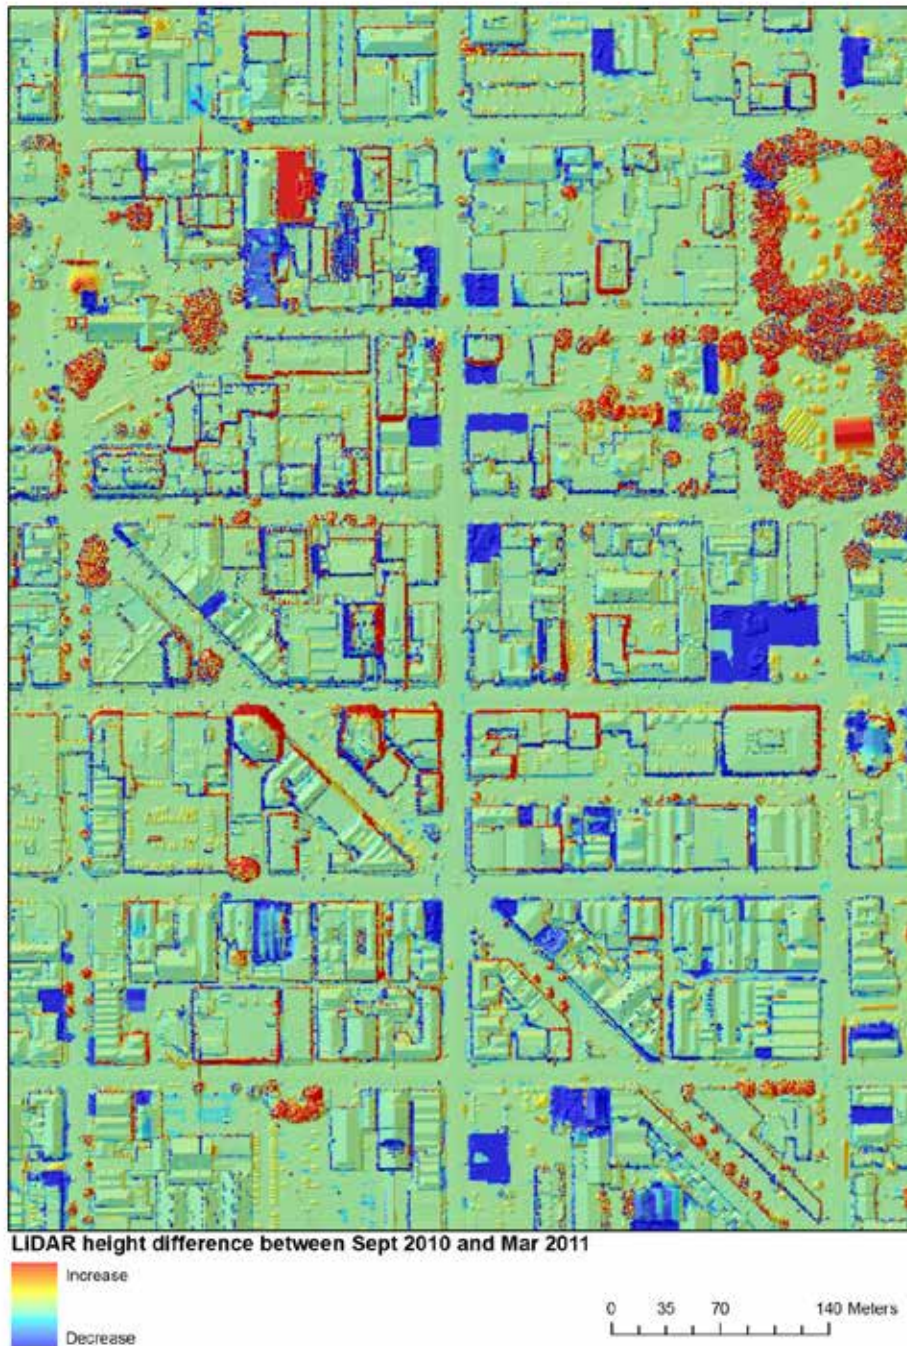
LiDAR change detection

Collapsed spire
and rubble

New construction

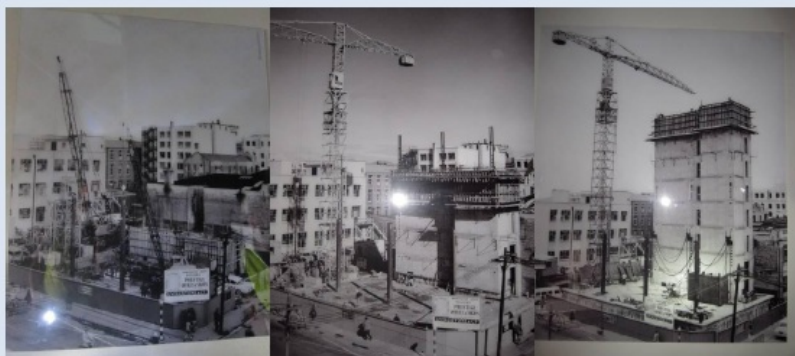
Photos of SBS Building under construction in the 1960s.

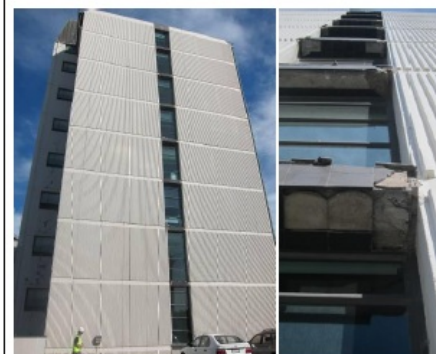
Detail 3: Minimal damage at the facade precast panels (except for local crushing at the slab-window region).

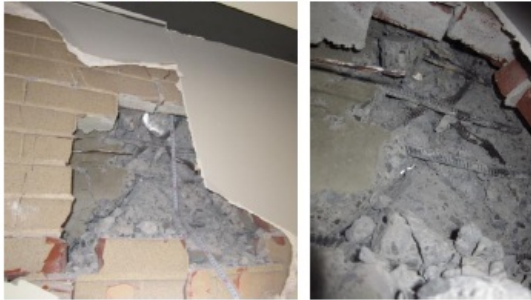
Detail 4: Interior view of the damaged coupling beam at the West elevation walls. Diagonal and horizontal deformed reinforcements were observed. No confining vertical ties can be found in the spalled locations.

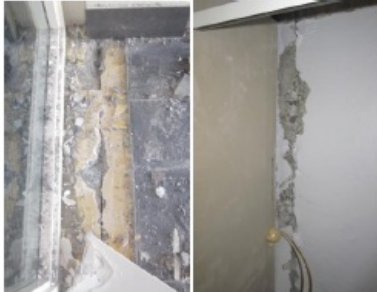
Detail 5: 10-20mm cracking on the RC slab along the internal shear walls (E-W direction).

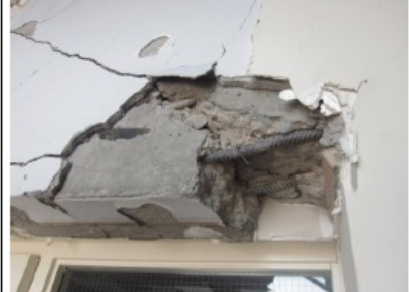
Detail 7: Damaged coupling beam at the internal coupled-walls (East-West direction).

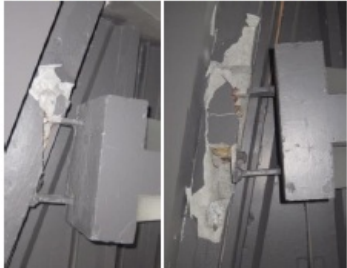
Detail 8: Concrete spalling at the pin support at the bottom landing of the staircases. Damage was more severe at the upper levels.

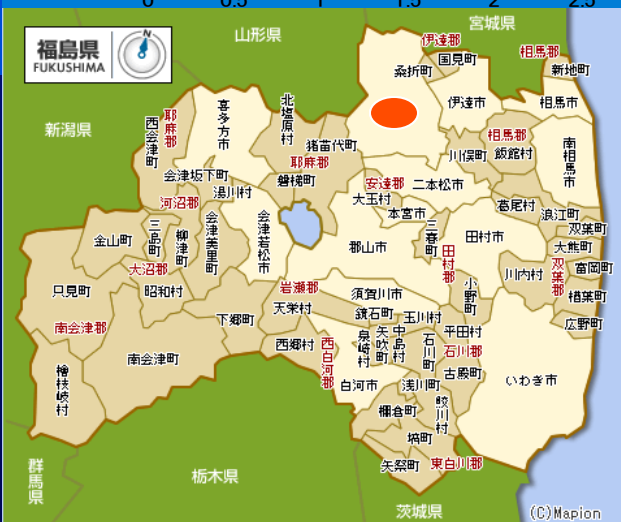
Acceleration and Velocity Spectra (Fukushima, FKS003)

**K-net
Fukushima city**

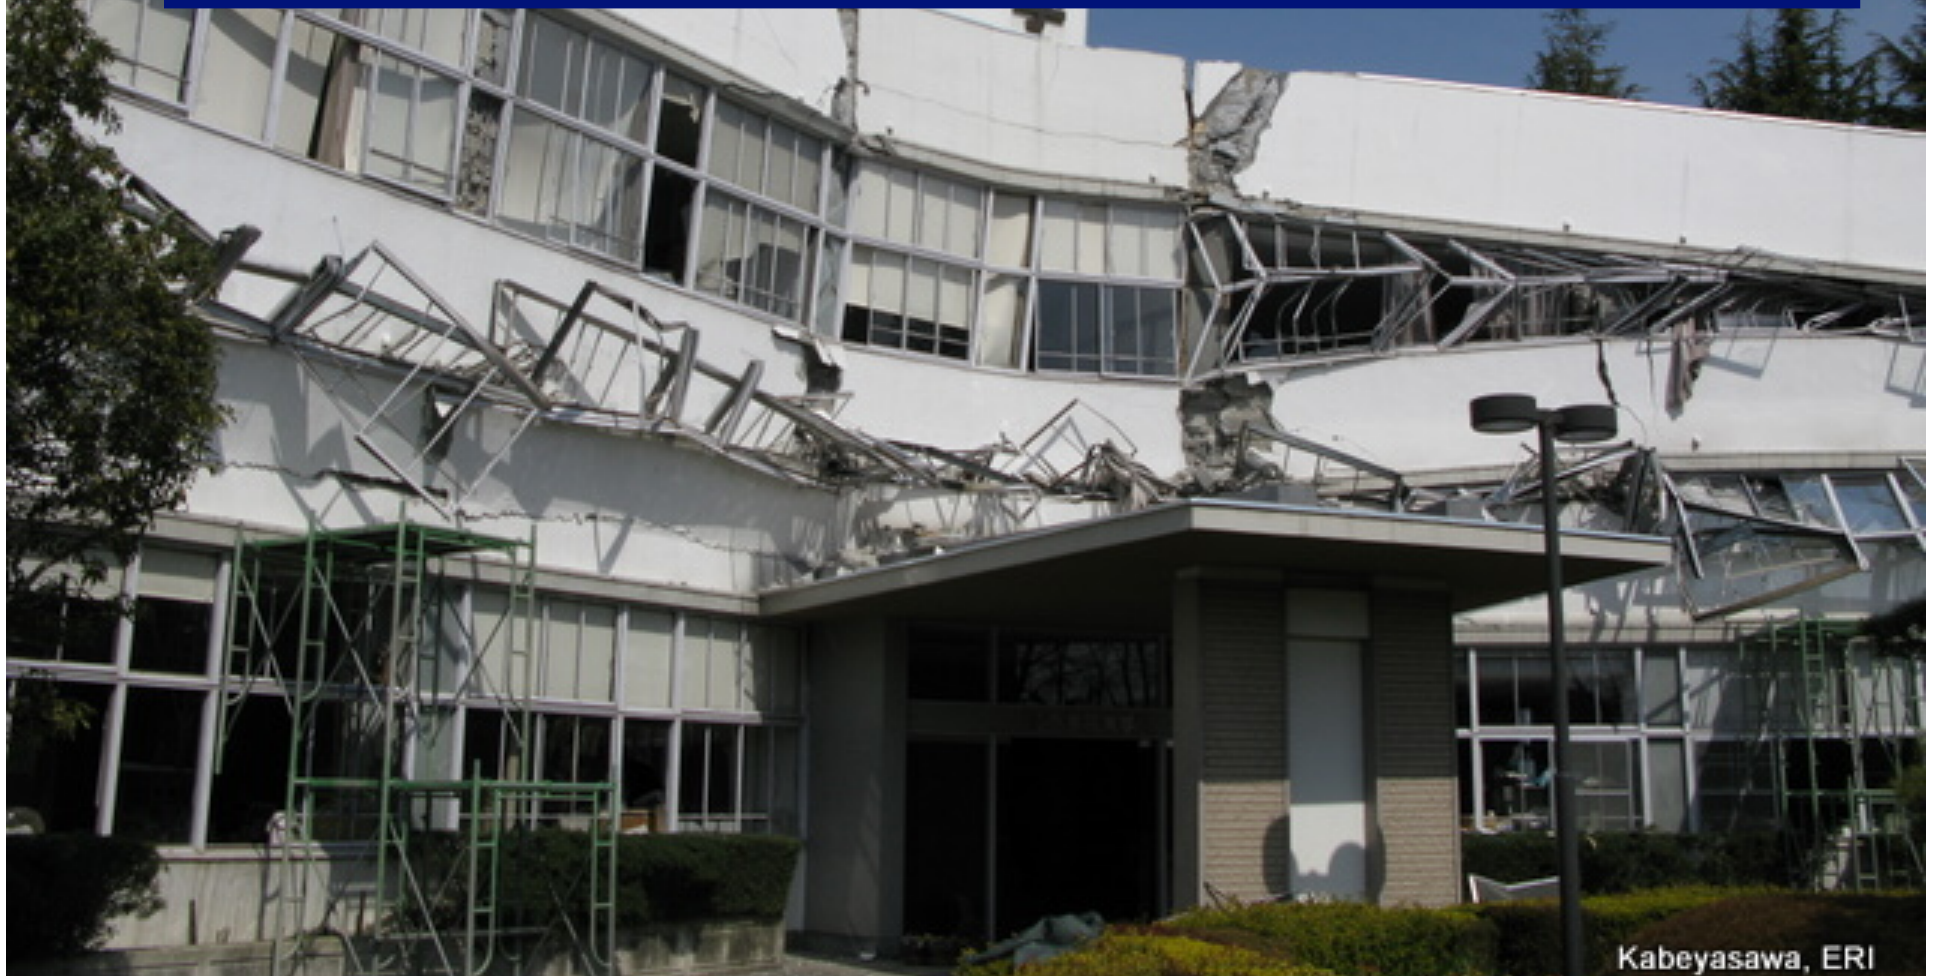
Pancake crush of a building in private college in Fukushima

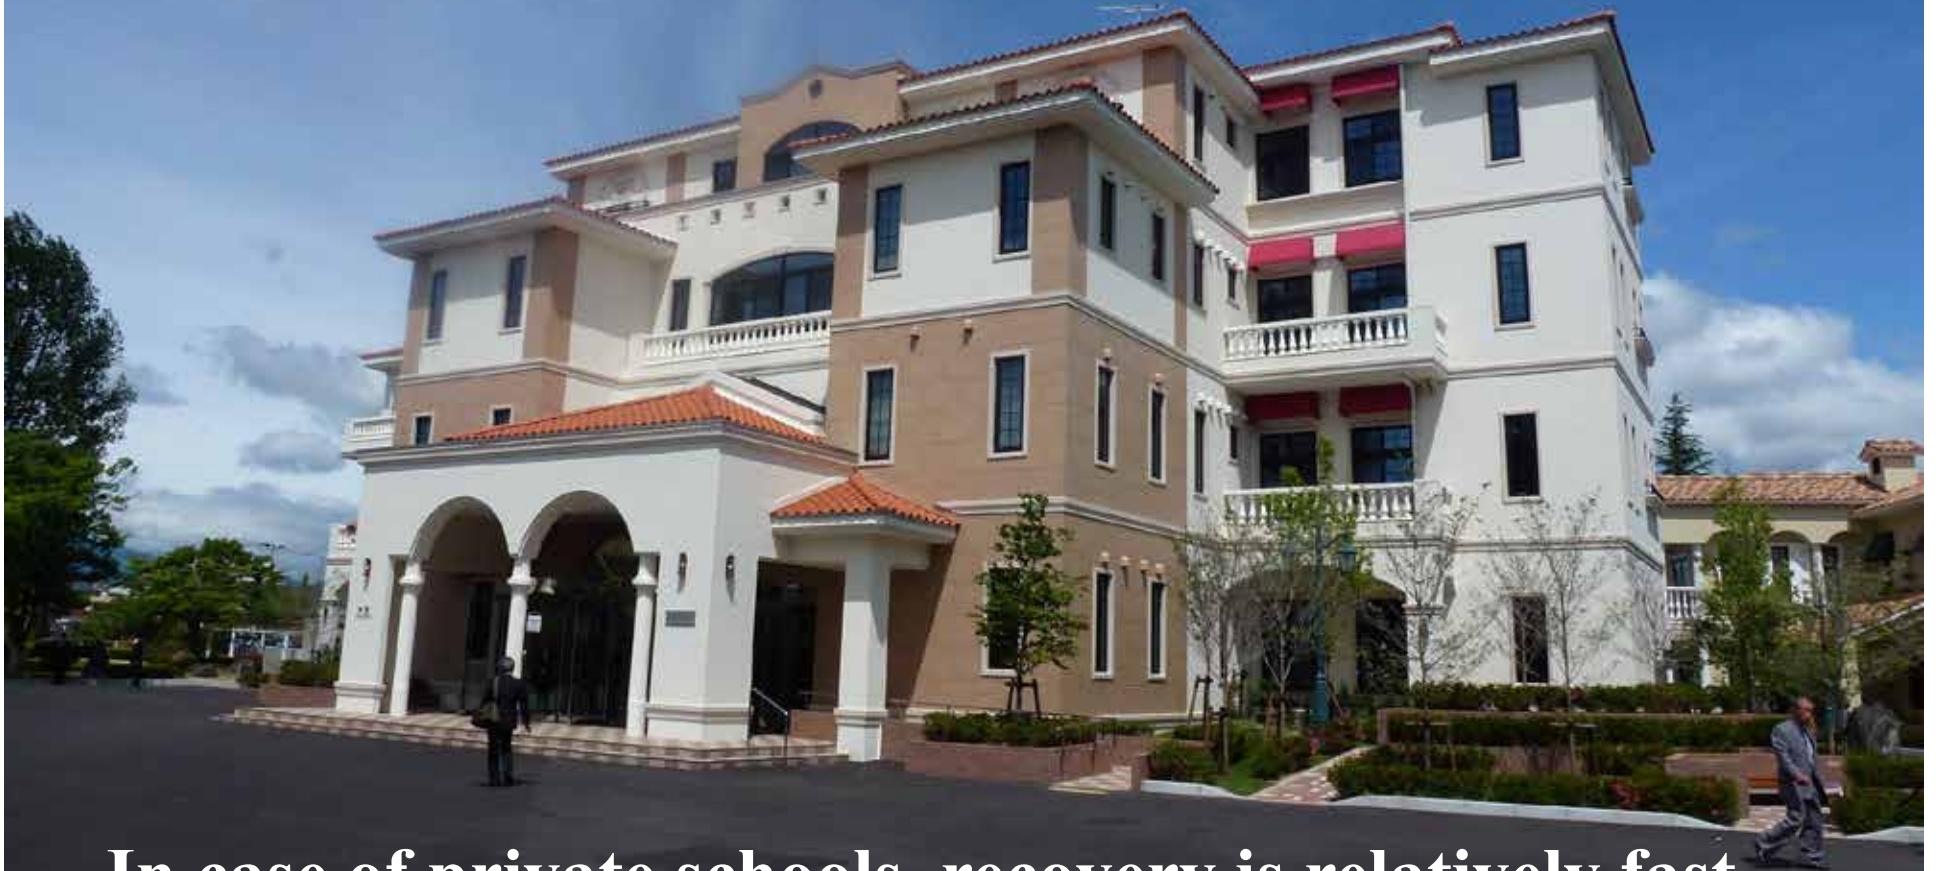
Reconstruction on 2012.6.23

In case of private schools, recovery is relatively fast, and demolish and reconstruction was completed until 15 months after.
