Post-Earthquake Data Collection Workshop

Executive Summary

Anchorage, Alaska

July 20-22, 2014

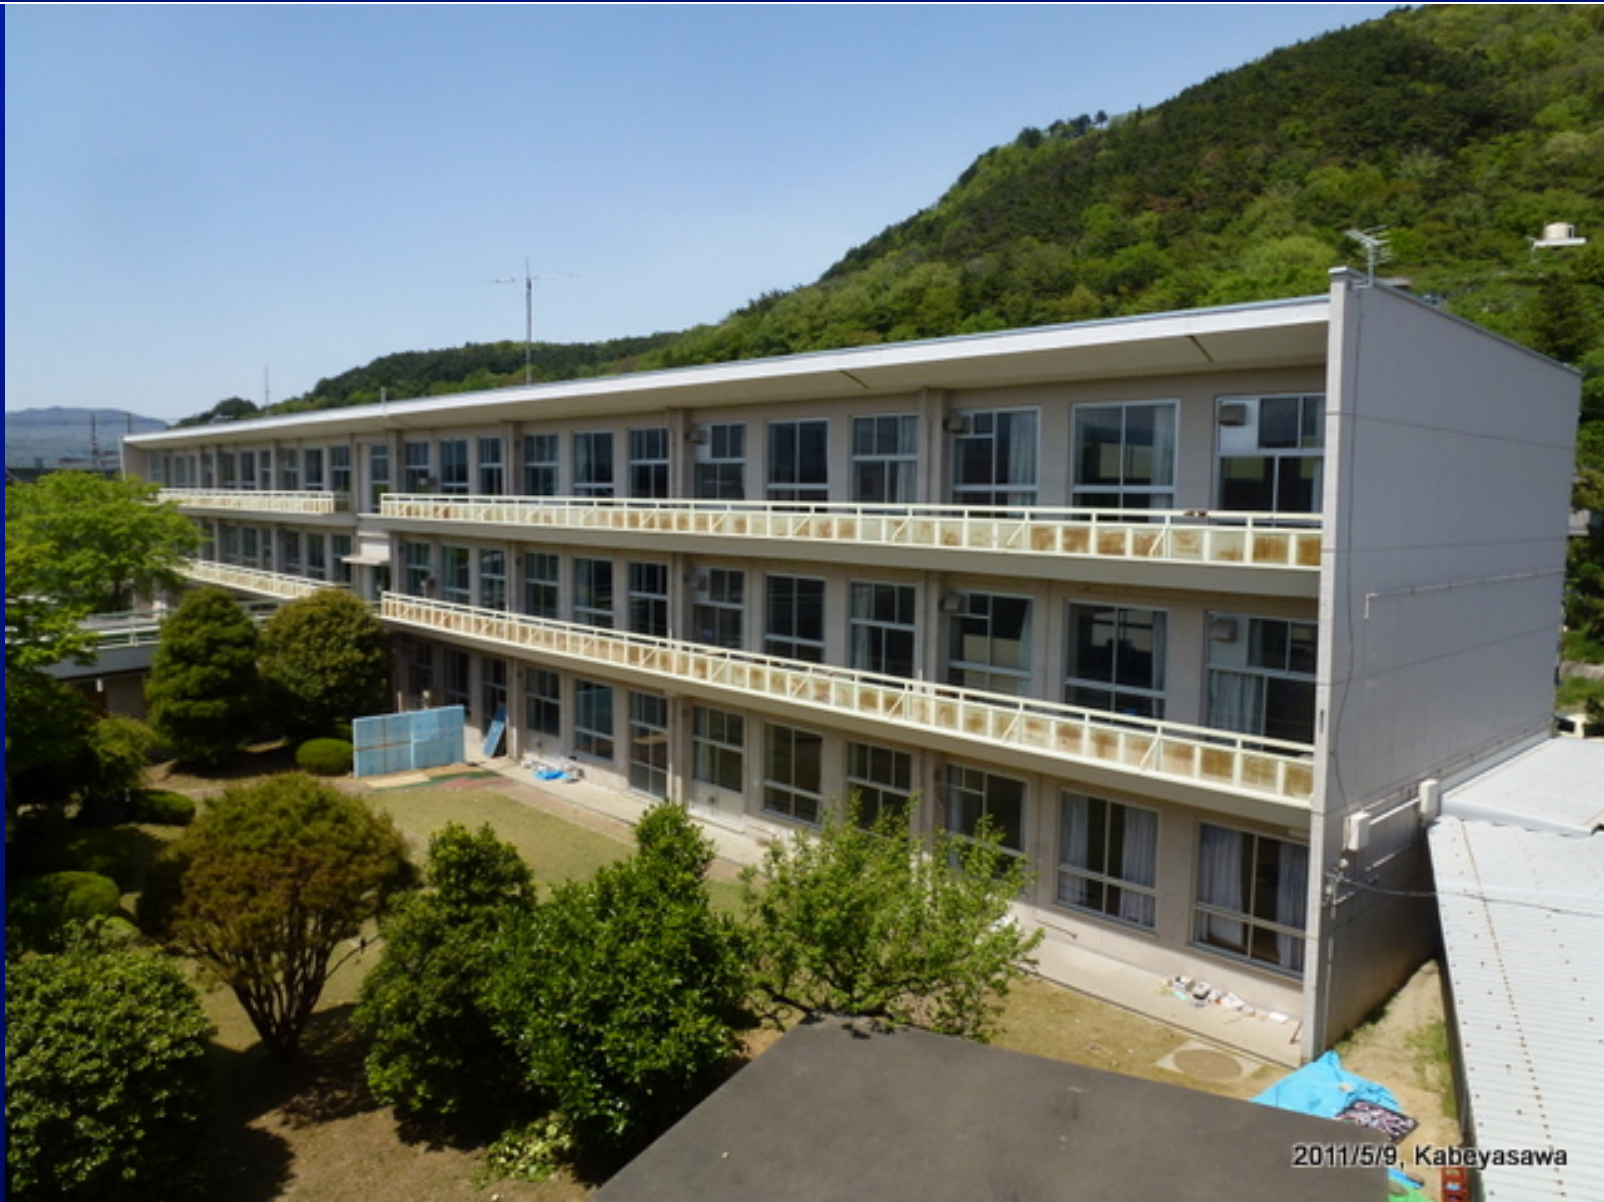
No. 4 Building of Public F-High School (F-cities, RC3, 1961-1963)

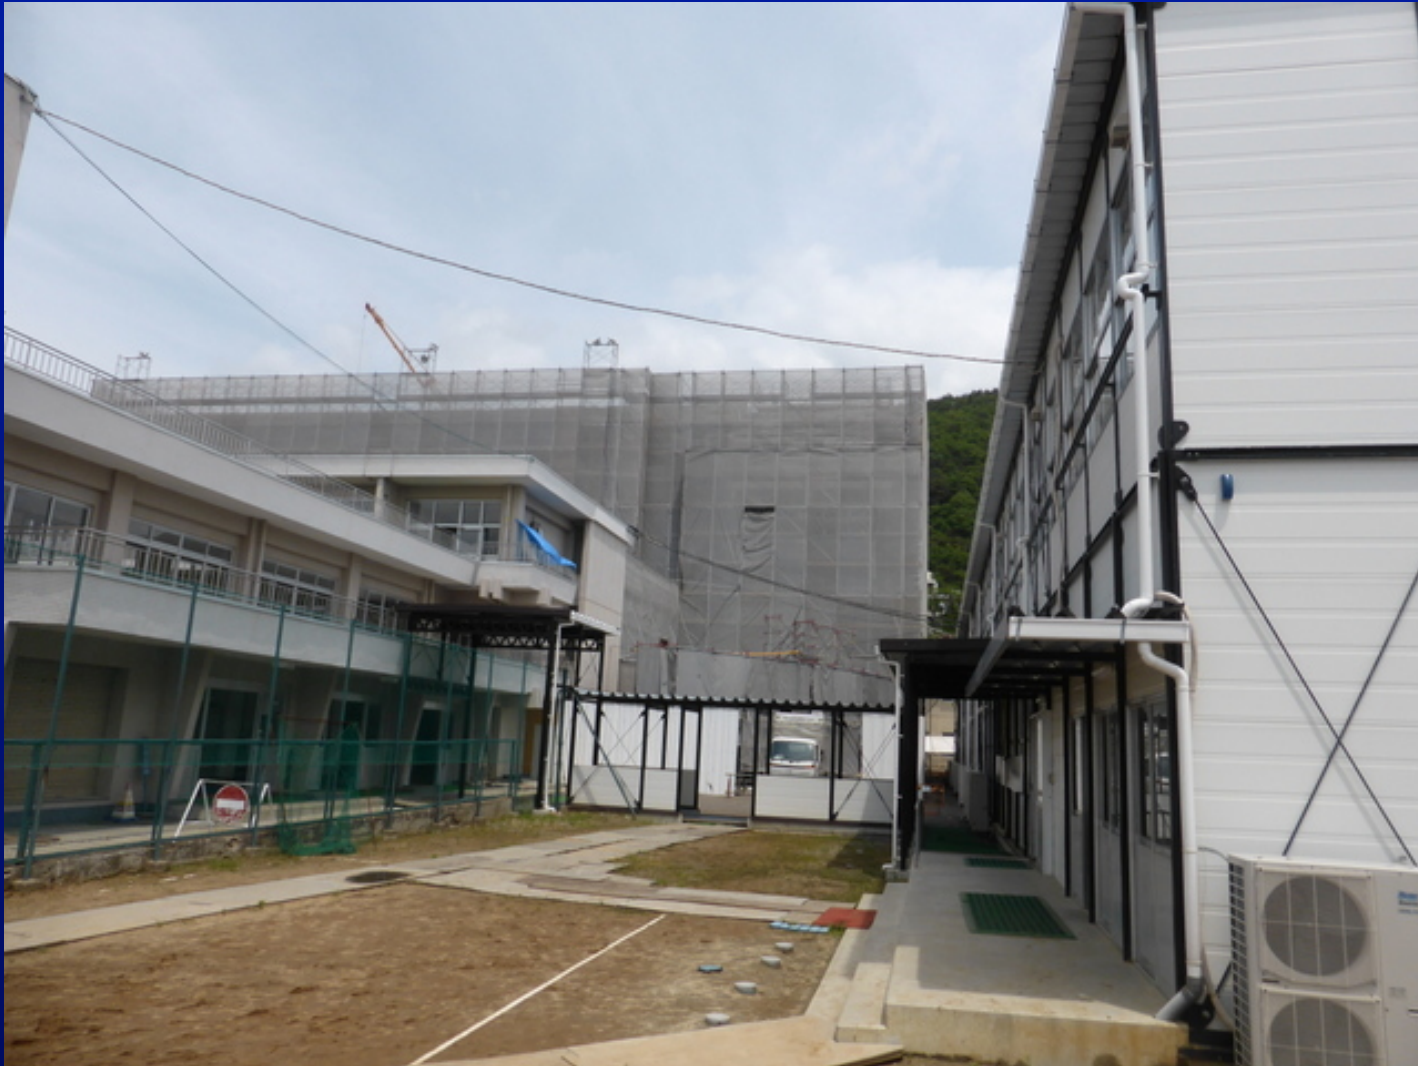
Reconstruction and temporary school building (April 23, 2014)

The reconstruction is still under procedure after three years in case of this public high school, my old school in Fukushima.

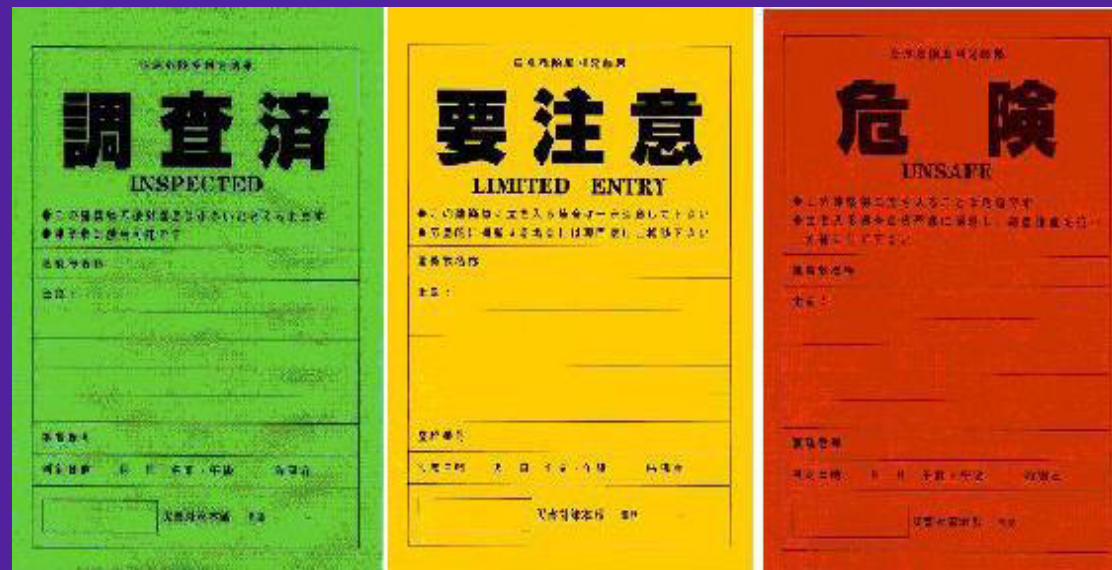
Check sheet for quick inspection

- Summary of the building
- ✓ Name, Address, Usage
- ✓ Structural type/system
- ✓ No. of story
- Hazard on structure (Rank A, B, C)
- ✓ Most severe damage to columns
- ✓ Ground, base and surroundings
- Hazard on falling objects
- ✓ Window glass
- ✓ Exterior finishing board
- ✓ Signboard, etc

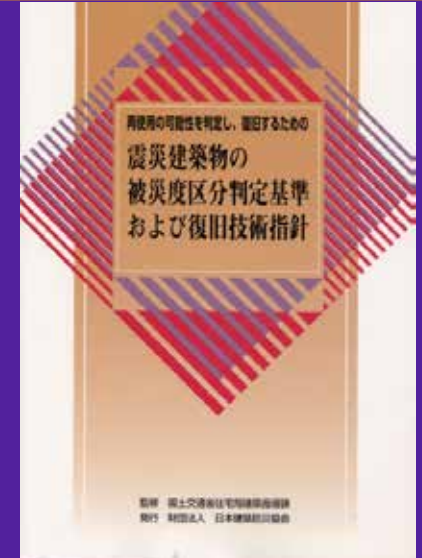
Basic concept of Damage level evaluation

- Residual seismic capacity, R , is evaluated by damage class (I, II, III, IV, V) of structural members

<i>R – index (%)</i>	<i>Limit state</i>
[Slight]	95 - 100	Serviceability
[Minor]	80 - 95	
[Moderate]	60 - 80	Reparability
[Severe]	- 60	
[Collapse]	$\div 0$	Safety

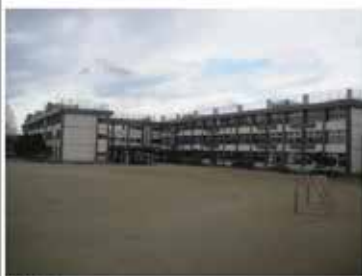
写真1

校舎全景。写真右が西校舎、左が東校舎。渡り廊下を通して連結され、Exp.Jが、渡り廊下の西校舎側の位置に設けられている。東校舎は耐震補強されているが、西校舎は耐震診断の結果、補強不要と判断されている。

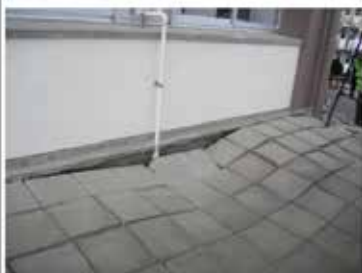
写真2

北側の周囲地盤で、20cm程度の沈下が見られた。損傷がほとんどない柱位置で傾斜を計測したところ、傾斜はほとんど0であった。

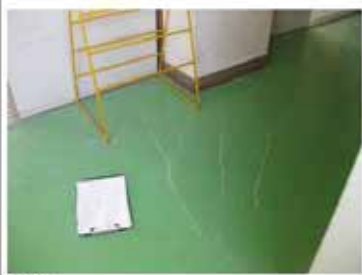
写真3

建物自体には、目立った傾斜や沈下は確認されなかったが、床には多数のひび割れが見られ、1cm程度の段差が生じている。また、これらのひび割れは、校庭に生じた亀裂と同じ位置に生じ、上階のスラブまでひび割れが生じている。

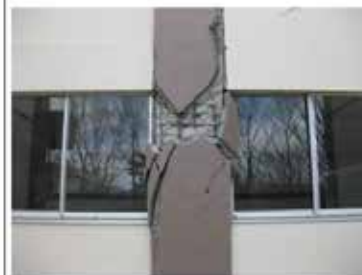
写真4

西面南側1階の柱。短柱となったことでせん断破壊し、損傷度V程度まで進行していた。この他に損傷度Vの短柱が1本、損傷度IVの短柱が5本、損傷度IIIの短柱が5本確認された。桁行は20スパンあり、北側の柱は同様に短柱となっていたものの、南側に比べて被害は小さかった（損傷度I～II程度）。また東面の柱は、西面とは異なり短柱となっておらず、概ね損傷度I～II程度であった。

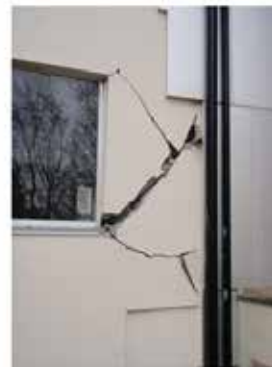
写真5

西面南側1階の柱型付壁。開口の部分でせん断破壊が生じ、ひび割れが内部まで貫通しており、地震力を負担できない状態であると思われる（損傷度V）。

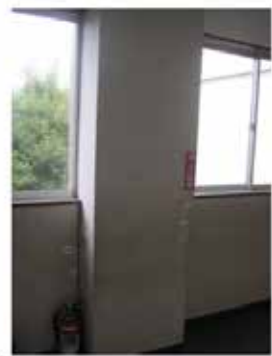
写真6

2階西面南側の柱（損傷度II）。短柱となっている場所でも、損傷度は最大II程度であり、1階と比較すると被害は軽微であった。3階についても、ほぼ同程度の被害であった。

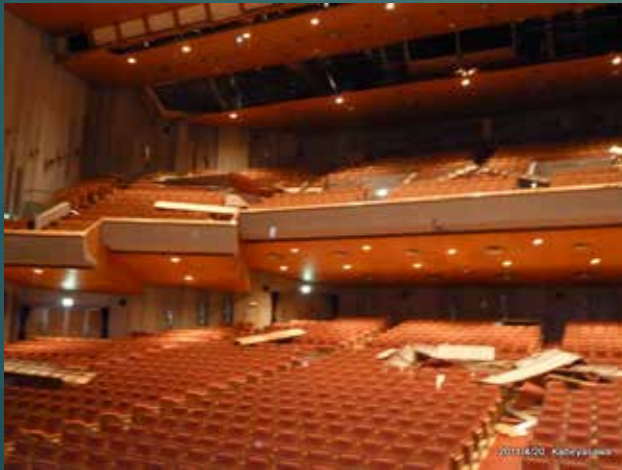
Ceiling system

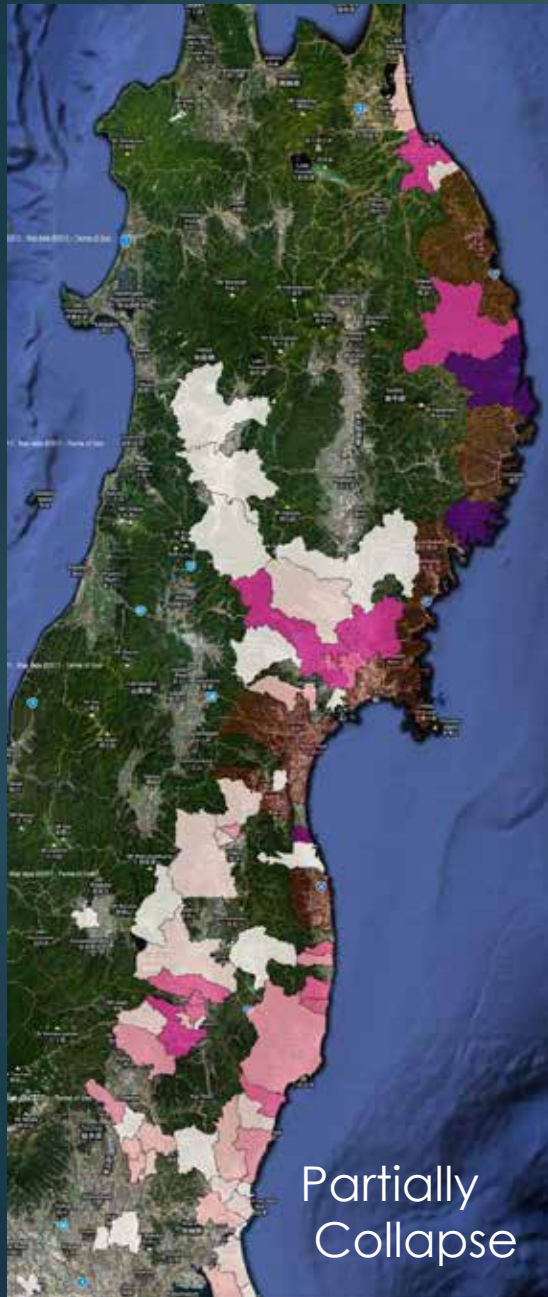
Partially
Collapse

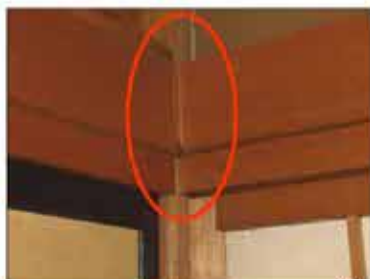
● 程度Ⅰ

柱と梁の仕口になずれが生じている。

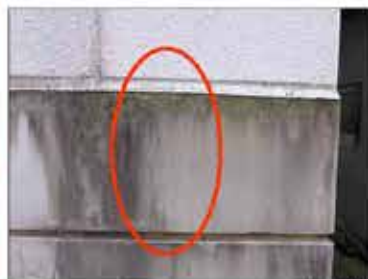
柱脚コンクリートのひび割れが見られる。

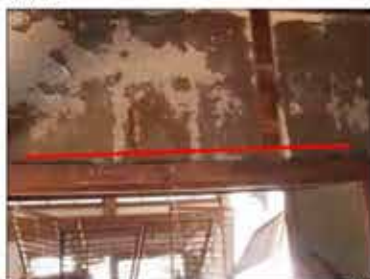
● 程度Ⅱ

柱、梁が若干たわんでいる。

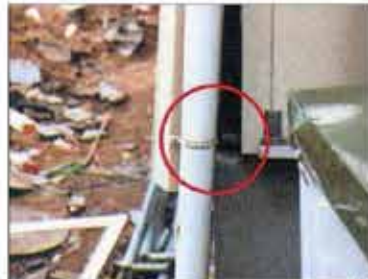
アンカーボルトの伸びが見られる。

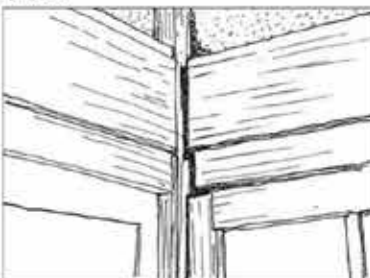
● 程度Ⅲ

柱と梁の仕口になずれが生じている。

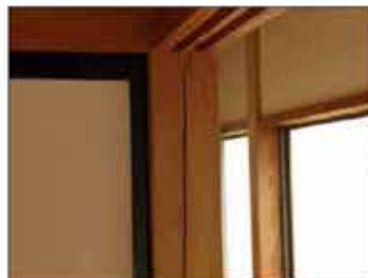
柱、梁に割れが見られる。

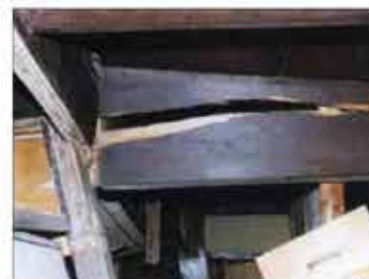
● 程度Ⅳ

柱、梁に大きな割れが見られる。

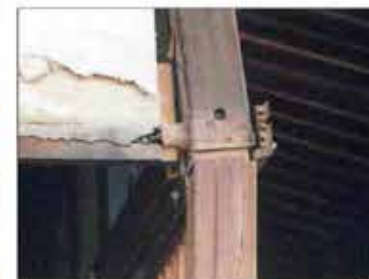
柱、梁の仕口になずれが見られる。

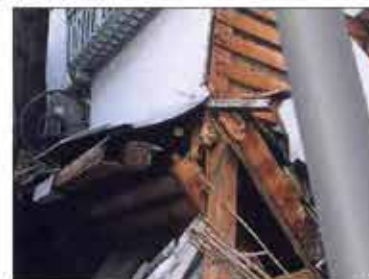
● 程度Ⅴ

柱、梁の割れ、断面欠損が著しい。

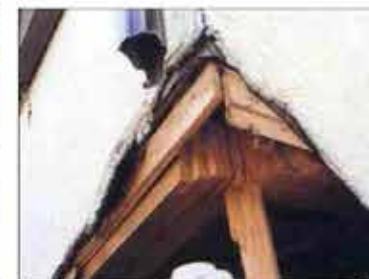
柱、梁に著しい損傷が生じており、交換が必要である。

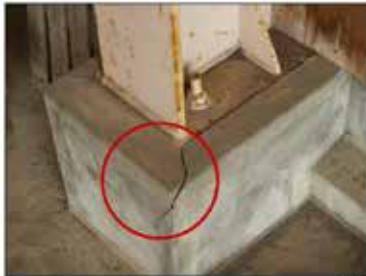
●程度Ⅰ

柱脚コンクリートのひび割れが見られる。

程度	損傷の例示	損傷程度
I	・柱脚コンクリートのひび割れが見られる。	10%
II	・アンカーボルトの伸びが見られる。 ・高力ボルトのすべりが見られる。	25%
III	・局部座屈による小さな変形が柱に見られる。	50%
IV	・局部座屈による中ぐらゐの変形が柱に見られる。	75%
V	・局部座屈による大きな変形が柱に見られる。 ・接合部の破断が見られる。	100%

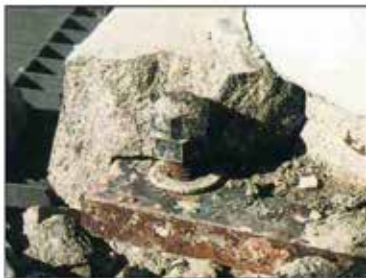
●程度Ⅱ

アンカーボルトの伸びが見られる。

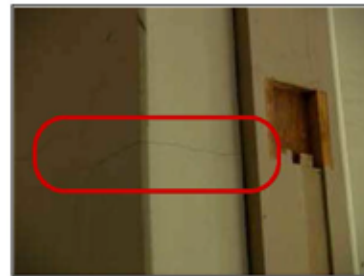
●程度Ⅰ

近寄らないと見えにくい程度のひび割れ(幅約0.2mm以下)が生じている。

程度	損傷の例示	損傷程度
I	・近寄らないと見えにくい程度のひび割れ(幅約0.2mm以下)が生じている。	10%
II	・肉眼ではっきりと見える程度のひび割れ(幅約0.2mm～1mm)が生じているが、コンクリートの剥落は生じていない。	25%
III	・比較的大きなひび割れ(幅約1mm～2mm)が生じているが、コンクリートの剥落は増わずで、鉄筋は露出していない。	50%
IV	・大きなひび割れ(2mmを超える)が多数生じ、コンクリートの剥落も激しい。鉄筋が露出しているが、鉄筋の変形は見られない。	75%
V	・鉄筋が大きく露出しており、鉄筋の曲がり・破断が見られる。内部のコンクリートも剥れ落ち、柱の高さ方向の変形が生じている。	100%

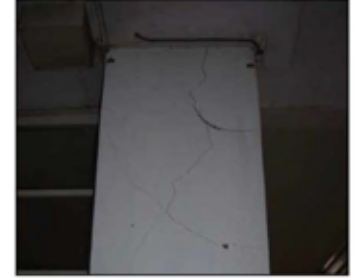
●程度Ⅱ

肉眼ではっきりと見える程度のひび割れ(幅約0.2mm～1mm)が生じているが、コンクリートの剥落は生じていない。

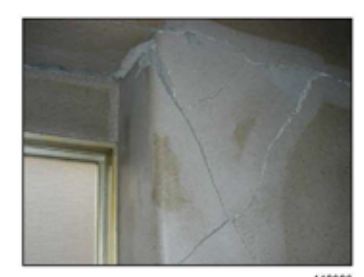
●程度Ⅲ

比較的大きなひび割れ(幅約1mm～2mm)が生じているが、コンクリートの剥落は増わずで、鉄筋は露出していない。

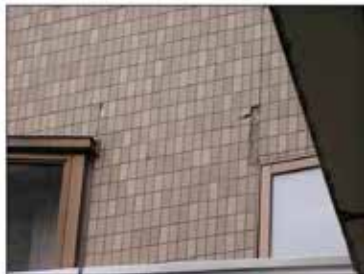
● 程度Ⅰ

【外部仕上】
仕上材のわずかな剥離、目地のずれが見られる。

【雑壁】
一部にひび割れ(幅約0.2mm～1mm)やはがれが生じている。

程度	損傷の例示	損傷程度
	【外部仕上】	【雑壁・雑壁】
I	・ 仕上や仕上材の目地にわずかなひび割れ(幅約0.2mm)が見られる。 ・ 仕上材の隅角部にわずかな亀裂が生じている。 ・ 仕上材のわずかな剥離、目地のずれが見られる。	・ 一部にひび割れ(幅約0.2mm～1mm)やはがれが生じている。
II	・ 仕上やパネルの目地にはっきりとしたひび割れが見られる。 ・ 仕上材の目地にずれが見られる。 ・ 仕上材が部分的に剥離している。 ・ 一部に飛来物による軽微な衝突痕がある。	・ 各所にひび割れ(幅約0.2mm～1mm)やはがれが生じている。 ・ 一部に飛来物による軽微な衝突痕がある。
III	・ 大きなひび割れ又は仕上の剥離が見られる。 ・ 仕上材が部分的に剥離・剥離している。 ・ 一部に飛来物による突き刺さり、貫通痕がある。	・ 全体にひび割れ(幅約0.2mm～1mm)やはがれが生じている。 ・ 一部に飛来物による突き刺さり、貫通痕がある。
IV	・ 仕上の面外へのはらみ出し、又は剥離が見られる。 ・ 仕上材の破壊、脱落が一部見られる。 ・ 大半にわたって飛来物による衝突痕、突き刺さり、貫通痕がある。	・ 全体にひび割れ(幅約1mm～5mm)やはがれが生じている。 ・ 大半にわたって飛来物による衝突痕、突き刺さり、貫通痕がある。
V	・ 全面にわたる大きな亀裂が見られ、面外への大きなはらみ出し、大きな剥離が見られる。 ・ 全面にわたって飛来物による衝突痕、突き刺さり、貫通痕がある。	・ 全体が変形し、仕上の大部分が剥離している。 ・ 全面にわたって飛来物による衝突痕、突き刺さり、貫通痕がある。

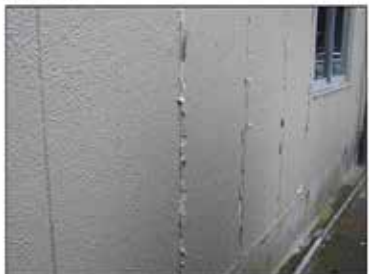
● 程度Ⅱ

【外部仕上】
仕上やパネルの目地にはっきりとしたひび割れが見られる。仕上材が部分的に剥離している。

【雑壁】
各所にひび割れ(幅約0.2mm～1mm)やはがれが生じている。

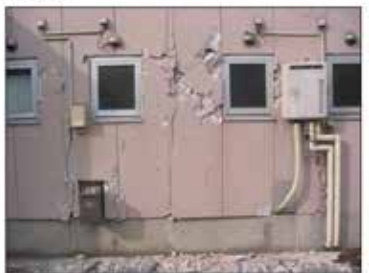
● 程度Ⅲ

【外部仕上】
大きなひび割れ又は仕上の剥離が見られる。

【雑壁】
全体にひび割れ(幅約0.2mm～1mm)やはがれが生じている。

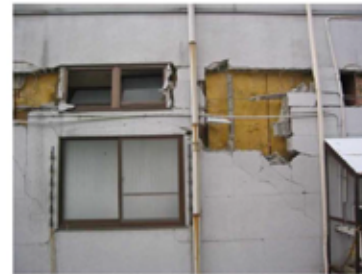
● 程度Ⅳ

【外部仕上】
仕上材の破壊、脱落が一部見られる。
