## EERI Learning From Earthquakes Program Travel Study Report:

# Reconfiguring New Zealand's Built Environment After the 2010-2011 Canterbury Earthquake Sequence and the 2016 Mw 7.8 Kaikoura Earthquake

### July 2019

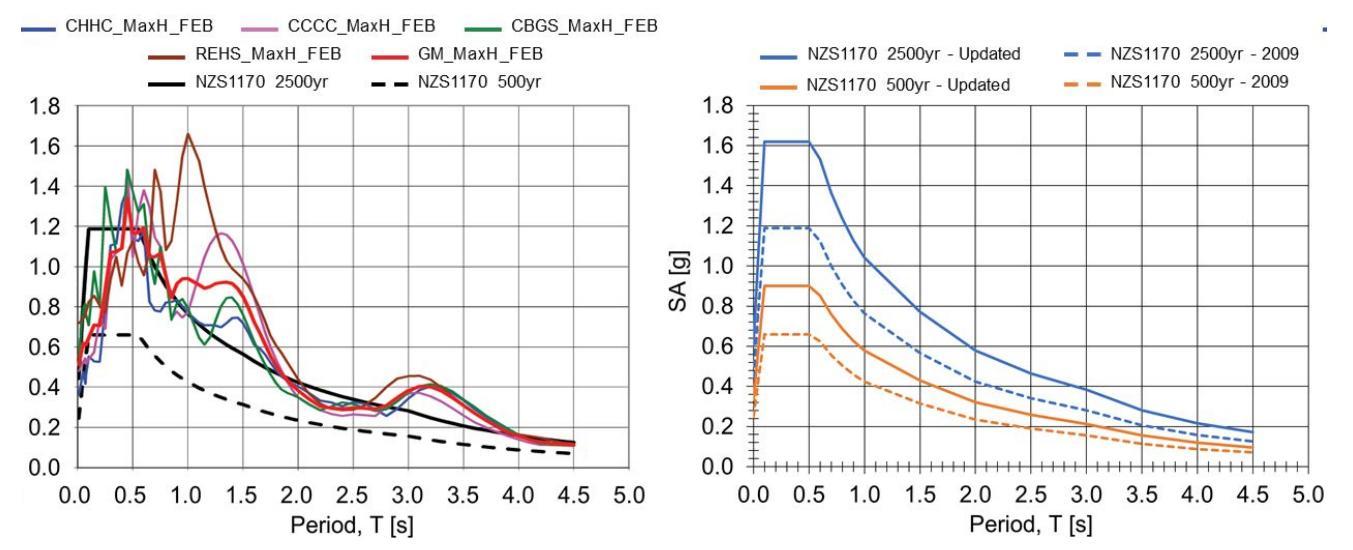
Figure 1. Christchurch soft soils (soil Class D) design spectra comparison. (Left) Recorded acceleration response spectra in the 22 February earthquake (5% damped); solid red line is the geometric mean of four sites and the dashed and solid black lines are the 500- and 2500-year NZS1170 spectra, respectively (adapted from McVerry et al., 2012). (Right) Design spectra before and after the CES.

The primary reason for the unanticipated extent and severity of damage in CES was an underestimation of the region's earthquake hazard. To demonstrate the underestimation, Figure 1(left) compares ground motion records from Christchurch to the design spectrum representing the 500 year return period earthquake. Not only do the records exceed the design spectrum at all periods, they even cross the solid line representing the 2500 year return period earthquake over a broad range of periods. In light of this, the Canterbury Earthquakes Royal Commission (CERC) recommended that the design provisions be increased to reflect the new knowledge regarding the seismicity of the Canterbury region. Per this recommendation, the earthquake loading specifications in NZS1170.5 increased the 500-year and 2,500-year spectra by approximately 36%, as shown in Figure 1(right).

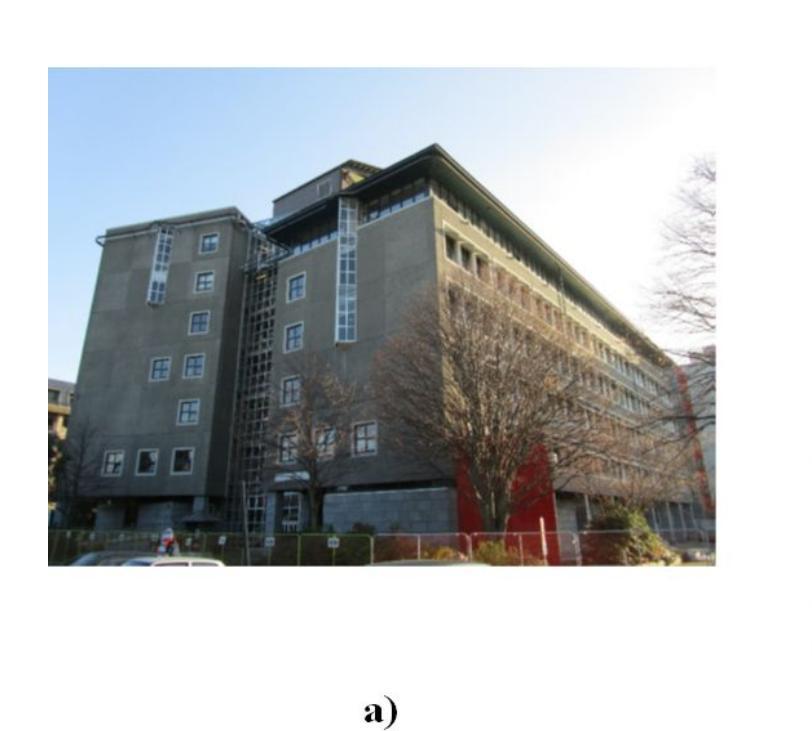
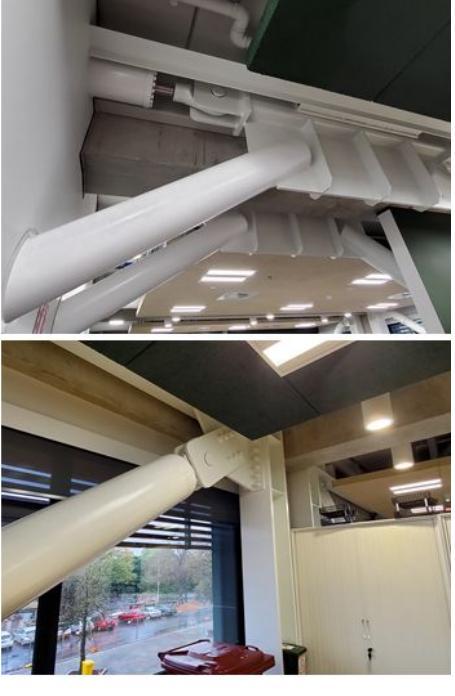
Figure 2. Rehua building at the University of Canterbury. a) Rehua building prior to retrofit (Pettinga, D., 2019); b) New steel framing including viscous dampers (top) and braces (bottom)

After the devastating outcomes of the CES, improved building performance and earthquake resilience were at the forefront of the recovery and reconstruction in Christchurch. Furthermore, structural engineers were more influential during the design process and clients more receptive to low-damage design solutions (as opposed to the minimum code requirement for Life-Safety). The new resilience-conscious market has increased the use of seismic isolation, buckling restrained braces, viscous dampers and other low-damage technologies (Campbell, 2018). While in Christchurch, the LFE participants encountered several buildings and other structures that implemented low damage design technologies. The Rehua building at the University of Canterbury (Figure 2a), originally a reinforced concrete moment frame building, was retrofit with a new steel framing system, braced frames, and viscous dampers, as shown in Figure 2b. Several other buildings on the University of Canterbury campus incorporated braced frames, seismic gaps, and other earthquake resistant design features. Similarly, new construction projects throughout Christchurch and Wellington are targeting low damage as an enhanced seismic performance criterion. In Christchurch, the Ernest Rutherford building and the parking garage, shown in Figure 3a and b, incorporate buckling restrained braces (BRB). In Wellington, the new PwC Center building features base isolation (Figure 4).

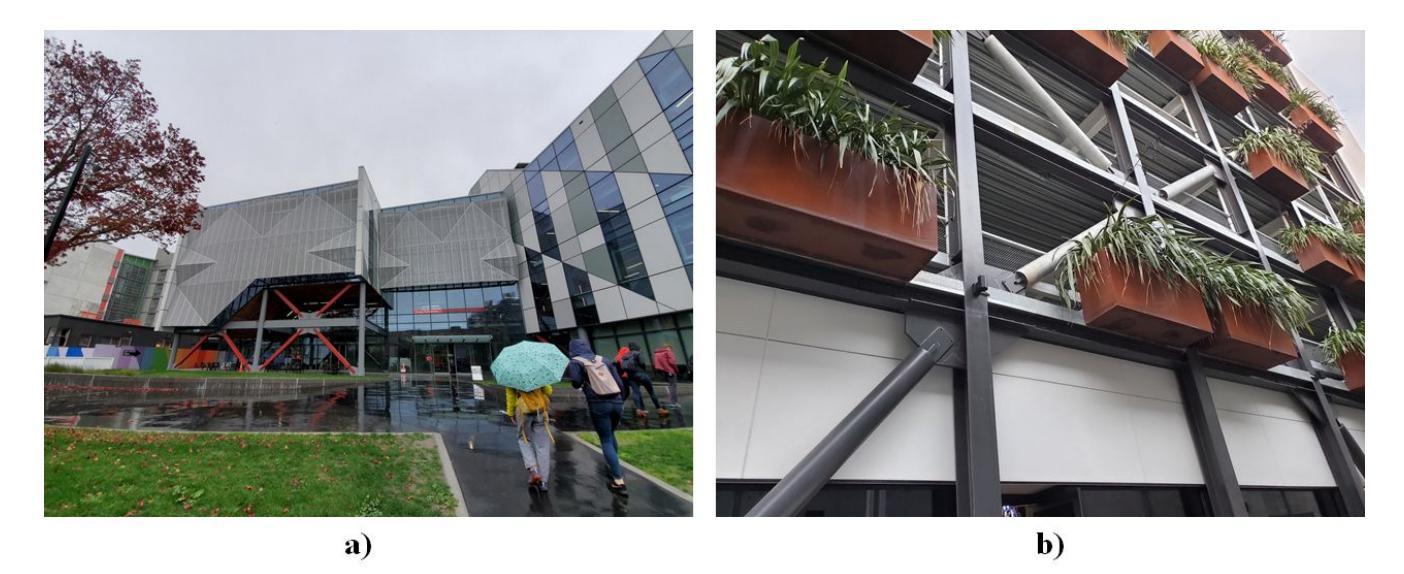
Figure 3. Buildings in Christchurch Implementing Buckling Restrained Braces. a) Ernest Rutherford Building, University of Canterbury. b) Multi-Story Parking Structure in Christchurch CBD.

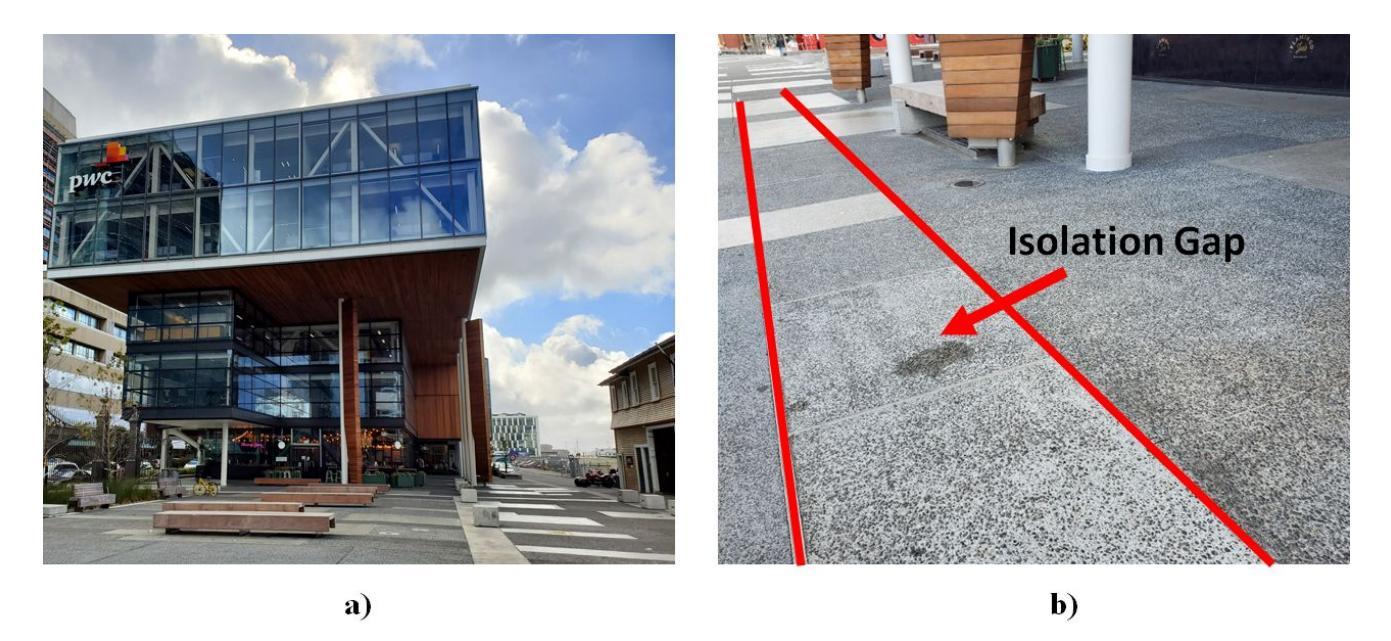
Figure 4. Base Isolated Building in Wellington's Waterfront. a) PwC Center; b) Seismic Isolation Gap.

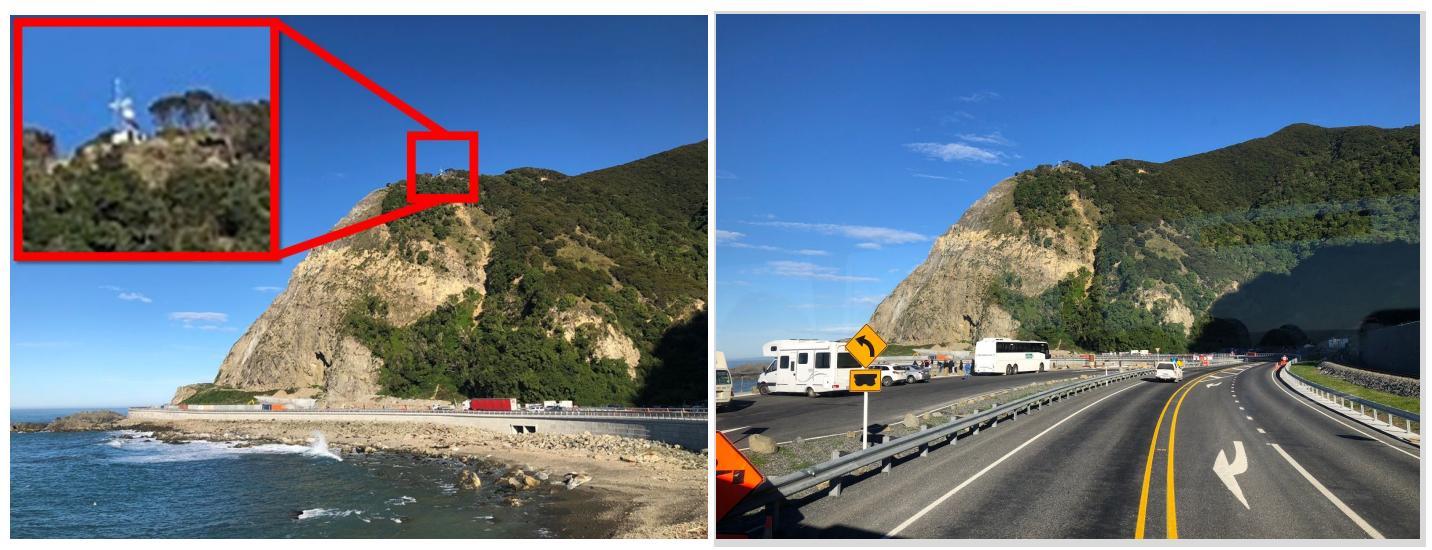
Figure 5. (Left) New Telecommunication Lines Along State Highway; (Right) Oahu Point.

An unexpected benefit of the strong shaking and during the Kaikoura earthquake is that it caused the seafloor to rise, creating new beachfront. This allowed the (NCTIR) to realign the severely affected State Highway 1 as shown in Figure 6. Increased elevation along the coast provides an additional buffer for the coastal road against the effects of long-term sea level rise. The extensive reconstruction and mitigation work provided several opportunities to improve the function along the highway, such as expanding the telecommunications reach, as shown in Figure 5.

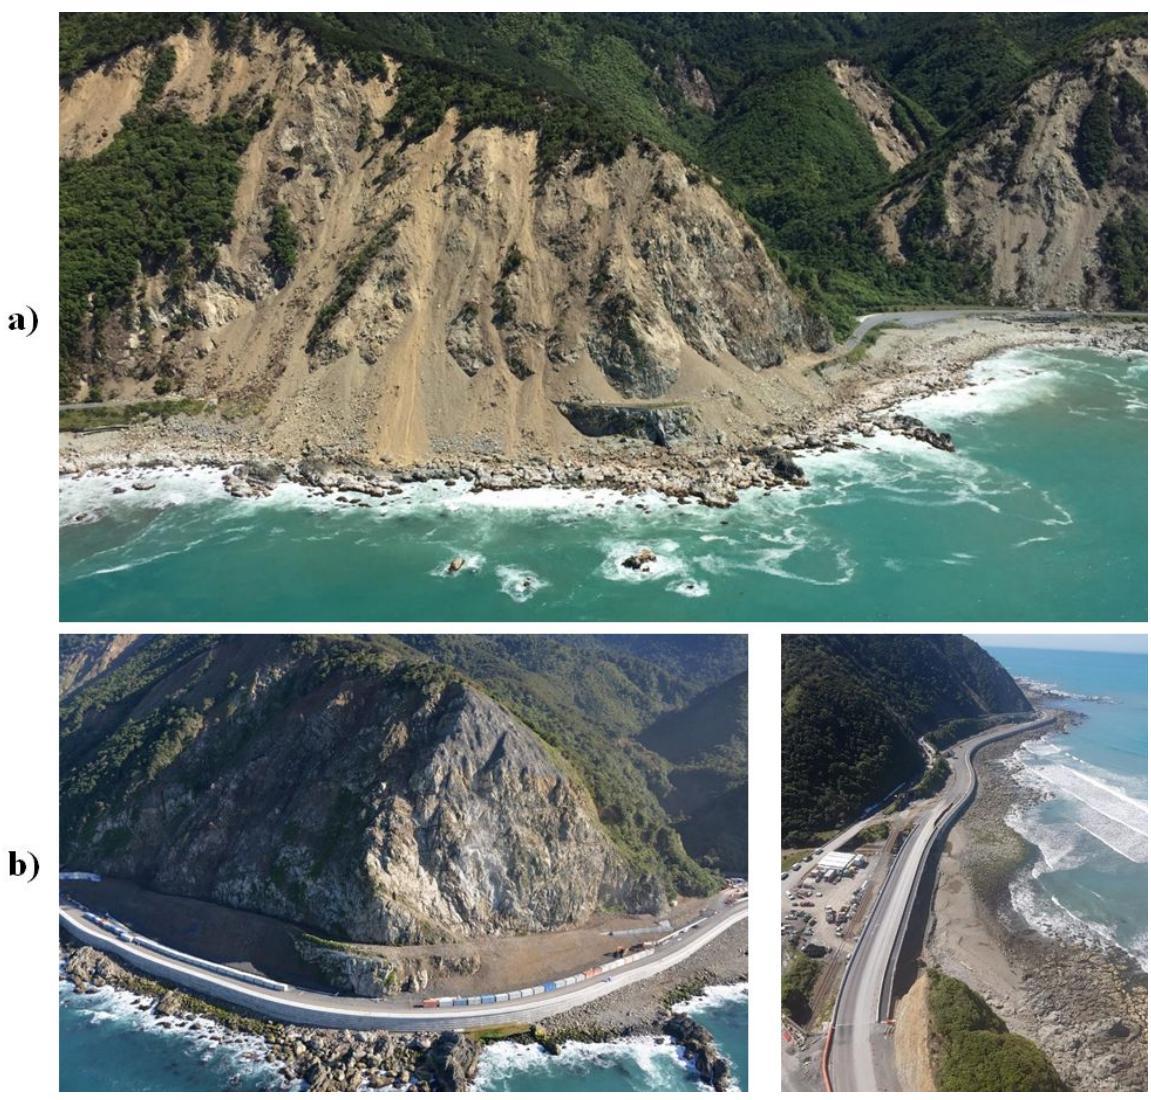
Figure 6. State Highway 1 Realignment. a) After 2016 Kaikoura Earthquake; b) After Reconstruction and Realignment. (Photos from NCTIR, 2019).

During the 2016 Kaikoura earthquake, transportation routes and railroad services were substantially impacted, whereas power and communications were restored within two days in the Northern Canterbury region, and within 24 hours in Wellington (Stevenson et al., 2017). The North Canterbury Transport Infrastructure Recovery (NCTIR) consortium was organized to restore the road and rail networks from the damage caused by the earthquake to the Main North Line railway and SH1 (Kaikoura earthquake response). State Highway 1 was blocked off and the main north line railway between Picton and Christchurch was disrupted. Inland roads such as Route 70 were also disrupted, making Kaikoura inaccessible from all directions (Davies et al, 2017). NCTIR increased functionality by straightening curves and adding scenic points (Figure 5: Ohau Point) along the highway. When rebuilding, the designs included both large barricades and culverts to direct debris under the road, protecting it from landslides (Figure 6).

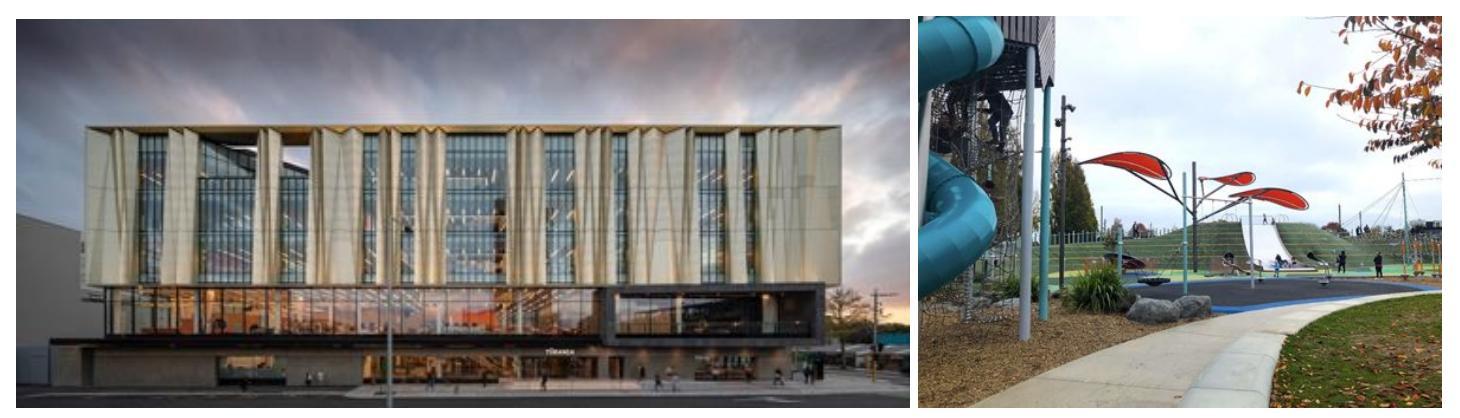
Figure 9. Turanga, Christchurch Public Library (left) and the Margaret Mahy Playground (right)

Tūranga, the Christchurch Public Library (Figure 9, left), was also a major CBD building project designed to bring all facets of the community together. It was built so that the people of Christchurch would have a public and safe place to gather, be creative, study, and enjoy each other and their community. In particular, its recurring architectural and design themes highlight and celebrate Maori Culture in many of its spaces. Tūranga was intended to host anchor projects that build community, and it contains playrooms for children to enjoy, study areas for everyone, reading stands, conference rooms, and creative spaces. On the library's opening day, many residents in the suburbs re-entered the CBD for the first time since the earthquake and families expressed joy in having public spaces where their children were welcomed. To improve performance during an earthquake, the building was designed with an enhanced seismic resistant system, which includes: steel moment resisting frames, post tensioned concrete rocking walls, U-Shaped flexural Plates, and lead extrusion dampers.

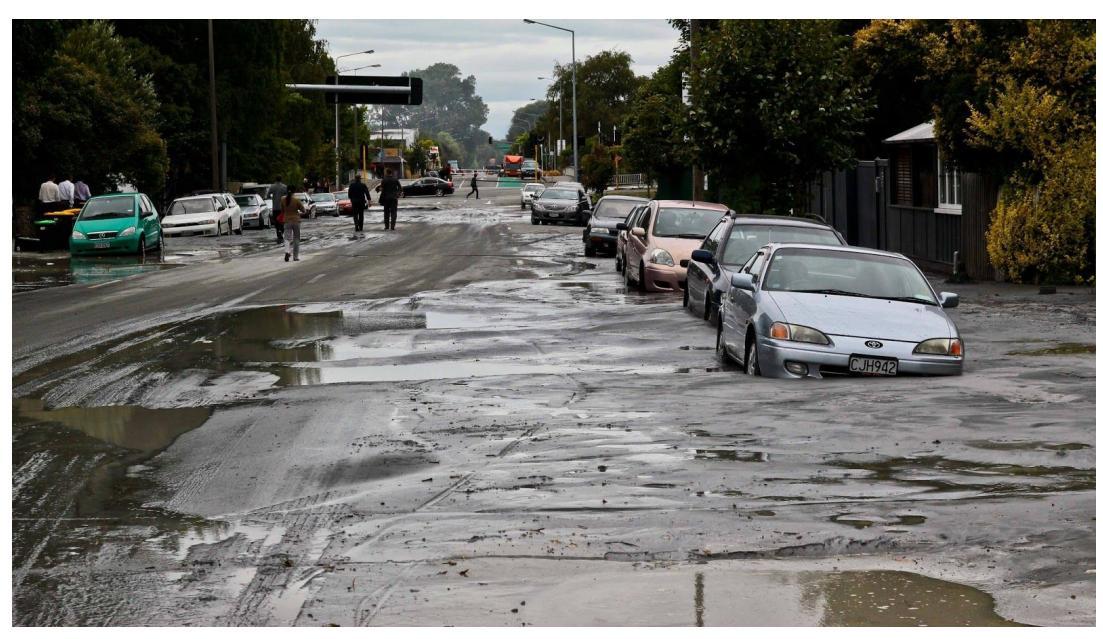
Figure 11. Damaged caused by liquefaction in Christchurch

Outside of the CBD, liquefaction in residential neighborhoods around the river caused significant ground movement, as is shown in Figure 11, leading to unstable foundations and damaging major infrastructure such as water and sewage lines (Christchurch Earthquake, 2011). The current conditions and future risk make these lands, now known as the Red Zone, not suitable for rebuilding; and much of the area was left as is. The fact that this damage occurs raises caution regarding permitting land development in known risk prone areas and the consequences of doing so. But it also offers opportunities to apply risk-based land use planning so that such disastrous outcomes are not repeated in the future. Plans are currently under development for new recreational space in the Ōtākaro Avon River Corridor (Figure 10, right) in order to strengthen the connection between people, the river, and the land.

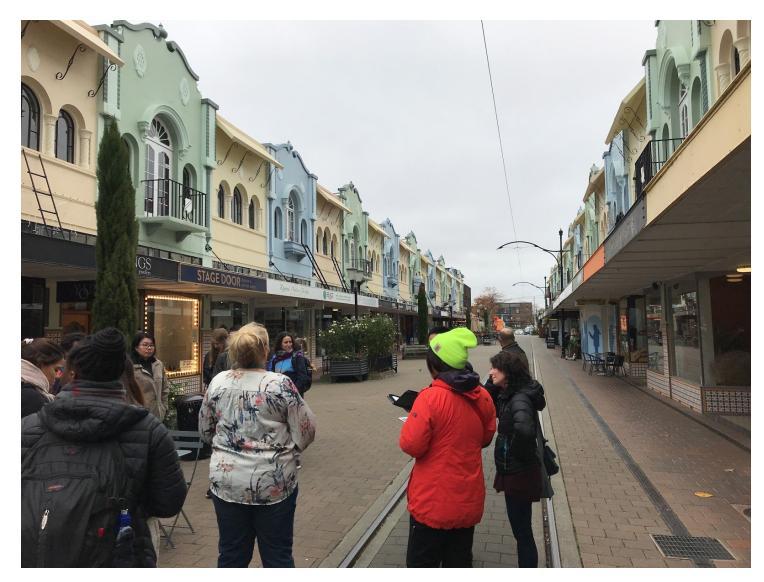
Figure 14. New Regent Street Precinct shopping mall in Christchurch with repaired historical facades.

With respect to the many damaged buildings in Christchurch, some buildings were repaired and restored while others were demolished. Figure 14 shows the New Regent Street Precinct located in Christchurch. The New Regent Street Precinct is a pedestrian mall built in the early 1930s with a Spanish Mission architectural style. The February 22 earthquake severely damaged the block, and because of limited resources and many delays in construction, the whole mall was not fully repaired. All the historic facades were repaired but some of the lots are completely empty behind the facade. After the mall reopened, many storefronts remained empty for a long time because new tenants were not interested in renting the spaces. This was a common issue throughout the Christchurch CBD.
