## Resilience Reconnaissance | Education

Laura Whitehurst, Kelsey Wittels, Keshab Sharma, and José Luis Baquedano  
EERI Learning From Earthquakes Travel Study Program, Chile 2017

### Introduction

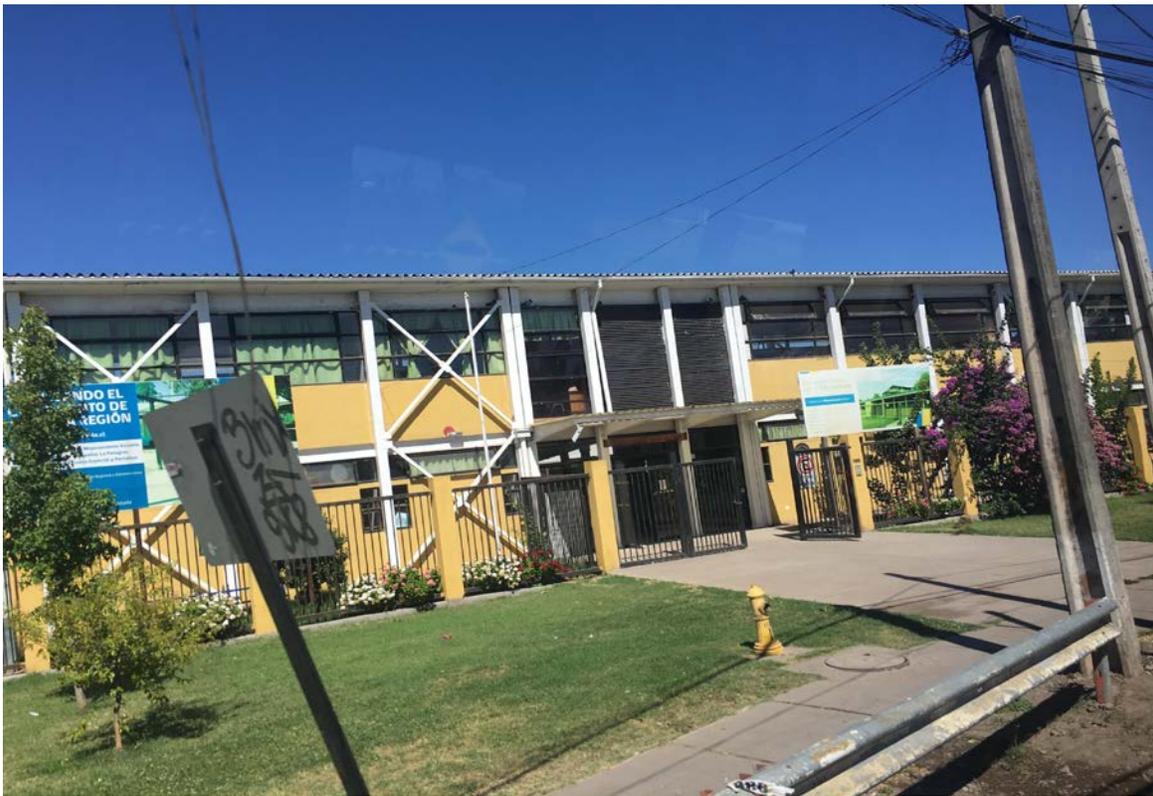
*Figure 1. Retrofitted School in Santa Cruz (credit: Laura Whitehurst)*

Per our observations and interviews, it seems that schools were a priority in the recovery process. Now, nearly seven years after the earthquake and tsunami, the level of recovery appears to be nearly complete and the education systems seems back to normal. Of the locals we spoke with, none reported any remaining damage, indicating that the recovery is nearly complete. Several of the schools we visited had already undergone recovery and had been retrofitted. For example, as seen in Figure 2, the University of Talca has a retrofitted lateral system. Several of the other schools that we passed, such as the one from Santa Cruz pictured in Figure 1 also appear to be completely recovered.

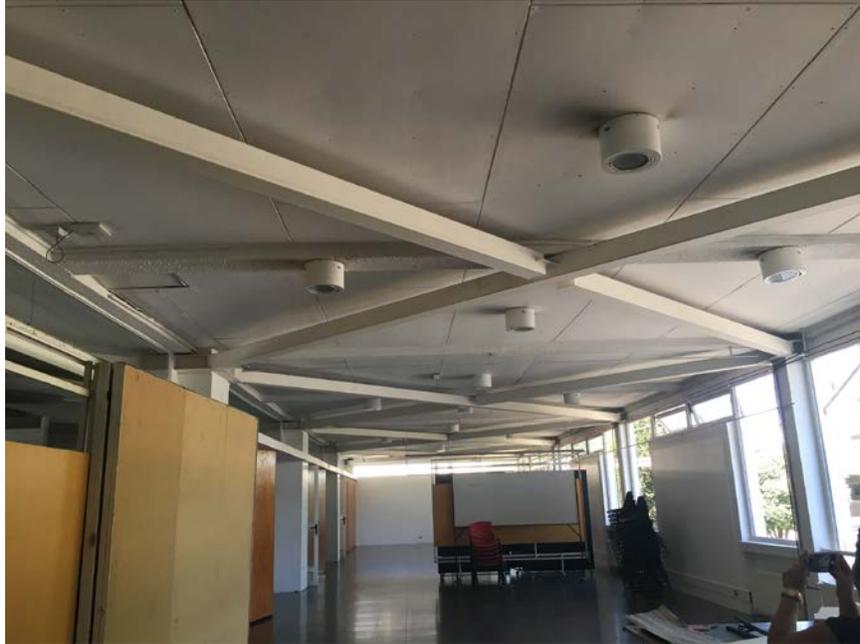
*Figure 2. University of Talca facility retrofitted with steel brace diaphragm (credit: Laura Whitehurst)*

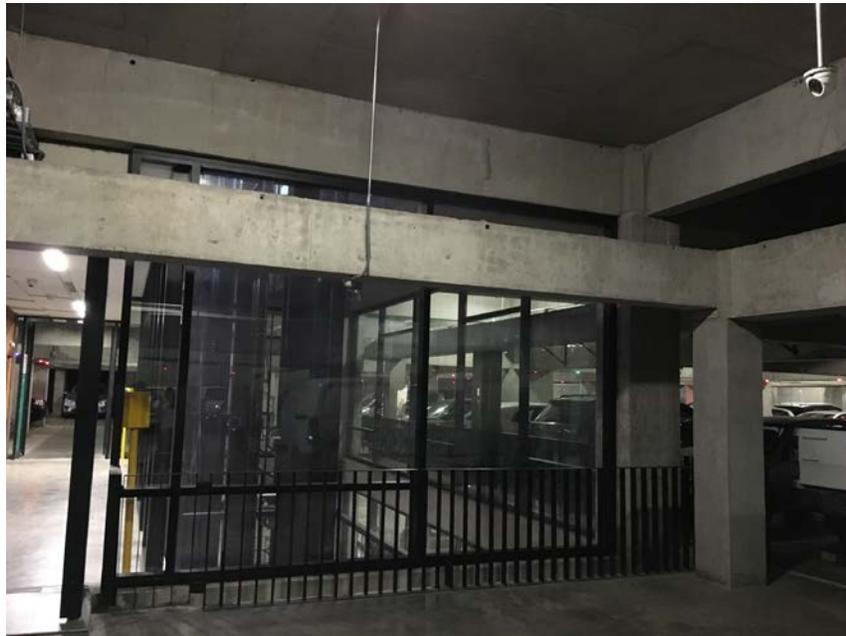
One university visited as part of the reconnaissance, Pontificia Universidad Católica, has placed an emphasis on new buildings being base isolated and two of these buildings were investigated (See Figure 3-4).

*Figure 3. Base Isolated Building on Pontificia Universidad Católica Campus (Innovation Center) (credit: Laura Whitehurst)*

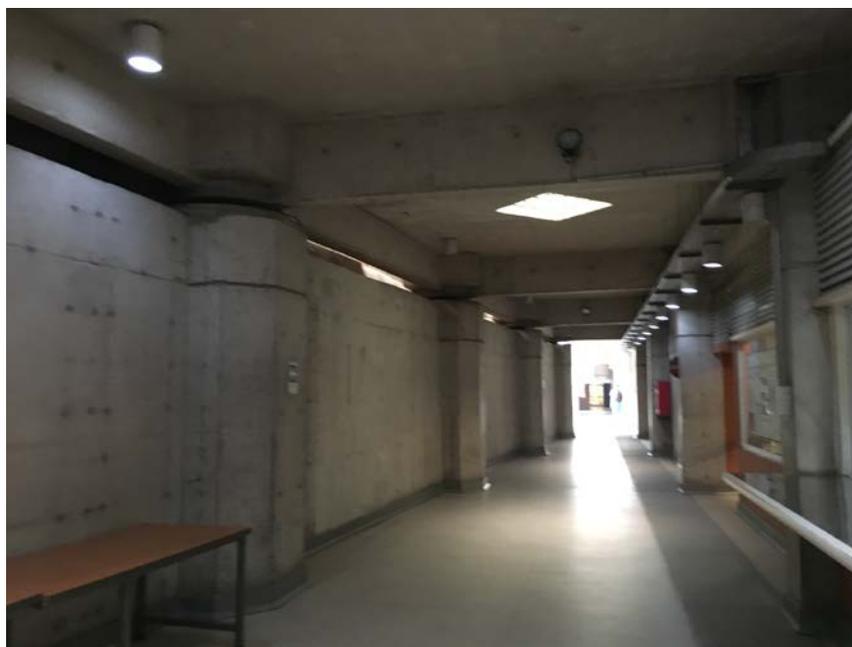
Figure 4. Base Isolated Building on Pontificia Universidad Católica Campus (Engineering School) (credit: Laura Whitehurst)
