Resilience Reconnaissance | Housing

Laura Hernandez, Catherine Johnson, Chad Norvell, and Alvaro Rubinos
EERI Learning From Earthquakes Travel Study Program, Chile 2017

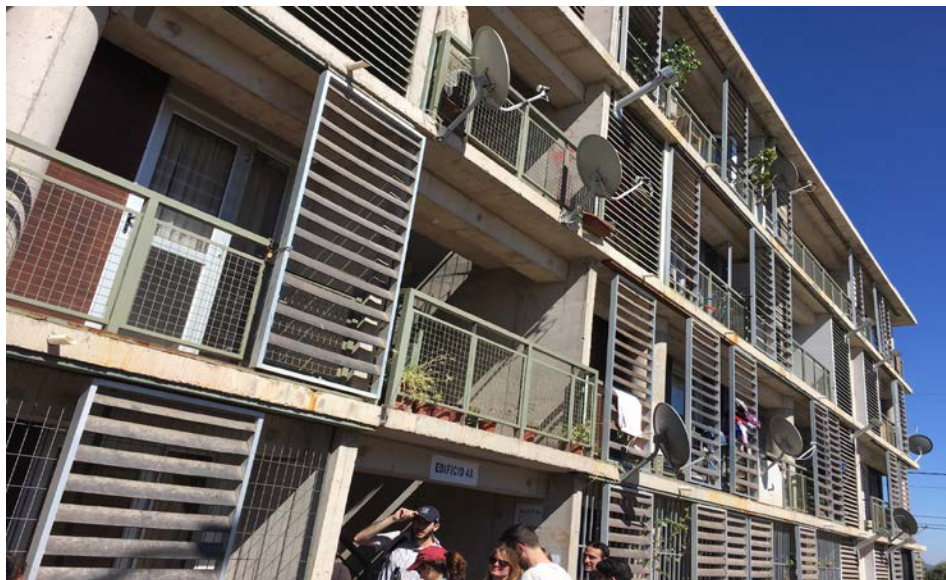
Figure 1. Location 1: Santa Cruz (VI Region O'Higgins)

A social housing complex of approximately 20 blocks of apartments on the edge of Santa Cruz experienced significant physical and emotional damage during the 2010 earthquake. One of the buildings' first floor completely collapsed, causing the second floor to fall on top. This resulted in two deaths. Approximately three other buildings had significant damage. Due to the fatalities during the earthquake and the extensive damage to the buildings, the government decided to demolish all of the existing buildings and build new social housing for the community (Figure 1).

A set of 8 blocks of apartment buildings were built at the same site of the original social housing units. Each building is 4-stories tall, and was built with base isolation to ensure safety during a major earthquake. Base isolation was chosen for seismic protection due to the poor soil conditions on site. The base isolation system consists of a combination of rubber lead isolators and sliders. The units in the new buildings are twice the size of those in the demolished buildings, allowing significantly more room for families. The units were granted to the residents by the government, giving them full ownership of their units. Within the complex, a park, a soccer field, and a memorial to those who died in the earthquake were built to add a sense of community. Residents of the new buildings consist of residents of the previous social housing on site mixed with new residents.

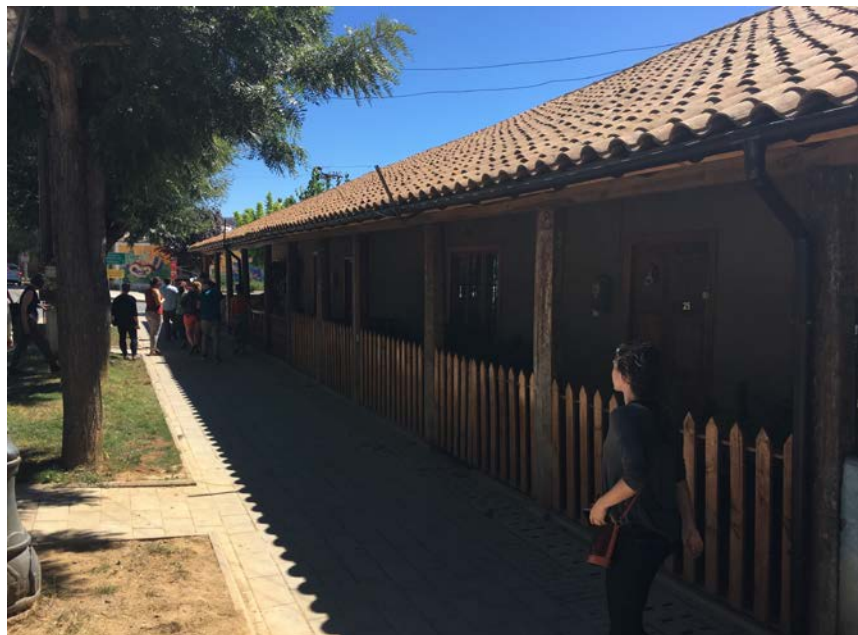
Figure 2. Location 2: Lolol (VI Region O'Higgins)

Lolol is a national heritage area due its large stock of traditionally-built adobe buildings, featuring continuous facades facing the street (Figure 2). This building style is perceived as the stereotypical design of homes in rural Chile and has had significant tourism appeal in Lolol. During the 2010 earthquake, many of these adobe homes were significantly damaged or completely collapsed due to weak materials and poor construction standards, especially in the historic district of Lolol. Only housing that featured a timber frame within the adobe blocks remained repairable, compared to those buildings that lacked a timber frame, which had to be demolished.

Homes were rebuilt by the government in the historic colonial style, but with structural upgrades. Timber frames were used to support the adobe blocks, and the adobe bricks were made with straw to act as reinforcement throughout the wall. Some houses were wrapped in light steel mesh as an alternative to using straw in the bricks. In either case, the walls were covered with adobe finish to give them their traditional appearance. All roofs were wood-framed with clay tile. Some houses were repaired or retrofitted with these improved methods, but most were rebuilt completely.

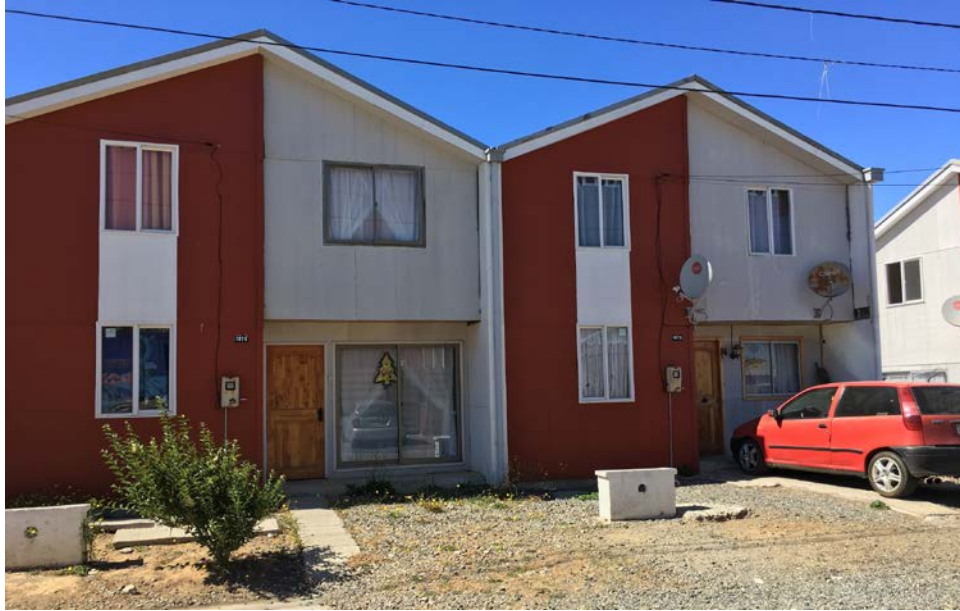
Figure 3. Location 3: Constitución (VII Region del Maule)

New social housing was built on the hills to the west of Constitución, well above the inundation zone. This new community, called Villa Verde, was designed by the Chilean architecture firm Elemental. The houses were designed to be built incrementally--initially a two story frame with a floor and roof were built, and half the house was finished and granted to the former occupants of the tsunami zone (Figure 3). The homeowners could then finish out the other half of the house with their own resources when it was feasible for them, and according to their own preferences. This simultaneously helped to spread the benefit of limited reconstruction resources to a larger population, while also encouraging homeowners to make the home their own, establishing a sense of ownership. Although the intent was that these homes would be exclusively for those families displaced from the inundation zone, as in other communities the resilience reconnaissance team found that many of the homes were occupied by families who lived in other areas prior to the earthquake.
