MIDDLE EAST TECHNICAL UNIVERSITY

Earthquake Engineering Research Center

Geotechnical Aspects of February 6, 2023 Kahramanmaraş-Türkiye Earthquake Sequence (Mw=7.8 and Mw=7.6)

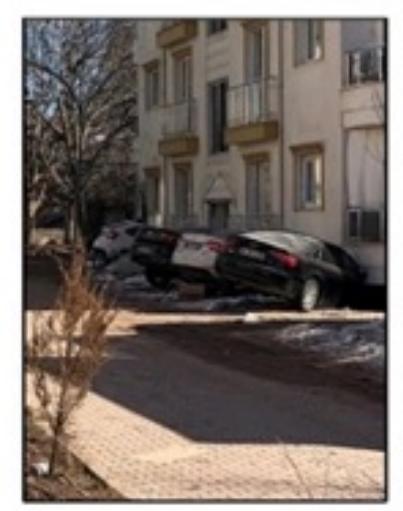
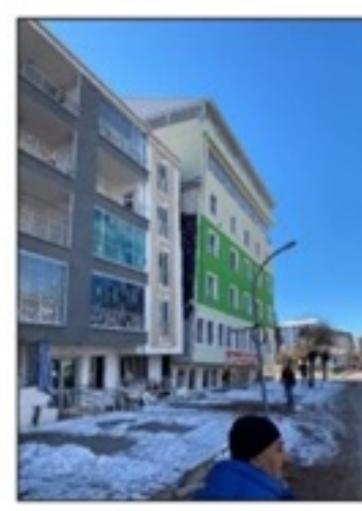
37.788°N 37.6432°E

Liquefaction-induced settlement observed at a) Gölbaşı-Adıyaman, and b) İskenderun-Hatay

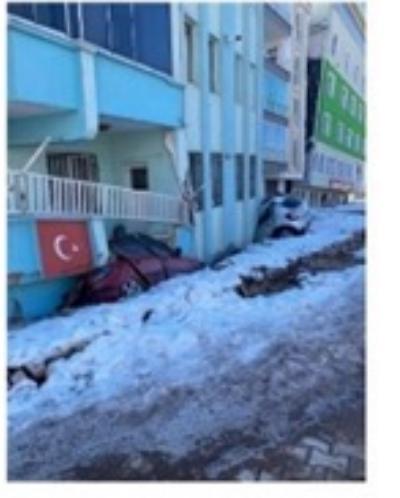
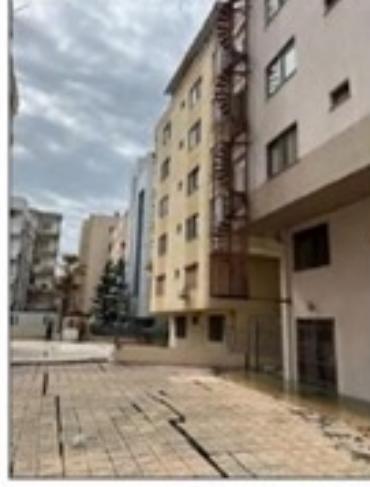
37.788°N 37.642°E a) Gölbaşı-Adıyaman

Liquefaction-induced settlement observed at Gölbaşı-Adıyaman

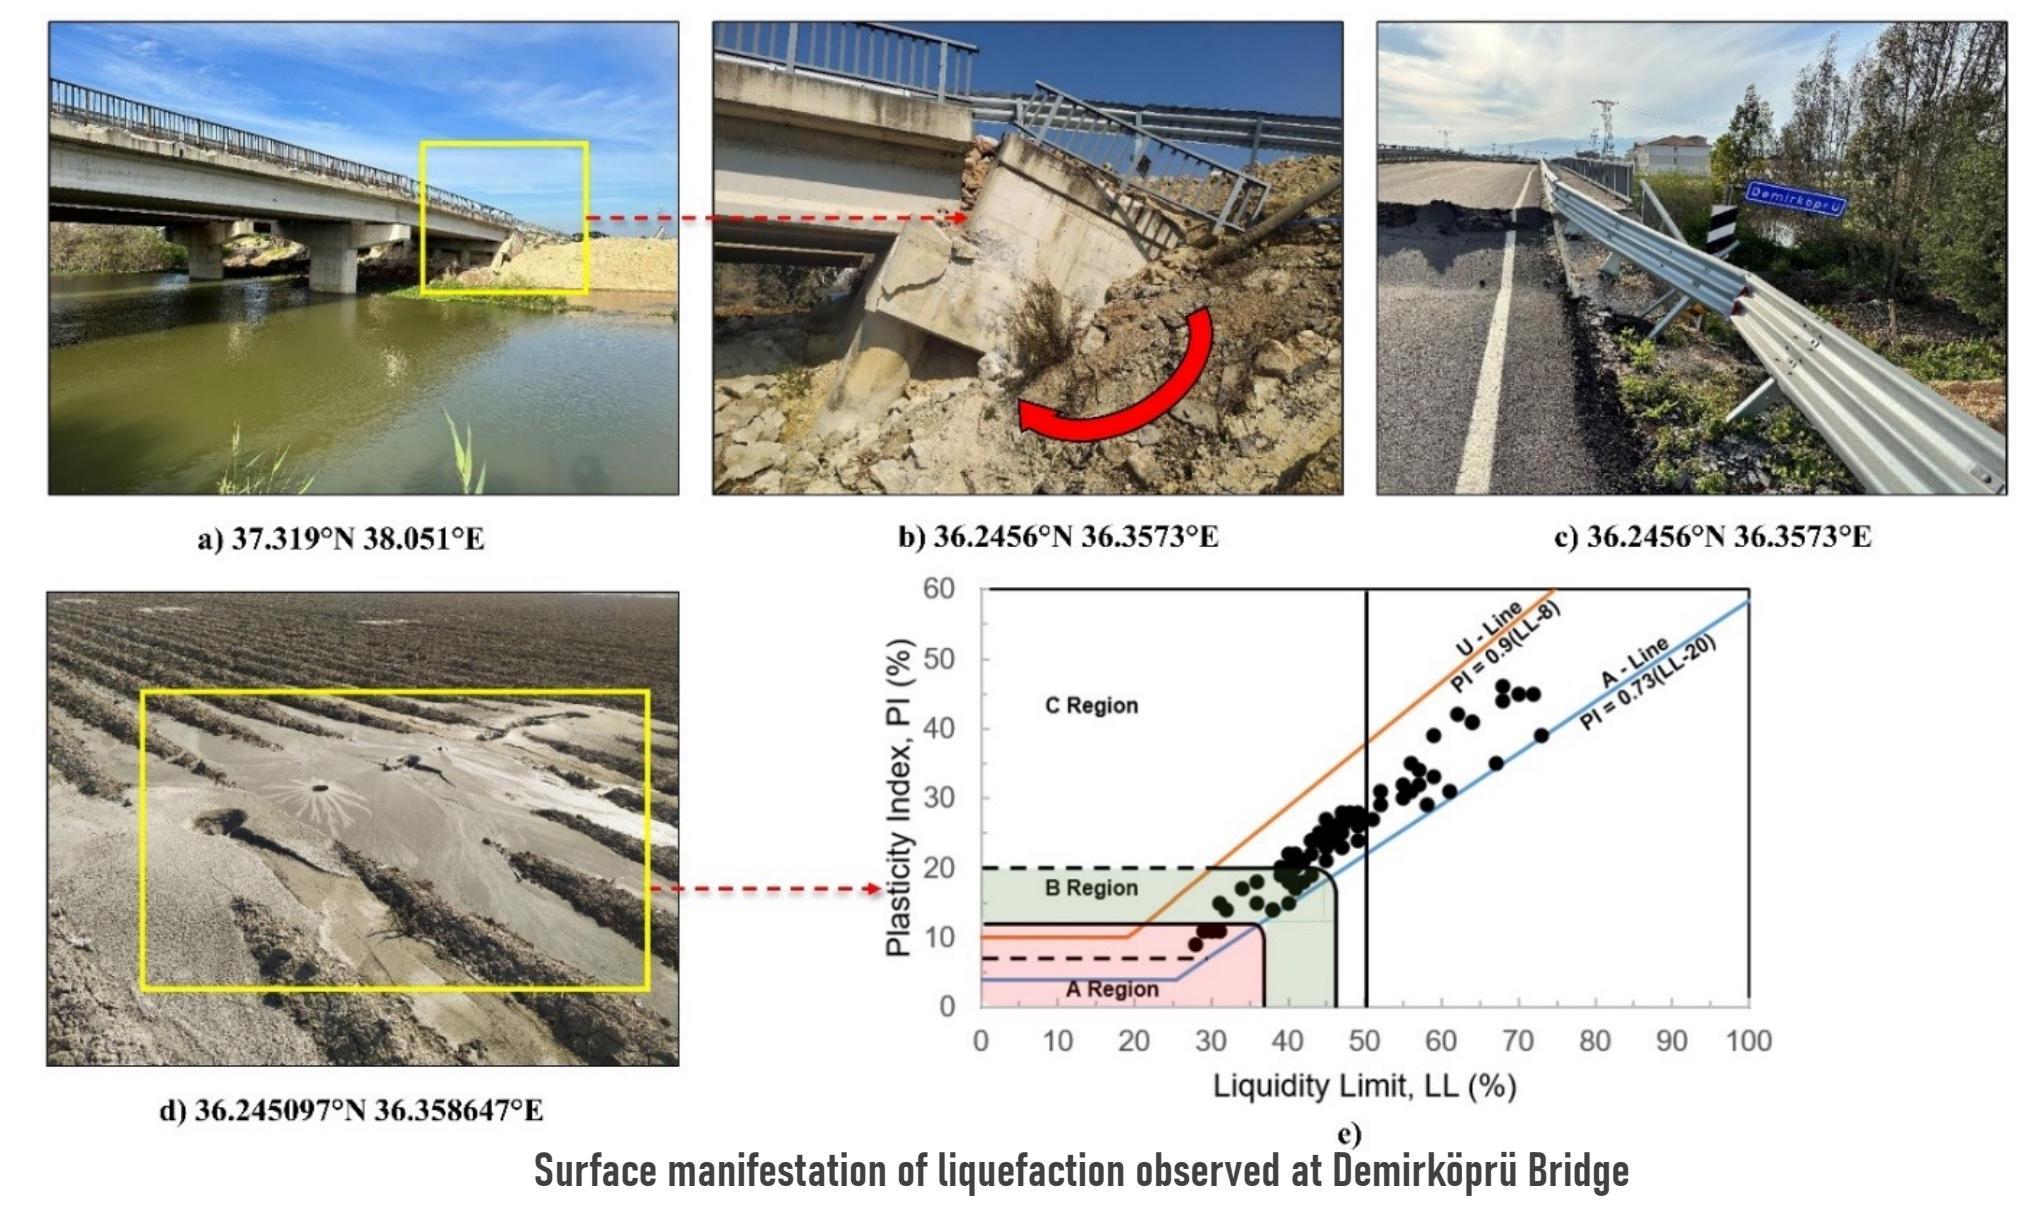
Surface manifestation of liquefaction observed at Demirköprü Bridge

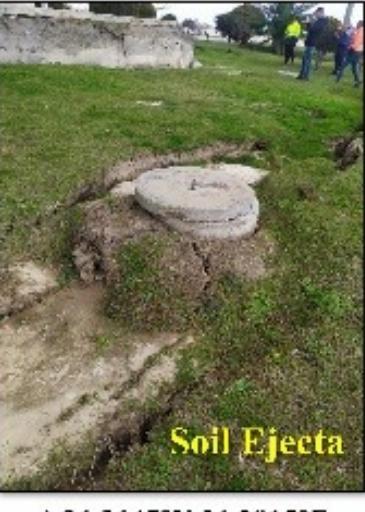
c) 36.3645°N 36.2815°E

Surface manifestation of liquefaction observed at Hatay Airport

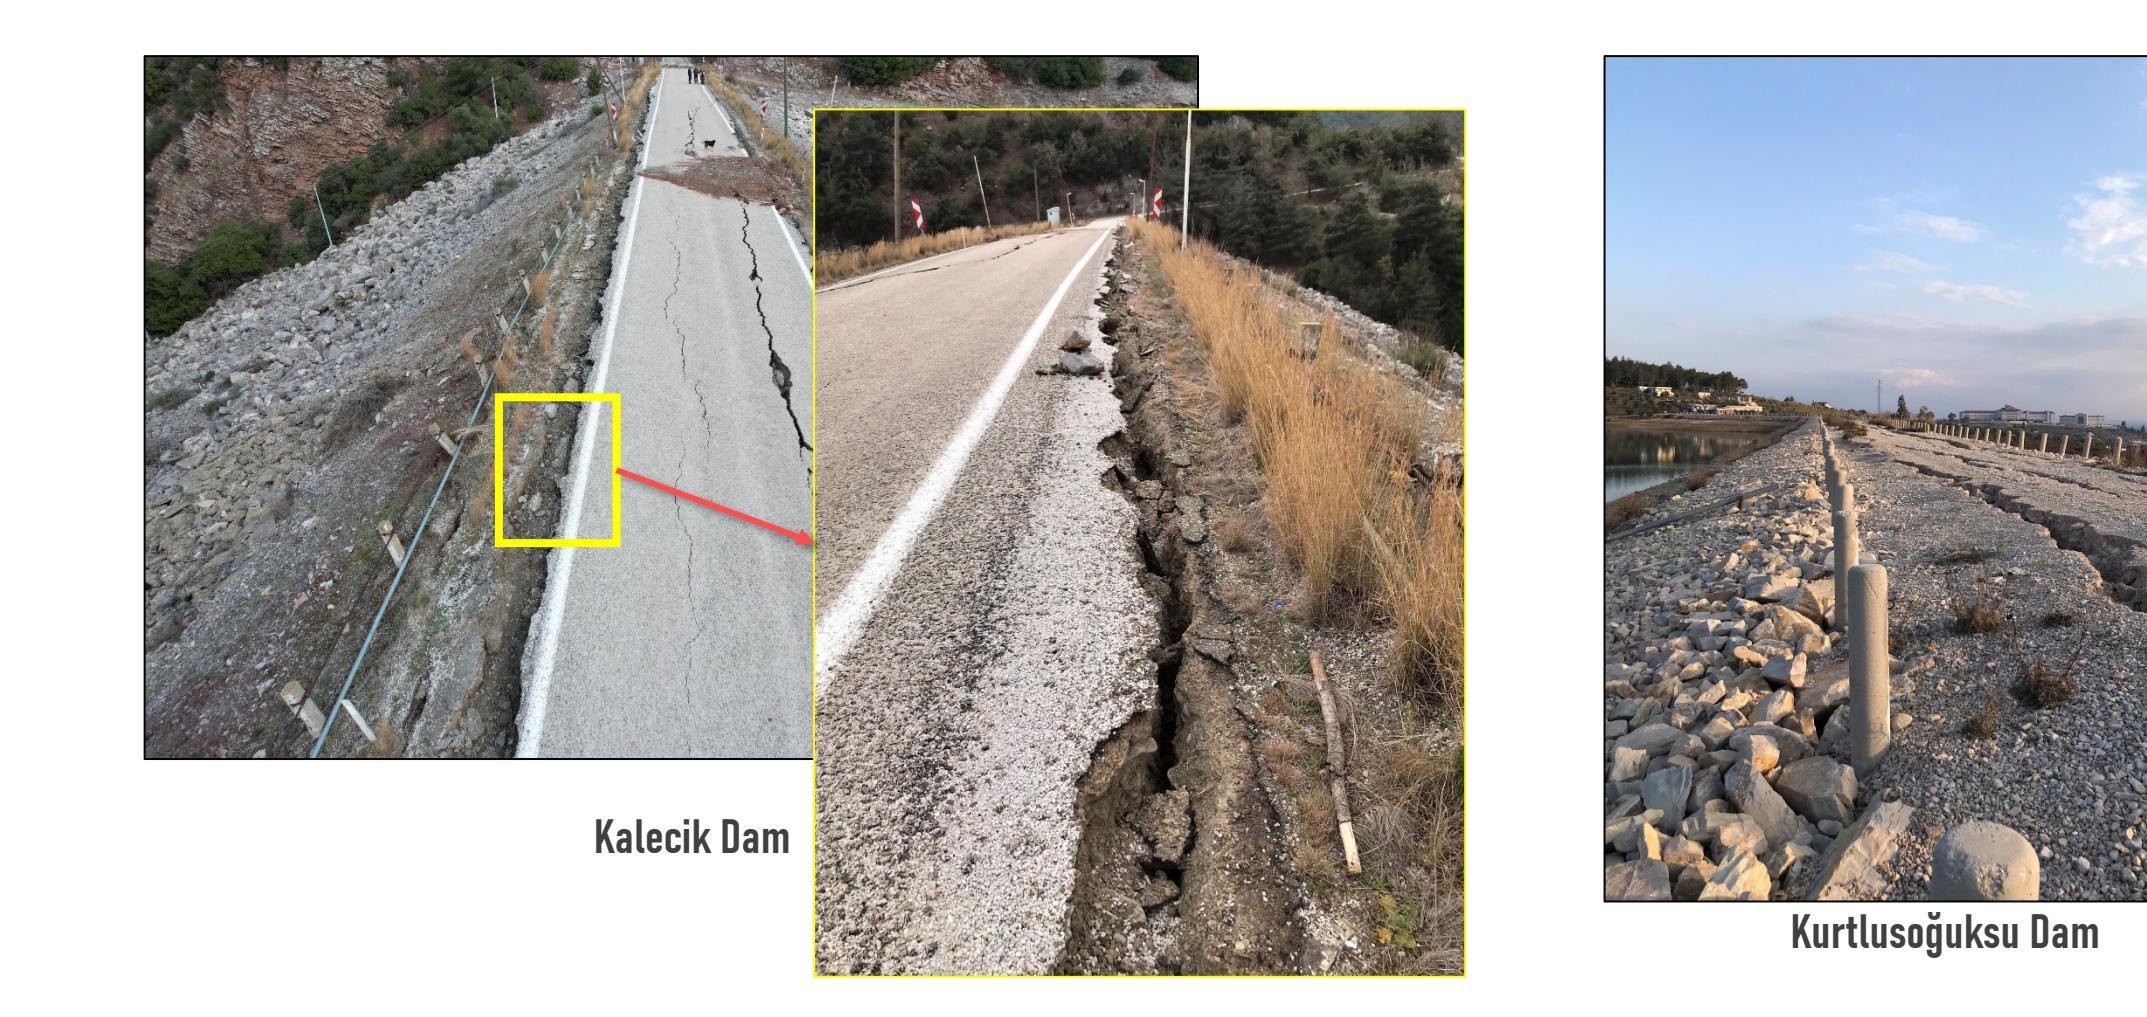
Permanent Ground/Soil Displacements Deformations: at Earthfill and Rockfill

- Stone gravity walls performed poorly under high seismic demands. Well-designed and constructed reinforced earth walls performed exceptionally well.
 - The filter zones in earthfill and rockfill dams typically consist of liquefiable sand and gravel. Inadequate compaction in these zones lead to liquefaction and concentrated displacements at filter interfaces.
