San José del Palmar Chocó Earthquake –  
August 10, 2026  
Effects in Cali and the Cauca Valley  
Department– Colombia  
Report  
V. 3.0 16/08/2026

Ana Maria Parra Bastidas, PhD, MSc, PE in Colombia EIT in California  
Projects Engineer  
Carlos H. Parra y Asociados S.A.S.

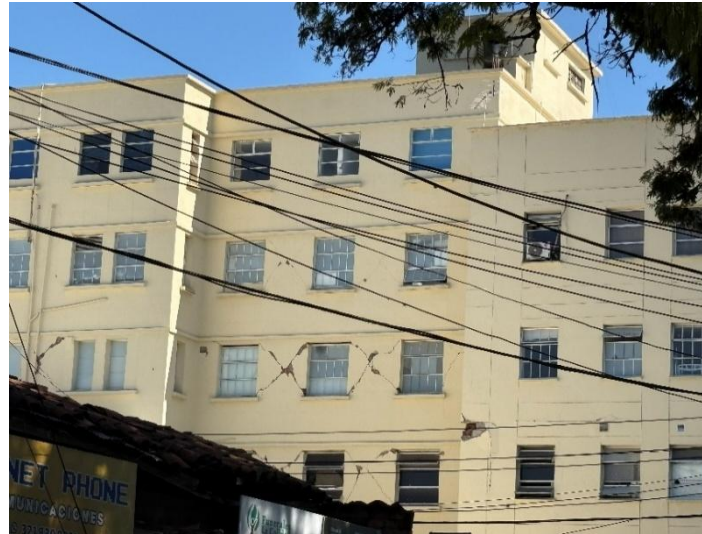
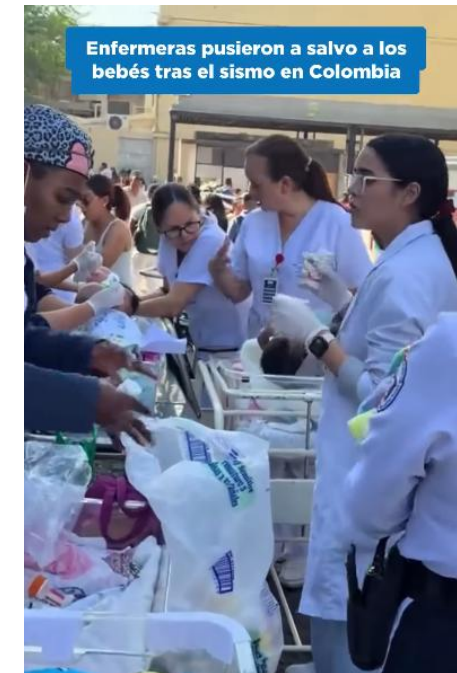
# Hospital Universitario del Valle (HUV)

- This hospital was retrofited before the San José del Palmar Chocó Earthquake – August 10, 2026 EQ.

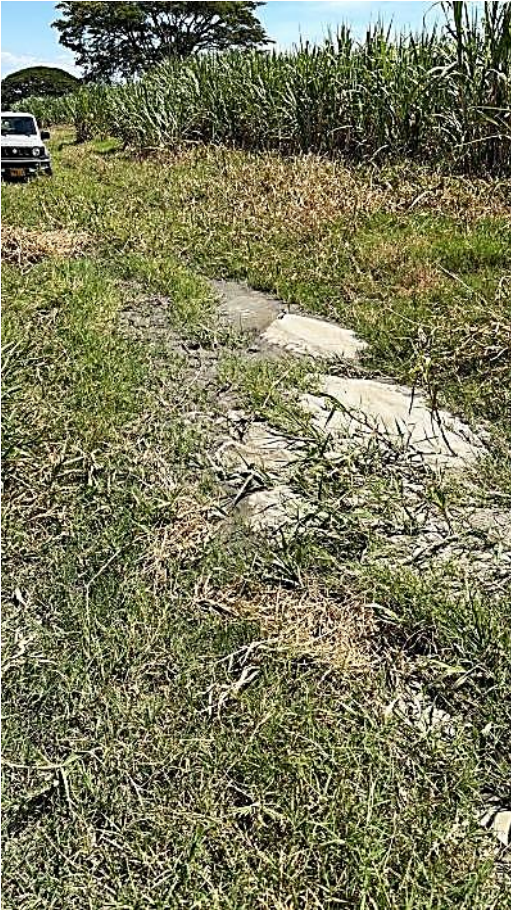
Sand boil, Bolivar, Cauca Valley
